The paper was published in the proceedings of the 7th International Conference on Earthquake Geotechnical Engineering and was edited by Francesco Silvestri, Nicola Moraci and Susanna Antonielli. The conference was held in Rome, Italy, 17 - 20 June 2019.

The legacy of the 1987 Edgecumbe earthquake, New Zealand

C.H. de Gale Price

K.J. Christensen

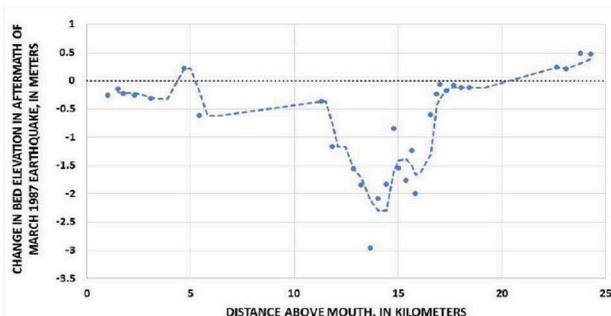
The 1987 Mw6.5 Edgcumbe earthquake caused settlement of up to 2 m across 200km² of the Rangitaiki plains, causing subsidence and damage to the flood protection system on the Rangitaiki River, and reducing its flood protection capability from a 100-year return period flood to an unacceptable standard of a 20-year return period flood (Dine et al 1988). Changes in the thalweg elevation of the river after the earthquake are shown in Figure 2 (Simon 2017).

Figure 2. Changes in thalweg elevation of the Rangitaiki River after the 1987 earthquake (Simon 2017)

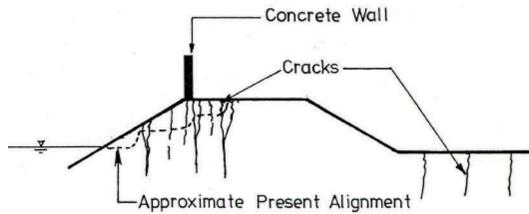
Following the subsidence at Edgumbe from the 1987 earthquake the 0.61 m high concrete floodwall constructed in 1973 was replaced by a 1.40m high wall in 1993. A report on the earthquake damage compiled immediately after the earthquake indicated that this floodwall had suffered foundation failure in the earthquake, and the initial estimates of damage rated this section of repairs as the most costly of all left bank works on the Rangitāiki River, at \$46,350 (value at 1987). The damage was described as “river bank slumping” and “foundation failure of concrete walls”, requiring “stabilisation of the toe above and below the plane of failure is required by placement of rock” and “re-establishment of the original structure”, and was illustrated in the damage summary report immediately after the earthquake as shown in Figure 3 (Jones 1987).

Figure 3. The illustration of damage to the floodwall foundations in the damage records for the earthquake, captioned in the report as “Damage Type: slumping of foundations with structures on top” (Jones 1987)

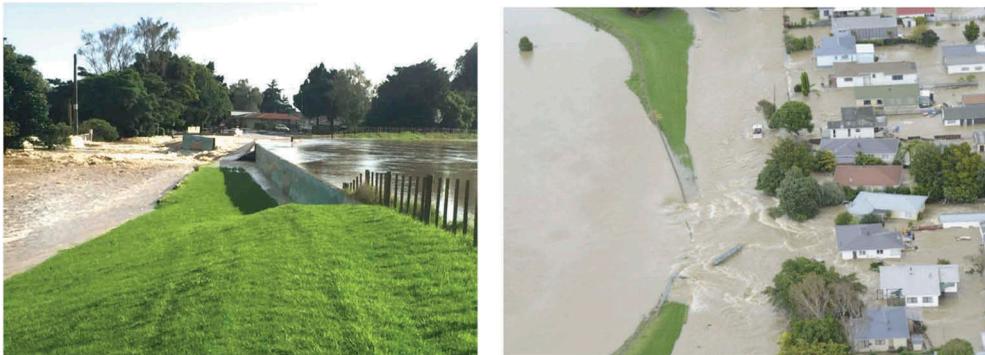
A number of causes could have contributed to the failure of the floodwall, and as most physical direct evidence was destroyed in the flood it is not possible to be conclusive as to its cause, but what is clear is that the wall collapse was a progressive failure consisting of two sliding failures, firstly that of a cribwall forming the toe of the stopbank, followed by the floodwall itself, which slid out onto the adjacent road. Further, these occurred as a result of a build-up of pore water pressure in the shallow ground on the landward side of the wall, which was accentuated by the confining effect of a concrete slab covering the ground surface and restricting seepage dissipation. The upright wall, still standing after the failure, can be seen in photographs taken 5 minutes and 2.5 hours after the breach first occurred, Figures 4 and 5.

Seepage analysis indicated that the duration of the flood was inadequate for sufficient pore pressure to have developed via porous flow, and therefore must have emanated through a preferential flowpath(s), and other evidence suggested that this must have been through shallow ground. Two factors most likely to provide such a flow path were identified as either a permeable layer arising from variable quality fill in the foundation, or ground fissuring from the 1987 earthquake which was recorded immediately after the earthquake but which was not rectified before the new wall was constructed in 1993. This failure is therefore likely to be a legacy of the 1987 earthquake 30 years earlier.

Figures 4 & 5. The breach, showing the failed wall 5 minutes and 2.5 hours respectively after the breach (Sources: Bay of Plenty Regional Council Contractor, and Bay of Plenty Regional Council respectively)

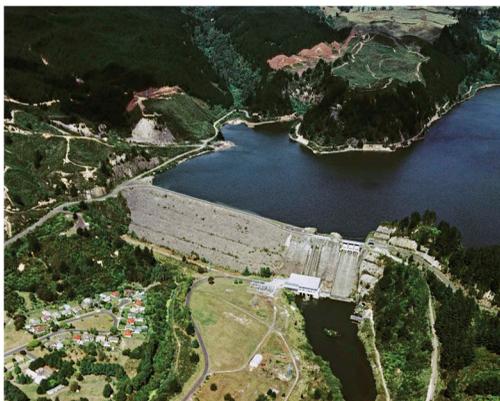
In March 1987 the dam suffered strong shaking from the Edgumbe earthquake, recording a peak ground acceleration of 0.33g at the base of the dam. This caused the rockfill at the dam crest to settle about 100 mm and the dam to move 250 mm downstream, generating deformation of the dam shoulders. Minor cracking on road surfaces were noted at both abutments. The rockfill in the upstream and downstream shoulders settled 0.8 m and 0.1 m respectively, and settlement continued for several weeks after the earthquake. Settlement was not

Figure 6. Matahina Dam in 1987 (GNS Science VML No 15554, photographer Lloyd Homer)

considered to be excessive, but nevertheless regarded by the dam's engineers with some disquiet due to the dam's history. Seepage increased into the drainage galleries, but no major leakage occurred (Gillon 1988, 2007).

During these investigations, nine months after the earthquake, an erosion cavity formed on the crest of the dam. An emergency drawdown of the reservoir was made and excavations into the left abutment identified serious erosion issues. These investigations showed that remedial measures following the 1967 internal erosion issue had performed well, but they unexpectedly revealed an erosion cavity in the right abutment considered to be unrelated to the earthquake shaking, in addition to a cavity in the left abutment (Gillon 2007). The reservoir level was then completely drawn down for further investigation and repairs.

It was concluded from the investigations that meta-stable filling within pre-existing settlement induced cracks in the left abutment had been disturbed by the strong ground motions, allowing internal erosion to re-commence. This eventually resulted in a cavity developing within the core just above water level, and should internal erosion have continued it was likely to have resulted in a sudden large outflow (Gillon 2007).

In the 1980s there was a move to improve the seismic safety of dams in New Zealand, and the poor performance of Matahina dam in the Edgecumbe earthquake indicated its need for such a re-evaluation. Studies then established that some of the known faults in the dam foundations previously thought to be inactive were in fact active, and it became clear that the seismic safety of the dam was inadequate. The dam was then dewatered and substantial remedial works were carried out in the 1990s.
