# Recovery and Resilient Design for the Future – a Case Study from Christchurch, New Zealand

Camilla Gibbons

Brenden Winder

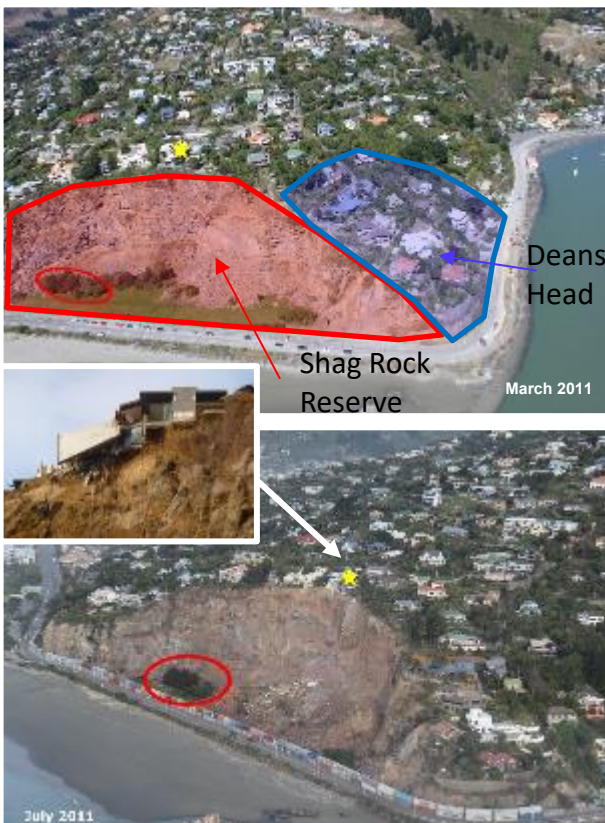
Figure 3. Shag Rock Reserve photographs taken in March 2011 and July 2011. Note the row of double stacked shipping containers protecting the road from rockfall

The western end of Shag Rock Reserve is Deans Head, this spur of land slopes steeply (40°) down towards the road below, refer to Figure 3. During the earthquakes, there was intense ground cracking observed and although no defined "toe" was observed, it was clear the hillside was a large mass movement area. The geology of the hillside comprises around 4-6m of Loess and Loess-colluvium soils overlying Basalt. Ground investigations were undertaken, inclinometers and piezometers installed and continuous GPS points were set up on the surface to monitor any movement. The ground only displayed significant movements during large aftershocks. GNS undertook slope stability modelling and determined that if the soil was saturated and then experienced a 1 in 10 year rainfall event, a large failure could be initiated that would inundate the road below. Just the other side of the road is the estuary and the modelling indicated that around 40,000m<sup>3</sup> of material could inundate the estuary. This would have significant knock-on effects to the low-lying estuarine residential areas, particularly on a spit 500m across the other side of the main channel, refer to Figure 4.

shipping containers was used as a rapid protection measure for the road. These were 40ft containers with 20t ballast, with a second row on top of empty containers. The two levels were connected with shipping grade locks, refer to Figure 3. The shipping containers were used in many places around the Port Hills to protect roads from the risk of rockfall. Likewise, in the centre of town, shipping container "walls" were put up to protect road users from the risk of collapsing facades.

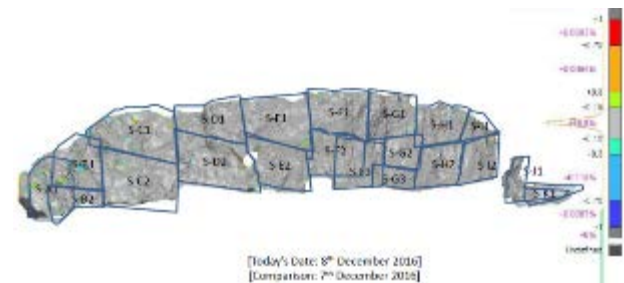
manually reviewed each morning prior to work commencing on site, refer to Figure 5. Scanning was undertaken during the day of the particular segments above the work areas.

Scanning was undertaken during the day of the areas of the cliff above the parts of the site where the work was being undertaken. The scans were manually checked during the day. The laser scanning approach did not provide a real-time alert system, however it was deemed that the system might provide some warning if blocks were beginning to move due to non-seismic triggers.

Figure 5. Laser Scan change model

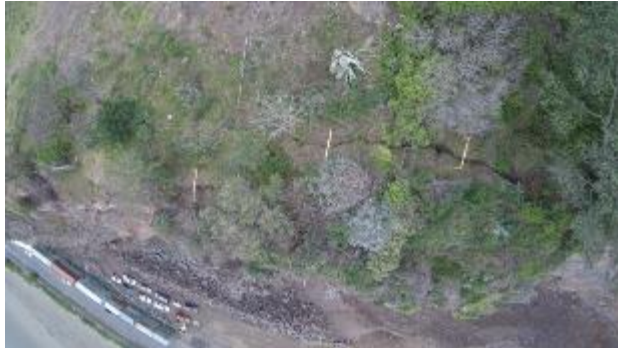
In addition to the surveying approach, there were also tell-tails installed across cracks on the top of the cliff, refer to Figure 6. There were two potential failures features in the upper half of the cliff; one was estimated to be approximately 500m<sup>3</sup>, the other about 2000m<sup>3</sup>. These two features were measured specifically with the laser scans in detail, however during the weekly drone flights the tell tales were checked using the drone. This provided a fail-safe check if the supporting technology failed for any reason.

Figure 6. Tell Tails on the top of the cliff
