## Observed Earthquake Damage to Christchurch City Council Owned Retaining Walls and the Repair Solutions Developed

L. Kendal Riches<sup>1</sup>

### ABSTRACT

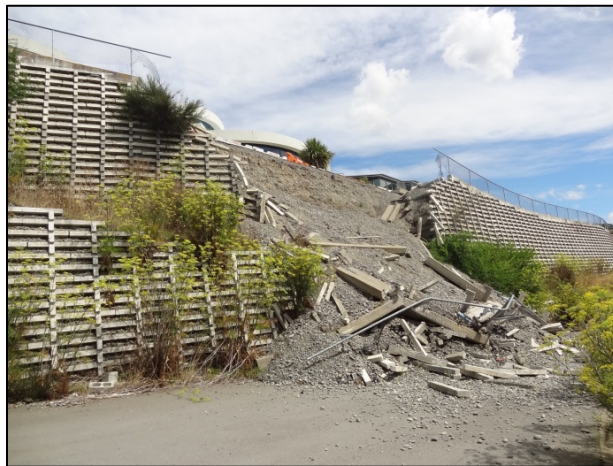
Crib walls developed a poor reputation because of the performance of some walls in the earthquakes. There is little holding the crib units together except gravity, so under vertical accelerations the crib units were able to shake apart and catastrophic collapse of these walls was not uncommon. An example is shown in Figure 1. Other walls were less damaged, but significant volumes of fill were lost from the wall and this reduced the stability of the structure as shown in Figure 2. The tendency to use rounded river run as fill for the walls was particularly detrimental because these rounded stones were easily mobilised during shaking and lost through the front of the wall.

Figure 1. An example of a collapsed crib wall

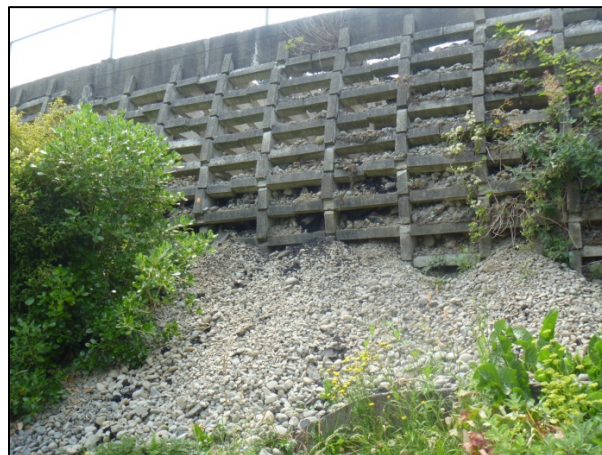
Figure 2. A crib wall showing bulging and loss of fill

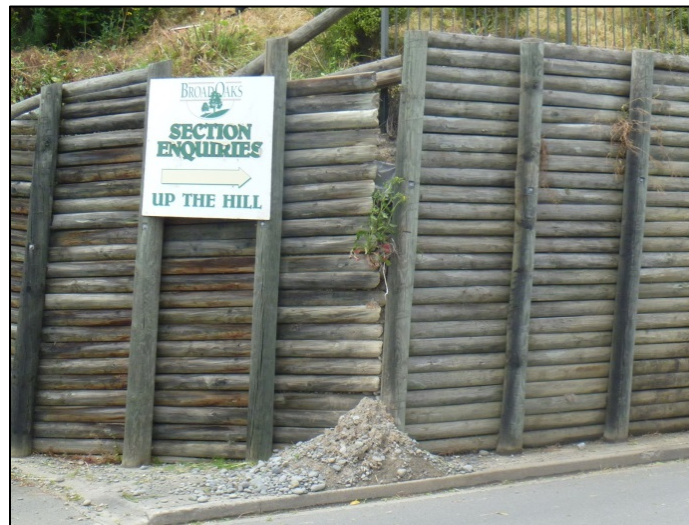
Both anchored and unanchored timber pole walls are common in Christchurch. The damage to these walls tended to be to individual elements or points of weakness. For example outside corners were often vulnerable, like the example shown in Figure 3, and lagging could pop out from behind the vertical poles. In other walls individual poles may splinter. However collapse of these walls was not routinely observed. One particular phenomenon was where anchors have small plates on the face of the timber poles and the shaking has caused the poles to move, but the anchors have remained in place. This often resulted in the anchor plate punching into the pole, as shown in Figure 4, or else the anchor head failing. Elsewhere walls may have deformed by moving forward during shaking and then the fill behind the wall has settled. This prevents the wall from returning to its original position and results in ground deformation behind the wall.

Figure 3. Damage to a vulnerable corner of a timber pole wall

Typically timber pole walls needed little repair and in some instances it was sufficient to replace damaged elements on a like for like basis. Where, for example, corner sections had been damaged additional poles or anchors were added.

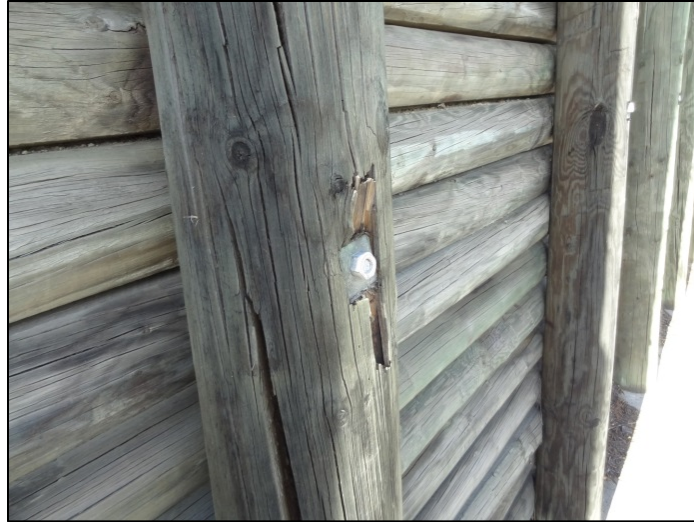
Figure 4. Damage around the anchor head of a timber pole wall

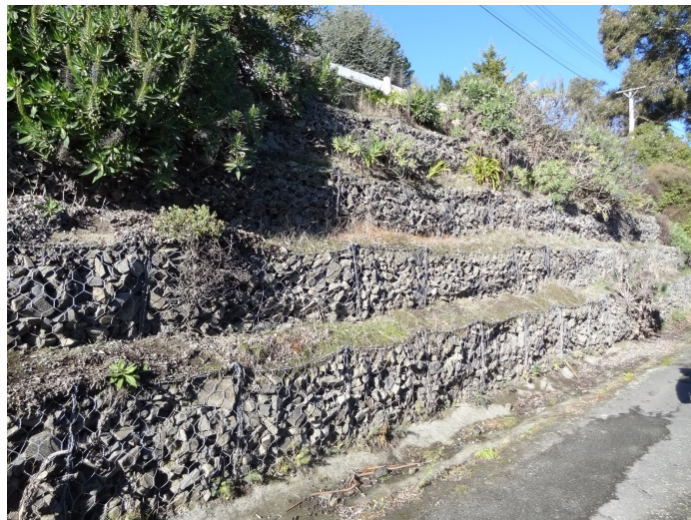
Gabion baskets are inherently flexible structures. Therefore during earthquake loading these walls tended to deform as can be seen in Figure 5. Generally baskets did not rupture and in the majority of cases the roads and infrastructure behind the walls remained serviceable, however deformation in both the wall a surface behind the wall could be considerable. Often where a road or footpath was above the wall, cracking could be observed in line with the back of the baskets. An example of this can be seen in Figure 6. Baskets filled with rounded river run or else loosely packed stone of any type often suffered greater deformation.

Figure 5. A badly deformed gabion wall

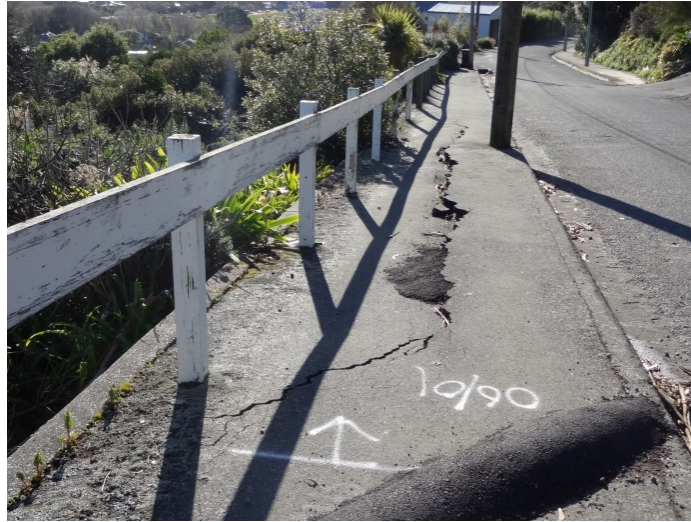
Figure 6. Footpath above a gabion wall showing cracking

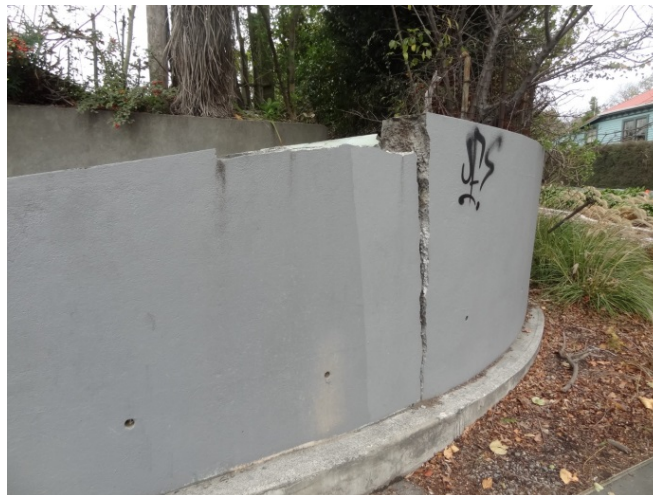
The performance of concrete walls could often be attributed to the pre-earthquake condition of the structure. For example a poorly reinforced or badly maintained wall would be more likely to be damaged. Cracking was usually at points of weakness and often resulted in excess rotation, rather than collapse as shown in Figure 7. One wall which performed well had been constructed as part of a hospital complex c.1900. Despite the age of the wall it showed no damage, except to a parapet which retained no fill. This parapet cracked as shown in Figure 8.

Figure 7. A typically damaged concrete retaining wall

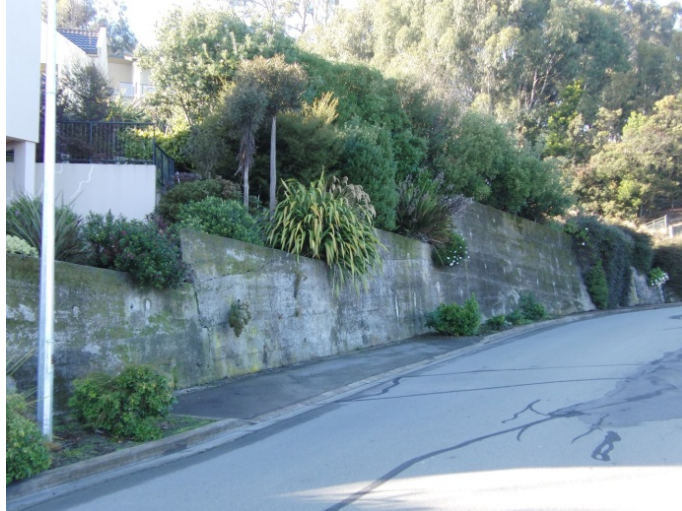
Figure 8. A concrete retaining wall c.1900 showing little damage

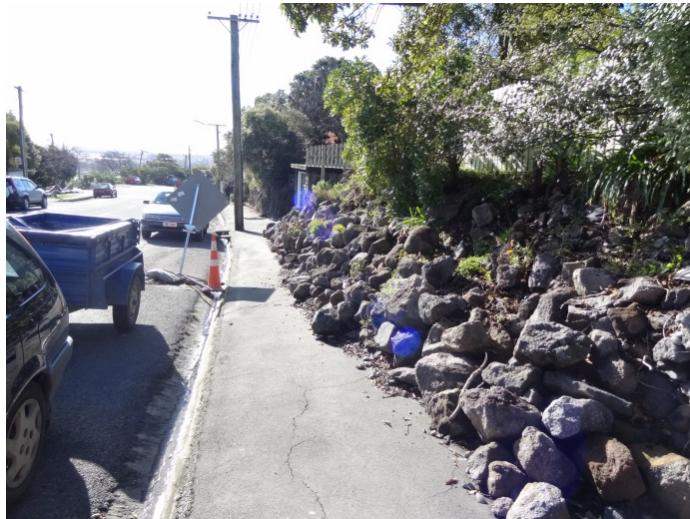
There are many stone walls in Christchurch. Typically these were at least 100 years old and were not engineered. It was not uncommon for these walls to have suffered complete collapse as shown in Figure 9. In fact many of the stone walls act as a facing to protect the loess slope behind. So it was not uncommon that when the wall collapsed that the loess face remained stable. This can be seen at the top of the wall shown in Figure 10. While these walls were typically in the region of 100 years old, those which had been rebuilt more recently did perform better. This may be due to younger mortar having greater flexibility.

Figure 9. A completely collapsed stone wall

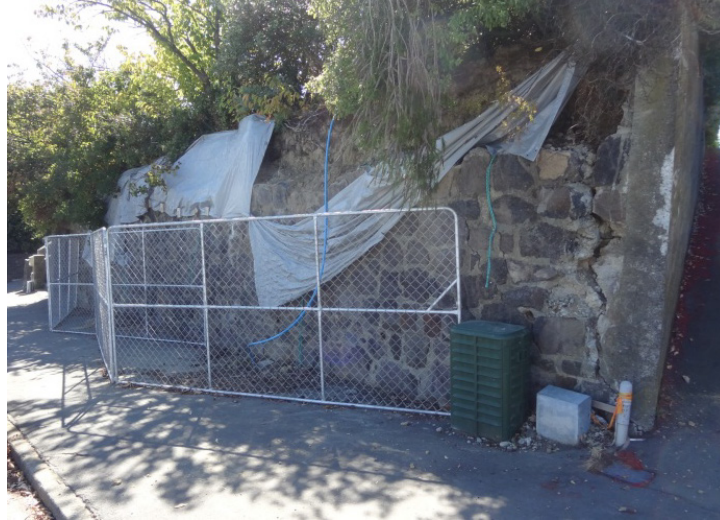
Figure 10. A partially collapsed stone wall showing typical damage

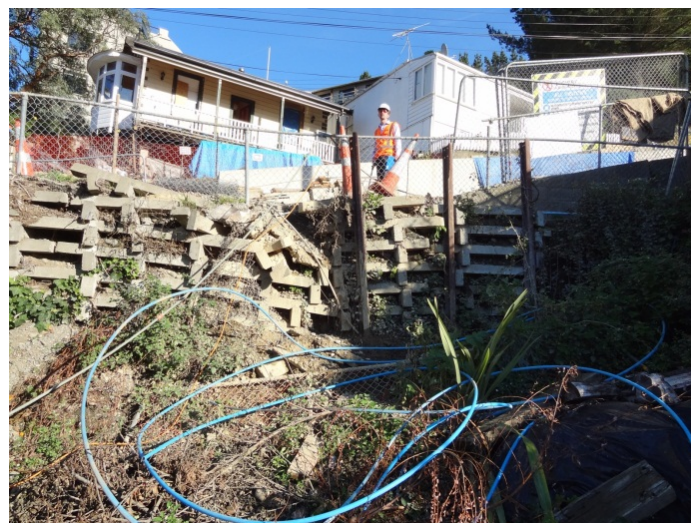
Figure 11. Damaged crib wall due for refurbishment as a soil nail wall

The analysis of a soil nail wall considers the nails to form a solid mass of soil which can resist soil and earthquake loading. In this case the existing crib wall is also considered to be part of this mass. An example of this can be seen in Figures 11 and 12.

In order to install soil nails through this crib wall the nails had to be drilled through a PVC casing through the crib units. Ideally the angle of the nails would match that of the crib units so as they do not need to be drilled through the rear stretchers, but this location had shallow buried services behind the wall which meant that the anchors had to be steeper and therefore extra drilling was necessary. A shotcrete facing was applied as the final face and this would hold in place the existing crib fill in the event of a future earthquake and maintain the mass of the structure.

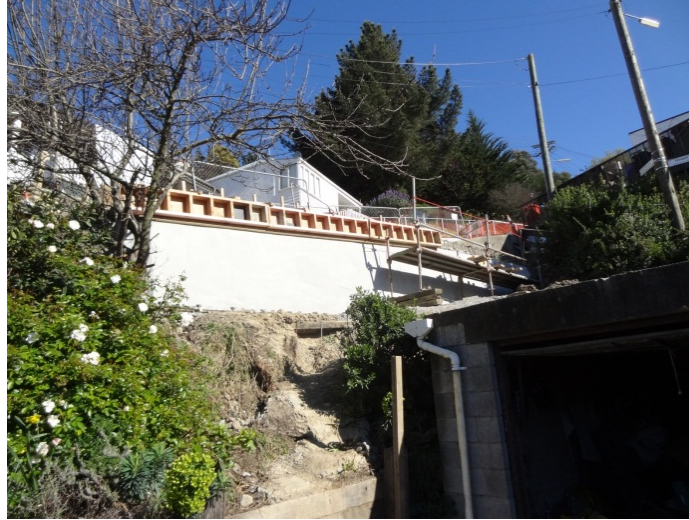
Figure 12. A soil nail wall refurbishment with shotcrete facing

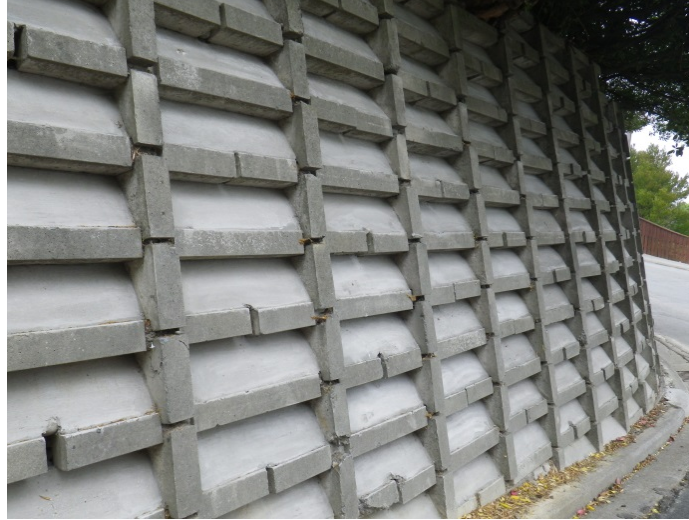
Figure 13. A crib wall with minor repairs to prevent future loss of fill

Some walls had minor damage to individual crib units and were at risk of loss of fill. These could be repaired by adding something to the front of the wall to block the front of the crib units. Options developed for this included cast in place concrete or geotextile strips. An example using concrete is shown in Figure 13. This would ensure the stability of the wall. Where the front of the wall became a solid face, drainage weep holes were also included in the design.

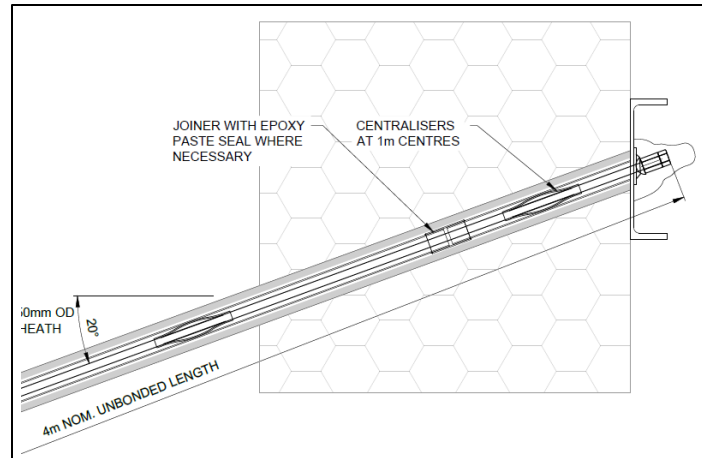
Figure 14. Sketch showing arrangement of anchors through gabion baskets

The anchored solution, shown in Figure 14, is designed to prevent further deformation under future seismic loading. In this case a PFC waling will span between anchors on the face of the wall. Drilling anchors through the gabion baskets was achievable, but there were some particular lessons learnt:

- Drilling of the anchors was possible and while the basket mesh at the rear of the basket was awkward to penetrate, it could be done.
- During grouting there is no grout recovery and therefore there is less certainty regarding how complete the grout is. Therefore all anchors were load tested.
- The testing regime needs careful consideration because measuring deflection was challenging because the baskets did not provide the required reaction for the jacking during testing.
- The gabion baskets were damaged by the plate used in testing. Therefore using a textile layer or other protection under the plate is recommended.
