Earthquake-Induced Ground Fissuring and Spring Formation in Foot-Slope Positions and Valley Floor of the Hillsborough Valley, Christchurch, New Zealand

C. S. Brownie¹, M. Green² and D. Bell³

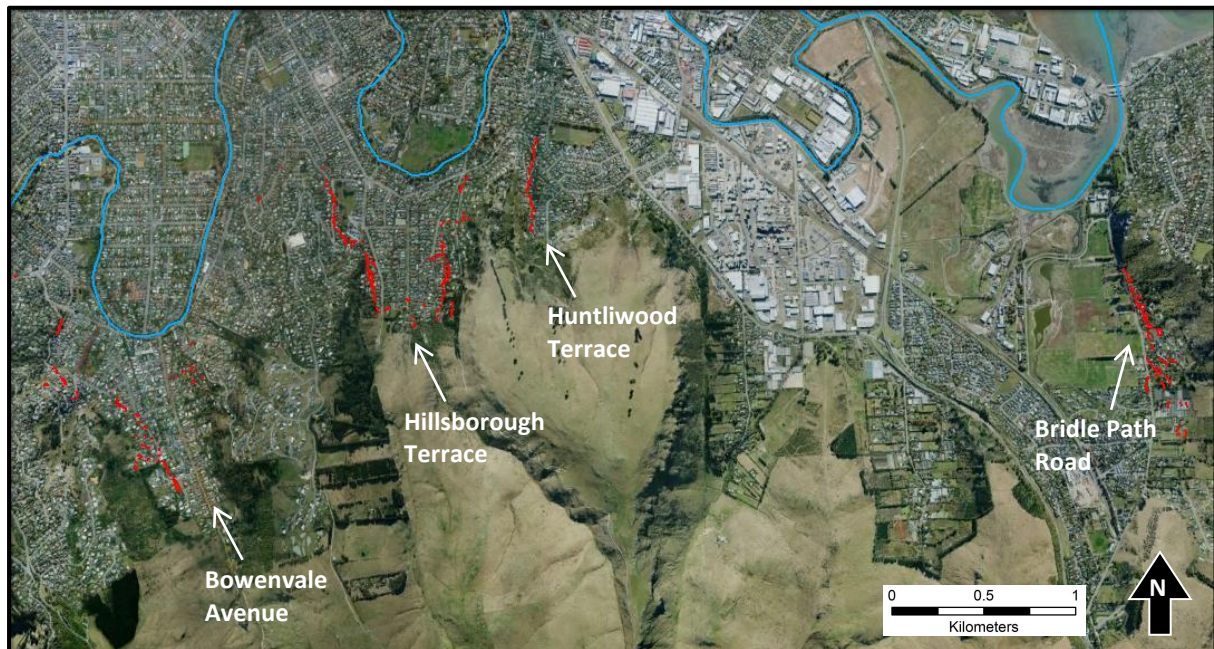
Figure 1: Overview map showing prominent fissure locations (fissure traces marked in red). Background imagery from Google Earth, 2012.

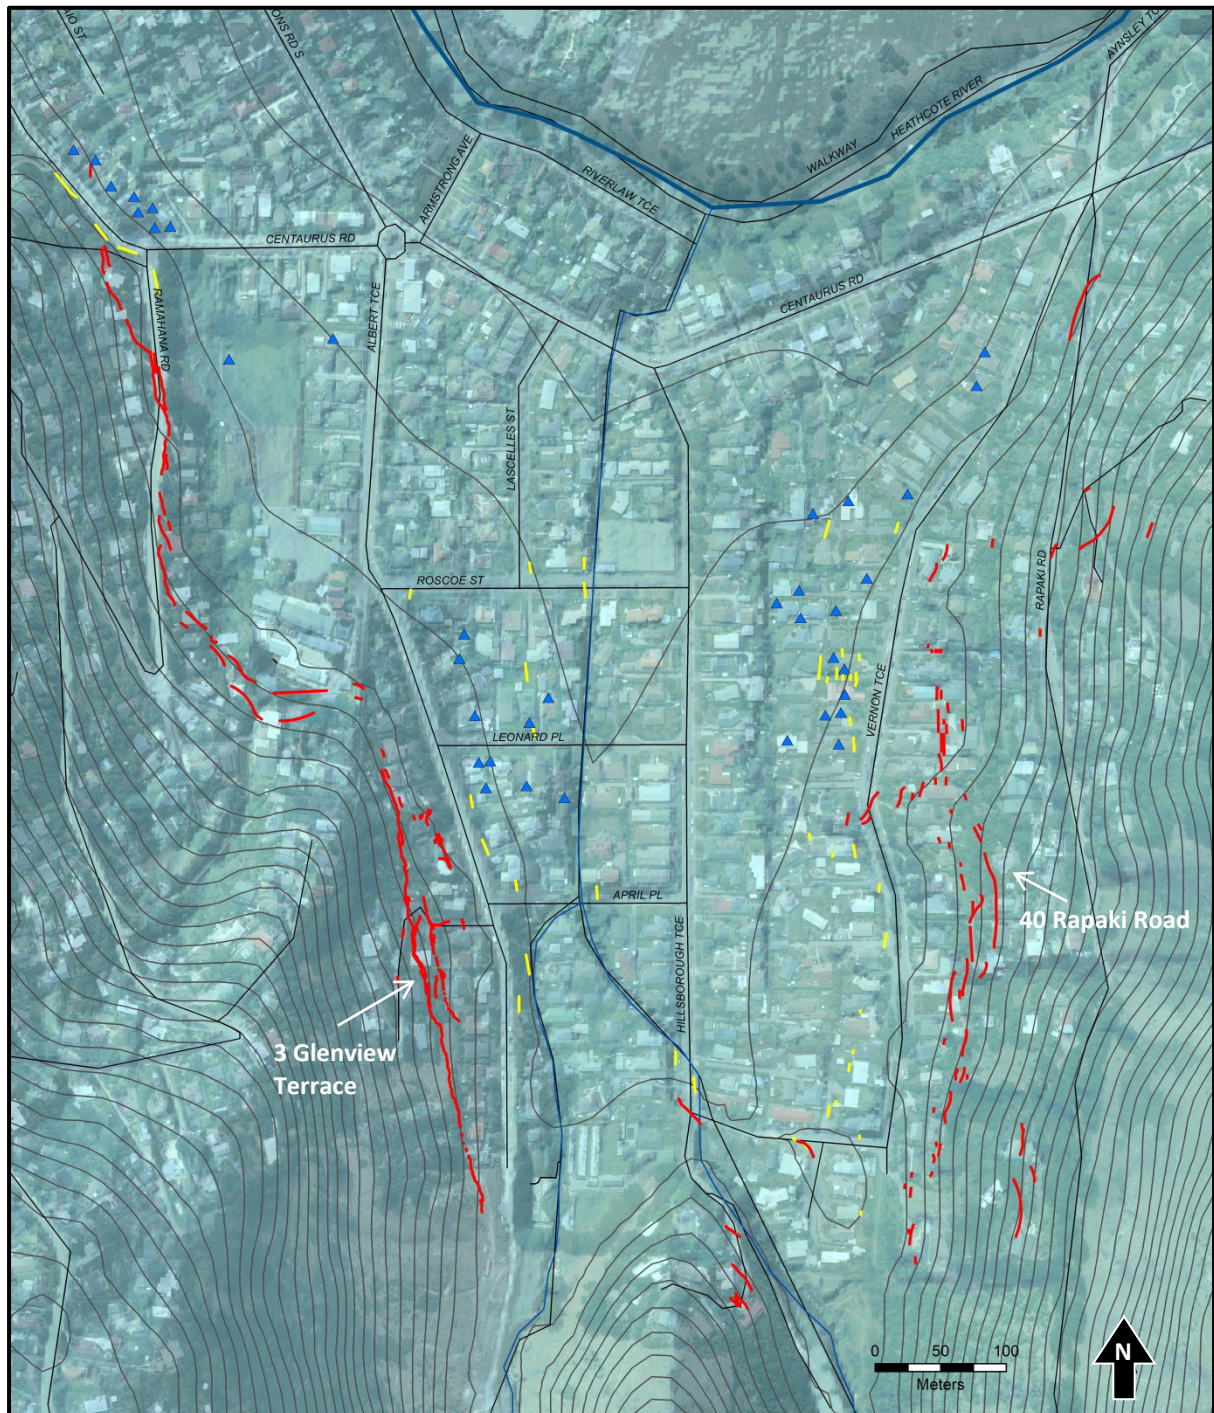
Figure 2: The Hillsborough Valley, showing fissure (red) and spring (blue) locations as well as compression zones (yellow). Contour intervals 5 m.

Formation of springs and seepages in valley floors of the Port Hills occurred contemporaneously with both the Darfield and Christchurch Earthquakes. Springs in the Hillsborough Valley formed in close proximity to the valley floor compression features (Figure 2). Three clusters of springs formed in the valley; one where Ramahana Road meets Centaurus Road (near 211 Centaurus Road); another at the junction of Albert Terrace and Leonard Place; and a third centrally located on the western side of Vernon Terrace (spring locations by H. Rutter, Aqualinc, pers. com. 2012).

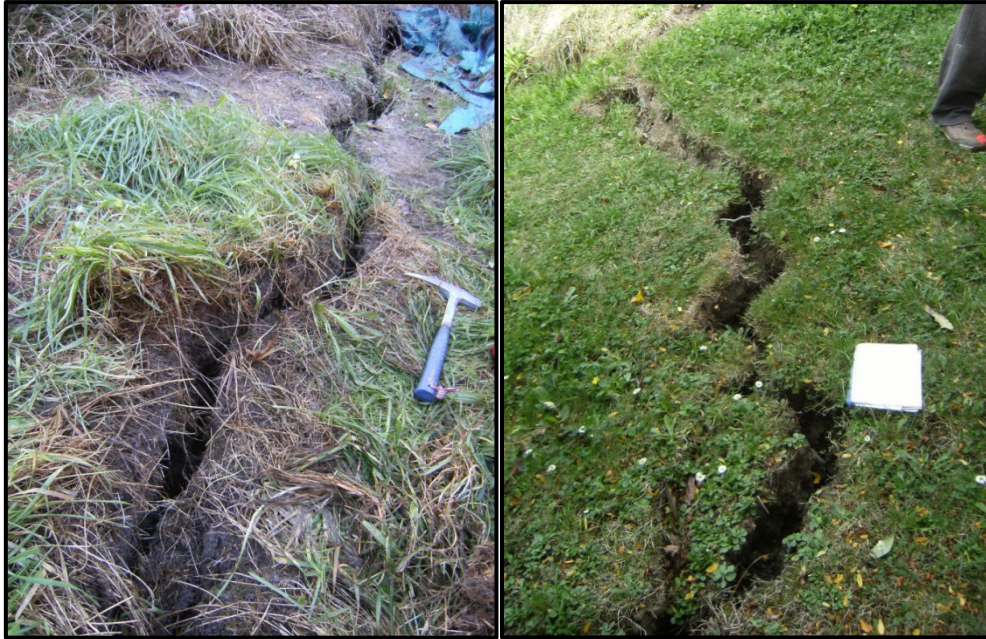
Figure 3: Ground fissuring at number 40 Rapaki Road (left) and number 3 Glenview Terrace (right). Both photographs taken facing south towards the head of the valley. Geological hammer and A4-size paper for scale.

The fissure traces were alike in appearance at any given location along the fissure trace. There was always some lateral extension (up to 0.2 m) and usually the down-slope side of the fissure trace dropped by up to 0.15 m. Loose soil frequently fell into the base of the fissure; however it was usually possible to extend a rigid tape measure into the fissure by over 1 m, and occasionally to depths of greater than 5 m. Only two instances where the down-slope side

of the fissure was higher with respect to the up-slope side (by approximately 0.10 m) were observed. These were at 3 Glenview Terrace and 44a Rapaki Road. Melt-water from heavy snowfall in Christchurch in 2011 caused a large collapse of loess at 3 Glenview Terrace, as the fissure system appeared to link up to subterranean tunnel gullying.

It is believed that it is unlikely that the fissure traces are incipient landslides. Should fissures be left unfilled, however, overland flow of rainwater will enter the fissures, ultimately causing further erosion underground, and there is a high likelihood of the development of additional erosion cavities. The subterranean infiltration of water into loess has high potential to cause further ground movement, potentially slumping or sliding, and as such it is important that the all fissures are infilled using bentonite and SAP-20 gravel mixture to prevent water ingress.

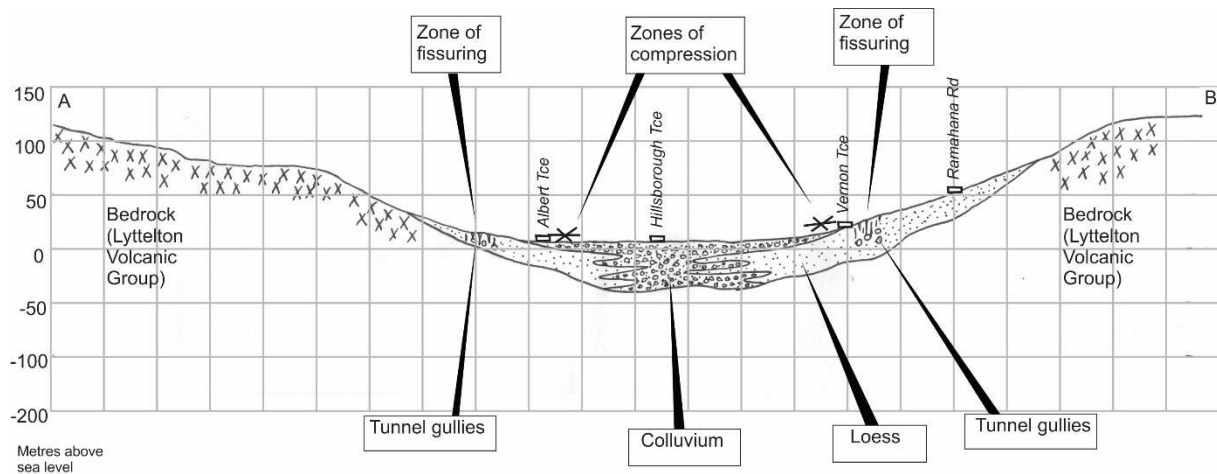
When overlaid onto the geologic map of Christchurch by Brown & Weeber (1992), the fissure traces coincide approximately with the boundary between the bedrock-mantling loess deposits and the colluvial valley fill. In the field it was observed that in most locations the fissures appear at least 20 m (overland distance) below the beginning of outcropping bedrock. Figure 4 shows a schematic cross section through the centre of the Hillsborough Valley, showing the location of the fissure traces and soil types.

Figure 4: Schematic profile of the Hillsborough Valley, facing northwards.

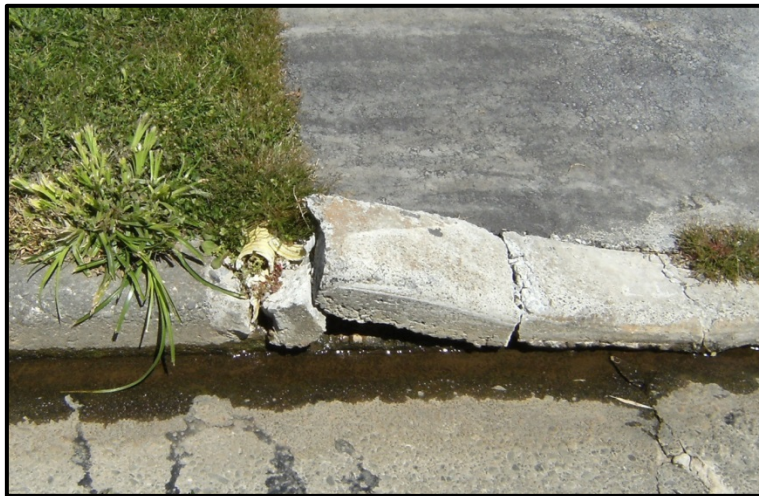
Nearly every section of fissure trace with measureable extension was accompanied by lateral compression features in the valley floor below. The extent of compression was comparable to the total lateral extension in the fissures above. In most of the east-west oriented streets in the Hillsborough Valley, lateral compression was seen in kerbing on the roadside. For example, a plastic outlet pipe in Roscoe Street created a weaker zone in the concrete kerbing, which encouraged compression to be focused in that location (Figure 5).

Figure 5: Kerbing in Roscoe Street. Such evidence of lateral compression was observed in kerbing at many sites in east-west oriented streets in the Hillsborough Valley floor.

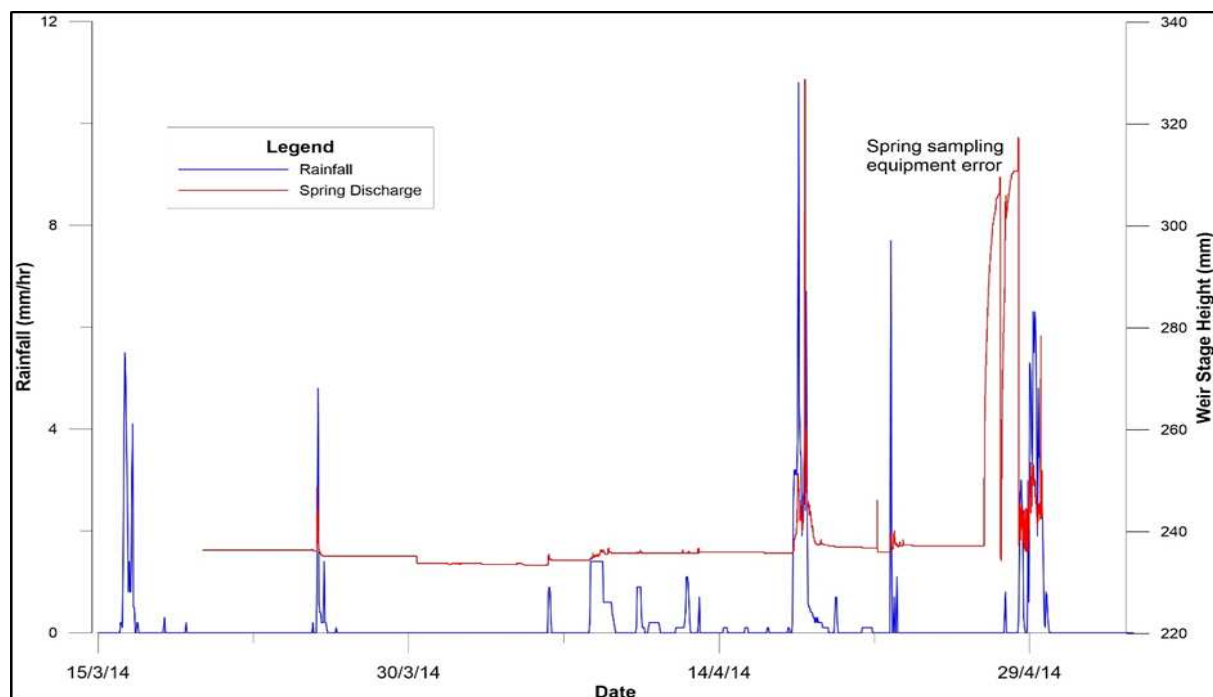
Spring water analysis shows a “base flow” of spring water that originates from volcanic (mostly basaltic) bedrock, with a strong rainwater input during storm events. Measured chloride concentrations from springs on Vernon Terrace range between 20 mg/l and 271.6 mg/L, sulphate levels range between 50 to 60 mg/L and Oxygen Stable Isotope values for the spring water range from -7.9 to -8.2 $\delta^{18}\text{O}$ (V-SMOW). These values correlate with Bank Peninsula bedrock derived groundwater (Brown and Weeber 1994). Rainwater collected in the area had much lower concentrations of chloride ranging from 0.2-15.9mg/l. Spring water chloride concentrations decreased following rainfall events. Both the groundwater piezometer and spring discharge analyses show fluctuations with strong correlation to rainfall events (Figure 6).

Figure 6: Spring discharge and rainfall volumes during April 2014, at 10 Vernon Terrace.

The weir was installed by Aqualinc beneath 10 Vernon Terrace, and it is noted that the apparent pre-rainfall spike in spring discharge around the 29th of April 2014 was caused by sampling equipment error.
