The Performance of Structures Subjected to Surface Fault Rupture during the Mw 6.0 South Napa Earthquake, California, USA

J. Cohen-Waeber¹, R. Lanzafame², J. Bray³, N. Sitar⁴

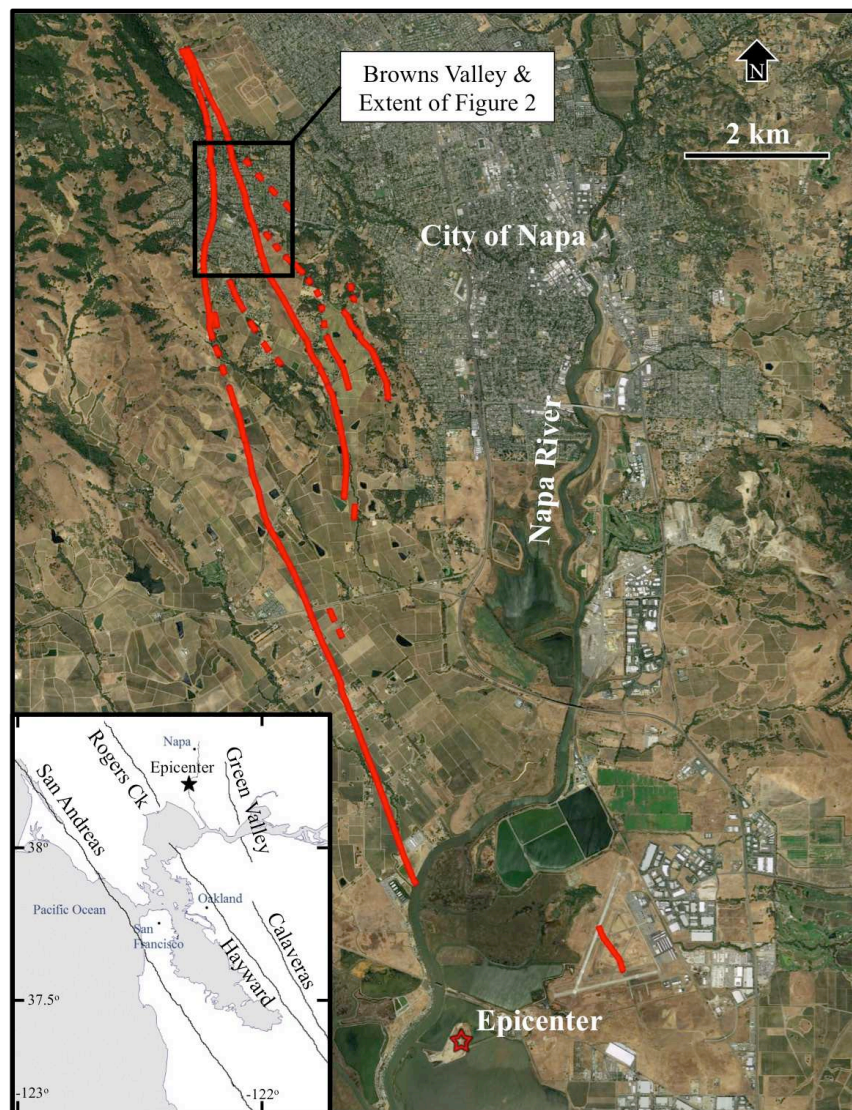
Figure 1. Surface rupture trace of the August 24, 2014 M_w 6 South Napa Earthquake.

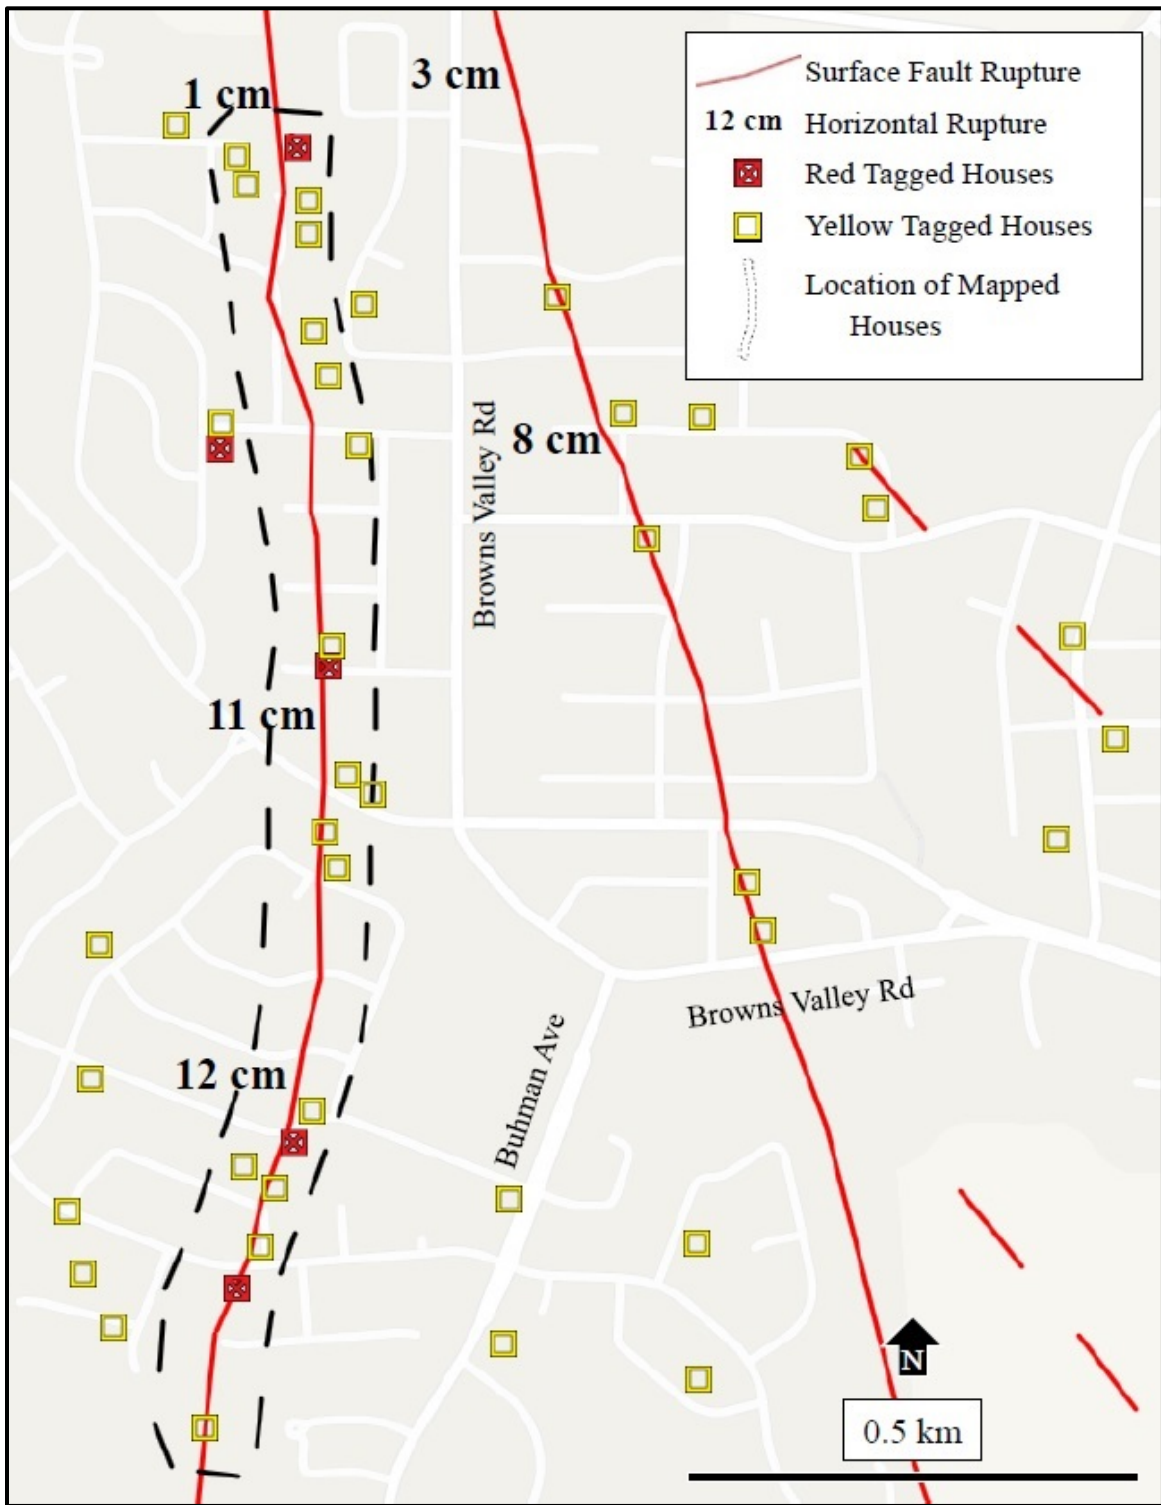
Structural damage due to shaking during the South Napa Earthquake was prevalent in the historic downtown Napa. However, principal damage to residential structures in the western Napa area of Browns Valley was due to surface fault rupture, along two coherent fault strands (Figure 2). Offset along the main (western) strand within Browns Valley was 10-20 cm (a maximum of 46 cm was measured 1-2 km to the south; Bray et al. 2014), and decreased progressively to the North (Hudnut et al. 2014). Smaller offsets of 2-8 cm were measured along the eastern strand (Hudnut et al. 2014). To ensure safe occupancy, California State regulation requires structures in areas affected by damaging earthquakes to be inspected by trained professionals, soon after the event. Based on the severity of their damage, structures suitable for only brief entry are assigned yellow tags and those not suitable for entry are assigned red tags. In the Browns Valley, most damaged and tagged structures were located on or near surface fault rupture, and red tagged structures were exclusively located along the main strand (Figure 2). The tagging system was used to guide the field mapping effort by the GEER teams.

Figure 2. Surface rupture trace of the South Napa Earthquake through Browns Valley, illustrating magnitudes of displacement and approximate damaged property locations. [Note: not all red and yellow tagged structures were visited by the GEER team]

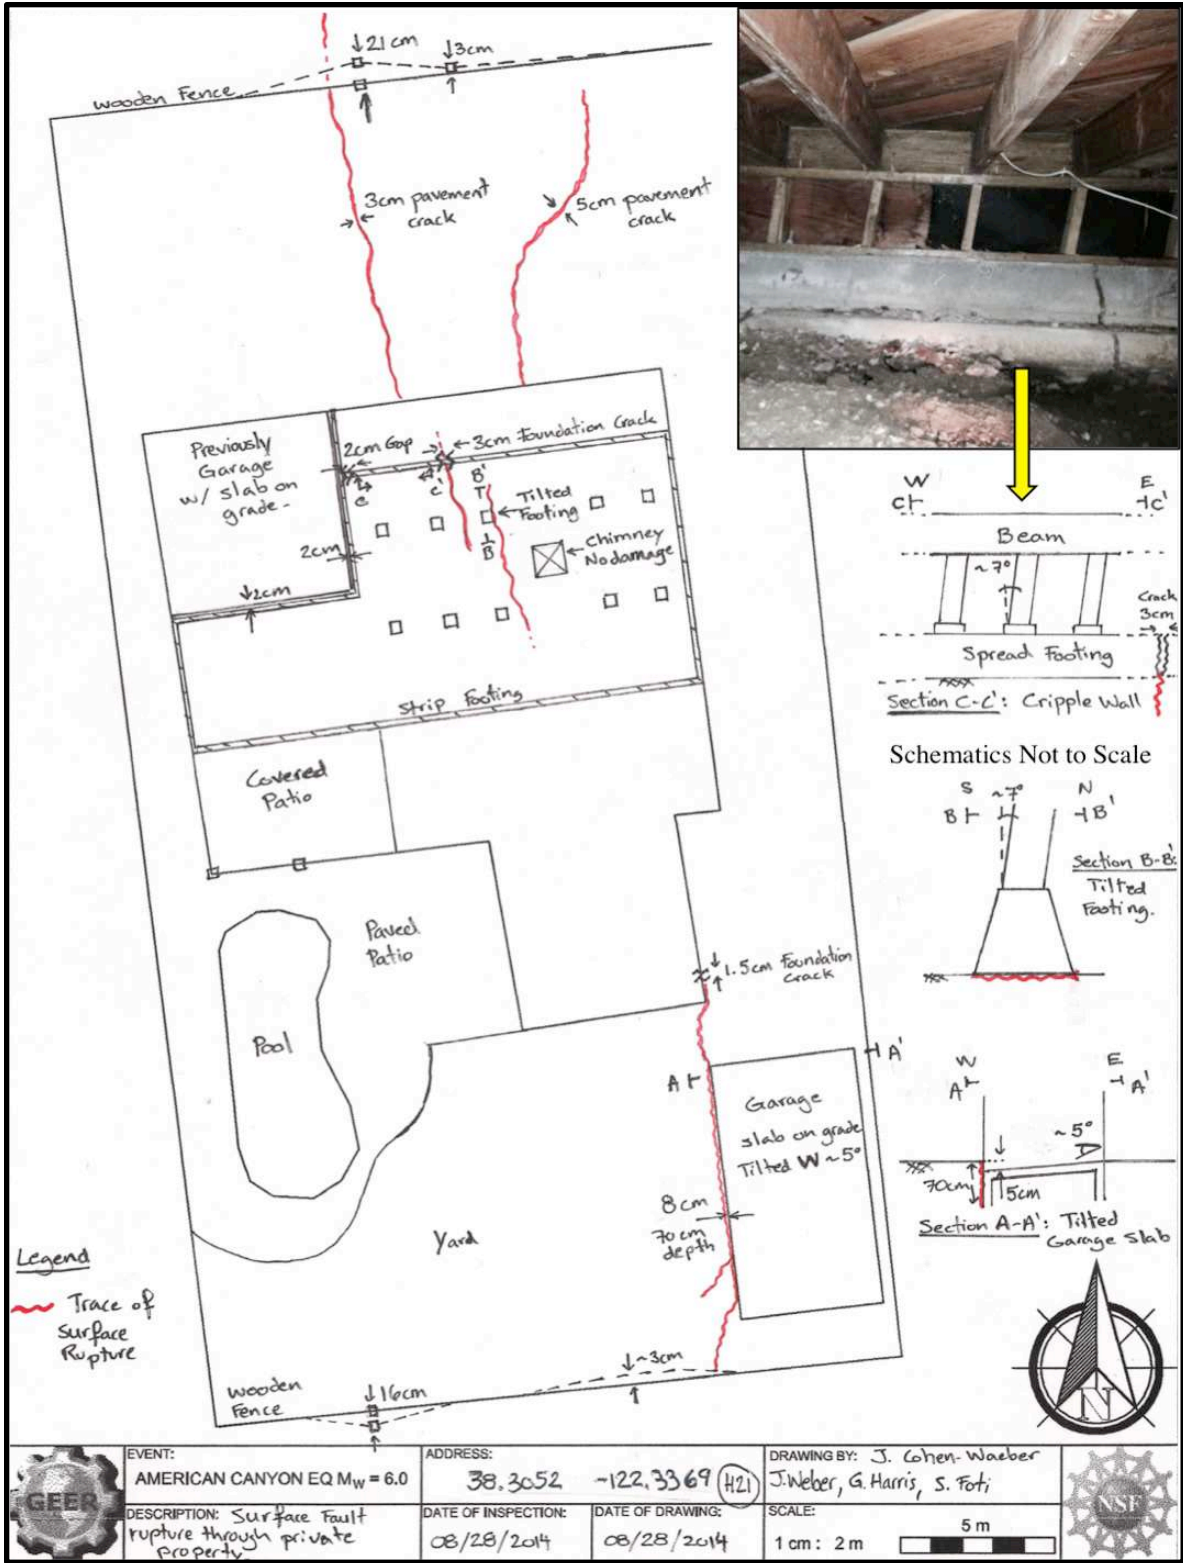
The structural damage associated with surface fault rupture in the Browns Valley area was mapped between August 25 and August 28 and detailed maps of damage to individual structures were produced (Bray et al. 2014). While not all tagged structures were mapped, damage to properties on or adjacent to the primary trace of the fault was mapped with a focus on tagged structures, and to the extent possible given time constraints and subject to property owners' permission. In total, of the approximately 60 residences along the main fault strand alignment within Browns Valley (outlined in Figure 2), exterior damage was mapped at 39 residences and 26 structures were mapped in detail. Though similar damage occurred along the secondary (eastern) strand, only one residence was mapped in detail, also due to time constraints, for a total of 27 structures mapped in detail (Bray et al. 2014). In each case, major damage was documented (including measurements and photographs) and drawn to scale, concentrating on structural damage and ignoring cosmetic damage, as illustrated in Figure 3.

Figure 3. Detailed damage map for a structure on strip footings affected by surface fault rupture in the Browns Valley area. Photo inset shows Type I and II damage.

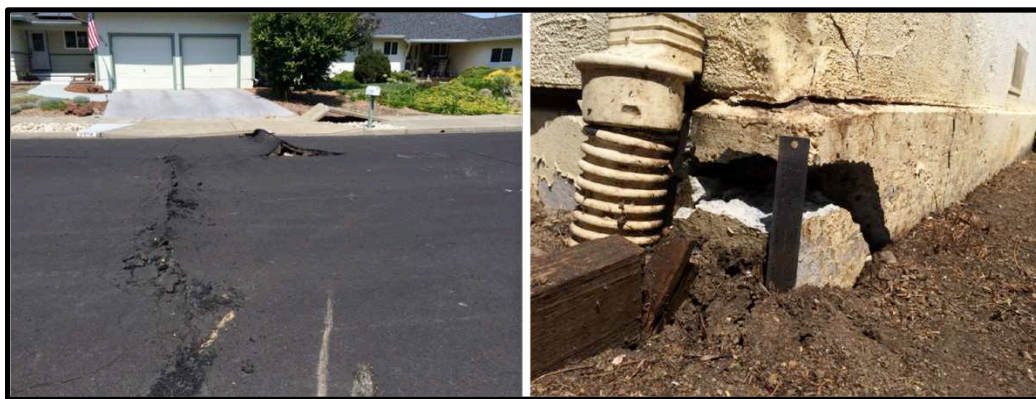
Type I: Cracking of reinforced concrete and concrete masonry components within structures ranged from cosmetic cracking of swimming pool patios to cracking of structure foundations (Figure 4). Damaged structures included: foundation elements (cracks up to 5 cm wide); non-foundation unreinforced and reinforced concrete slabs (cracks up to 8 cm wide); and curbs and sidewalks (i.e., buckling due to compression).

Type III: Cracking of paved and unpaved areas at the ground level (Figure 4) included tension and compression features in paved (i.e., asphalt) and unpaved surface, and was a clear indicator of fault trace location (for both main and eastern strands). These features ranged from thin fissures to deep open cracks or buckled asphalt and soil mounds. This damage mode was consistently mapped in a narrow alignment that is very consistent with surface fault rupture as mapped by Hudnut et al. (2014), and this type of damage away from the fault trace is negligible. Asphalt cracking reached depths of 50 cm and horizontal offsets up to 20 cm; buckling reached a maximum height of 24 cm. Rupture of unpaved surfaces reached maximums of 13 cm horizontal offset and 76 cm depth.

Figure 4. (Left) Type III damage in street; negligible damage to left structure, significant damage to right structure, including (Right) Type I foundation damage.
