GEOTECHNICAL PROPERTIES OF LANDSLIDE DAMS INDUCED BY THE IWATE-MIYAGI NAIRIKI EARTHQUAKE IN 2008

ABSTRACT

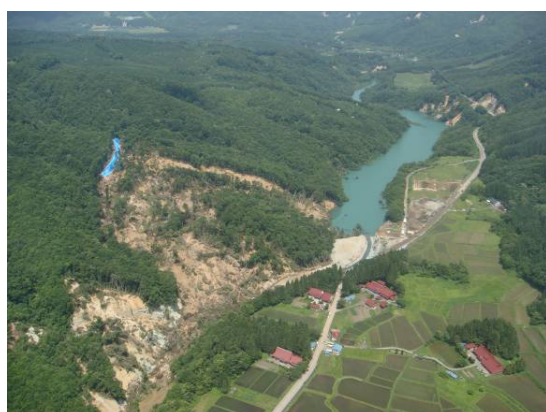
(a) Ichinonobara (No. 2 in Figure 1)

corresponds to the location in Figure 1. At Ichinonobara (No. 2), large amount of collapsed soil dammed up the Iwai River (Photo 1). The collapsed slope was gentler than other most natural slope failures which caused landslide dams, and the potential slide is possible to be triggered by this earthquake. As the Iwai River had no artificial dam with a large capacity at the downstream side of the Ichinonobara quake lake, the countermeasure works against the erosion of landslide dam was started immediately after the main shock. A temporal drain on the left bank was expected to avoid the overtopping on the landslide dam (Photo 1). The volume of collapsed soil at Ubusume (No. 5) was the largest one which made a quake lake. The length of landslide dam was about 260 m along the Ubusume River (Photo 1).

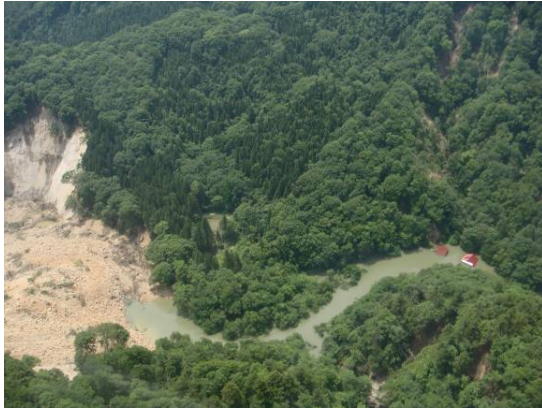
(a) Overview by Motoki Kazama, 28 June

Photo 2. Landslide dams at Yunokura (No. 10 in Figure 1)

The original slope consists of welded tuff and pumice tuff which were from the Kurikoma volcano. The large boulders on the surface (Photo 2) were originally from the welded tuff layer on the top of the slope. The geological properties are typical one in the damaged area as mentioned before. The mechanical properties of the original surface rock should be investigated in order to clarify the seismic stability of the

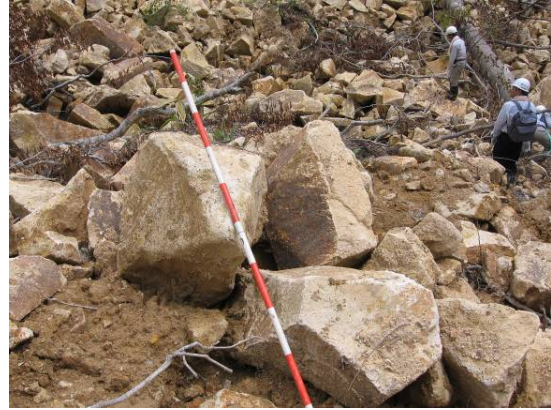
(b) Surface view by Hiroaki Kabuki, 20 July

are major surface geologic material around Mt. Kurikoma. In addition, fine surface soils and weathered pumice tuff were also observed in the dam (e.g. right photograph in Photo 2). It is possible that the soil constitutions of the landslide dams varied with the locations and the depth. The constitutions are dependent on the geology, the degree of weathering of the original slope and the failure configuration such as the height of main scarp and flow distance. When the sediment of collapsed soil contains fine particles and the dam is long along the river, the permeability of dam becomes small and the rising rate in the water level of dammed lake becomes large during precipitation. Moreover, the rise in the water level reduces the stability of the dam due to overtopping-induced erosion and piping.

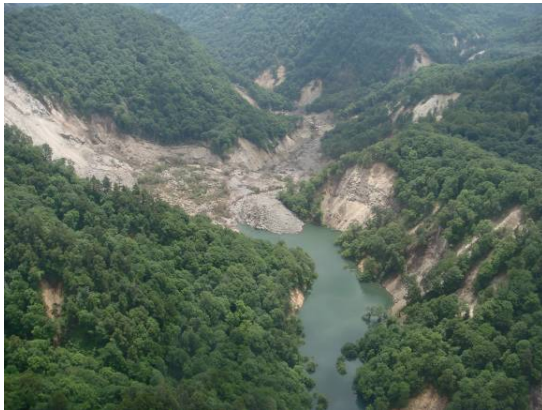
(a) Overview by Motoki Kazama, 28 June

Photo 3. Landslide dams at Yubama (No. 11 in Figure 1)

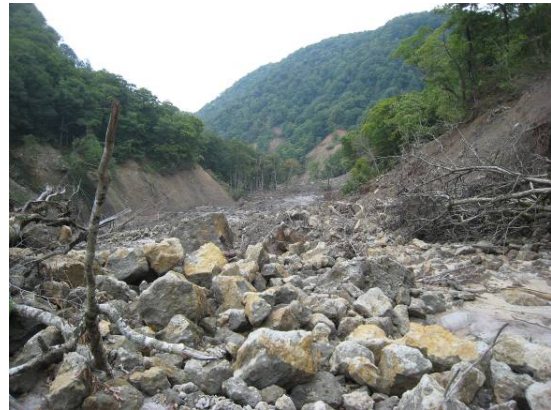
(b) Surface view by Ryosuke Uzuoka, 7 September

Many landslide dams appeared along the Hasama River in Miyagi Prefecture. Although a large artificial dam (Hanayama) is located at the downstream side, immediate countermeasure works began after the main shock because many people live along the river. At Azabu (No. 7) and Kogawara (No. 8) on the plane at the downstream side and at Yunokura (No. 10) (Photo 2) and Yubama (No. 11) (Photo 3) in the mountain area, the large volume of collapsed soil caused large quake lakes. The length of the landslide dam Yubama was about 1 km long; this was the longest one among the landslide dams. Large rock boulders with the diameter of over 1 meter and broken trees were observed on the surface of landslide dams (e.g. right photographs in Photos 2 and 3). Some rocks were welded tuff with columnar joints which

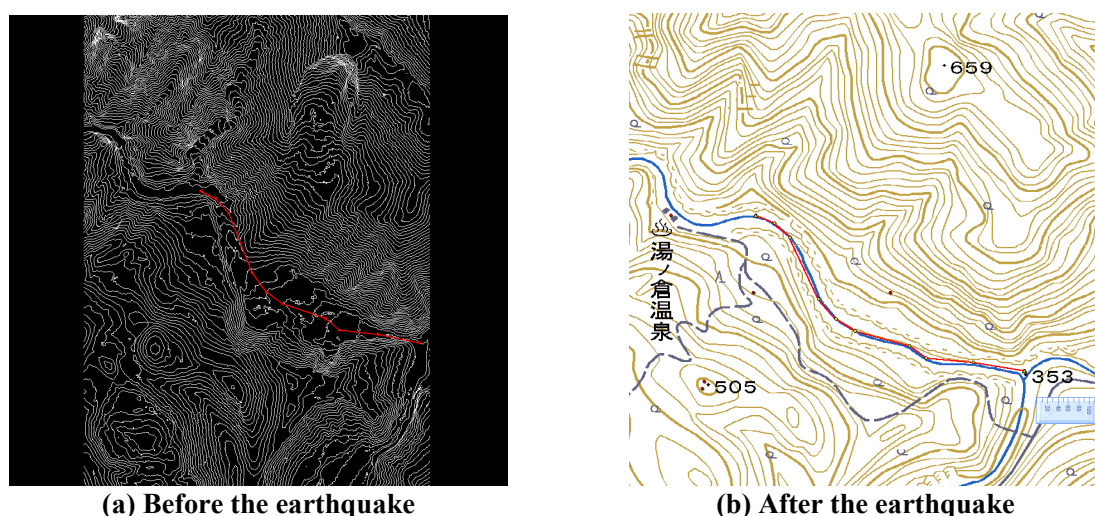
Figure 2. Topography before and after the earthquake at Yunokura

Figure 2 shows the topographical map before and after the earthquake. The topography before the earthquake is 1:25,000 topographical map by Geographical Survey Institute (GSI). The topography after the earthquake was obtained by aerial laser profiler conducted by MLIT. The slope failure occurred from near the top of the mountain at the left bank. Figure 3 shows the cross section of the landslide dam along the river which is obtained by comparing the topography before and after the earthquake in Figure 2. The collapsed soil of about 810,000 m³ flowed down the left bank slope and deposited on the downstream along the river. The bottom length and the maximum height of landslide dam are about 540 m long and 30 m high.

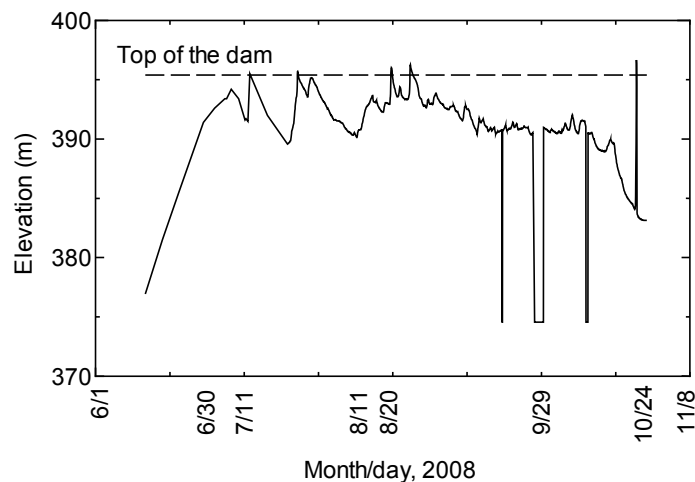
Figure 4. Time history of the water elevation of the dammed lake at Yunokura

Overtopping often occurred at Yunokura landslide dam. Figure 4 shows the time history of the water elevation of the dammed lake. The water elevation data before June 30 is estimated from the pictures taken by media and the data after June 30 is provided by MLIT. The water elevation have attained to the top elevation (395.4 m) of the landslide dam five times until November 2008.

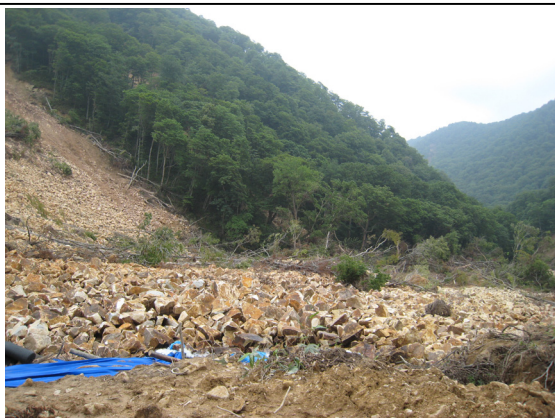
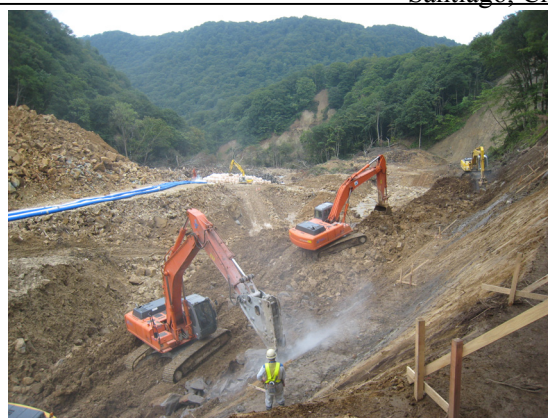
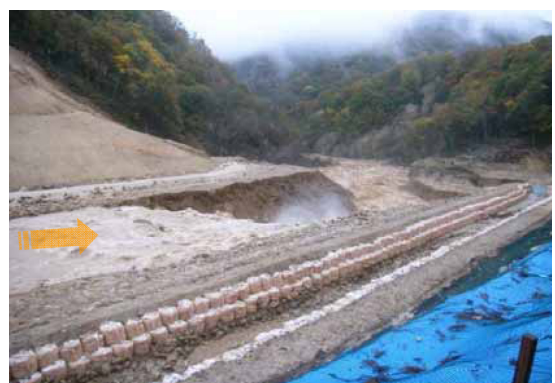
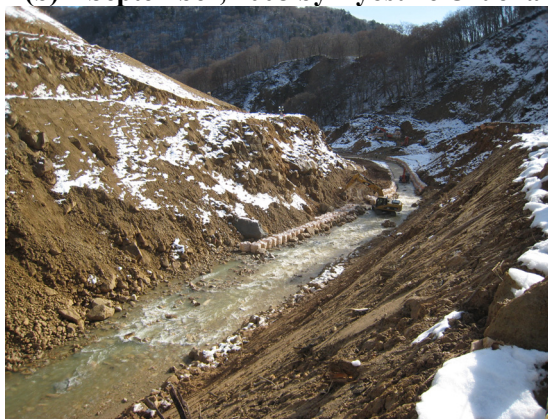
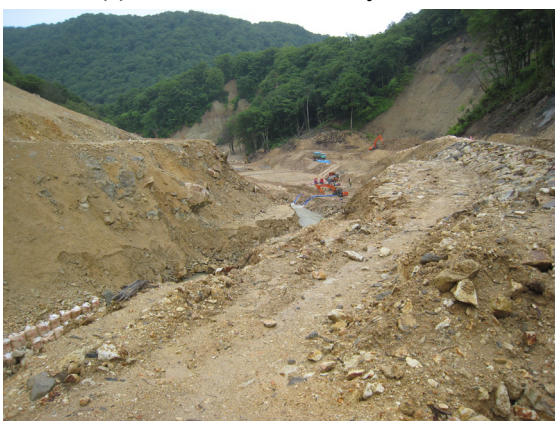
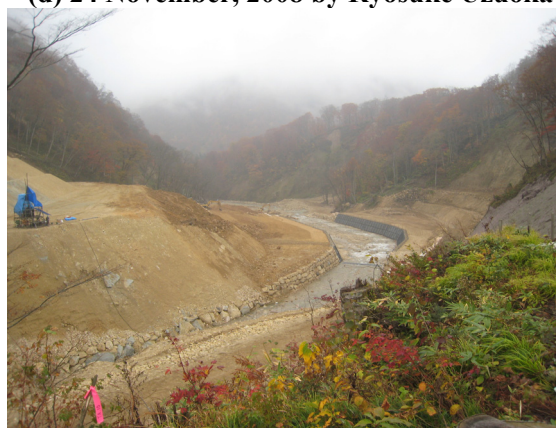
Photo 4. Transition views of the landslide dam from right bank to downstream at Yunokura

Photo 4 shows the transition views of the landslide dam for about one half year after the earthquake. The restoration works could not be started immediately after the earthquake because there were no access roads enough to carry the vehicles and materials to the site. On July 5 the drainage with a few pumps was started (blue lines in Photo 4(a)). On July 9 the number of pumps became sixteen and the water elevation began to decline. After the achievement of access road on August 10, a temporal drainage channel on the right bank began to work. Moreover the second channel with larger section was planned (Photo 4(b)); however, large erosion occurred on October 24 (Photo 4(c)). The accumulation rainfall was about 106 mm from 2:00 to 21:00 on October 24, which is the largest continuous rainfall since the earthquake. The erosion due to the overtopping began from the downstream side of the landslide dam at about 14:40 on October 24 and moved toward the upstream side after about two hours (Photo 4(c)). The failure type of the landslide dam was a progressive failure with erosion. It is possible that the restoration works on the dam surface reduced the stability by removing large boulders. The dimensions of erosion were about 40 m wide, 15 m deep and 250 m long, and the volume was about 100,000 m³ (Photo 4(d)). Due to the erosion, the water elevation of the dammed lake declined about 10 m for an hour from 16:40 to 17:40, and the capacity of the lake decreased from 462,000 m³ to 127,000 m³ (MLIT, 2008). About one year later the eroded channel kept the configuration although snow melted water flowed in the spring (Photo 4(e)). The river bed at the downstream side was reinforced against further erosion (Photo 4(f)).

The tests results show that the shallow part to the depth of about 8 m contains mainly soils with relatively lower N values and lower elastic wave velocities. On October 24, 2008, the surface of the landslide dam was eroded with the depth of about 15 m. If the elevation at the boring site was not changed since the erosion, not only the soft layer with soils but also the stiff layer with gravels and boulders was eroded.

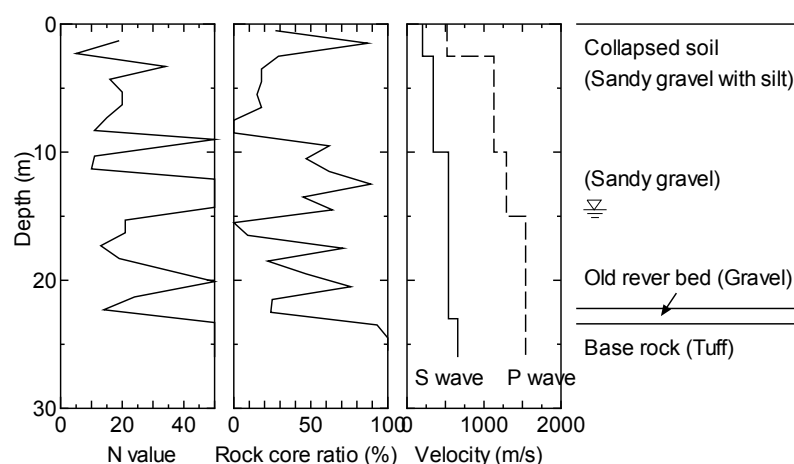
Figure 6. Depth distributions of the N values by SPT, the rock core ratio and P, S wave velocities

The surface soil with the depth of about 2 m might be disturbed by the restoration works; therefore the N values and elastic wave velocities are very low. The N values until 8 m deep are from 10 to 20 which are smaller than the deeper part. In addition, the elastic wave velocities until 10 m deep are smaller than the

deeper part. Although the N values become large at some depths due to rock hitting in the depth of more than 8 m, the N values of the fill among the boulders are less than 20. It is possible that the fill among the boulders is not compacted despite the depth. The depth distribution of the rock core ratio agrees with that of N values. The landslide dam induced by rock slope failure consists of not only rock gravels or boulders but sand or silt. The shallow part to the depth of about 8 m contains mainly soils with lower N values and lower elastic wave velocities.

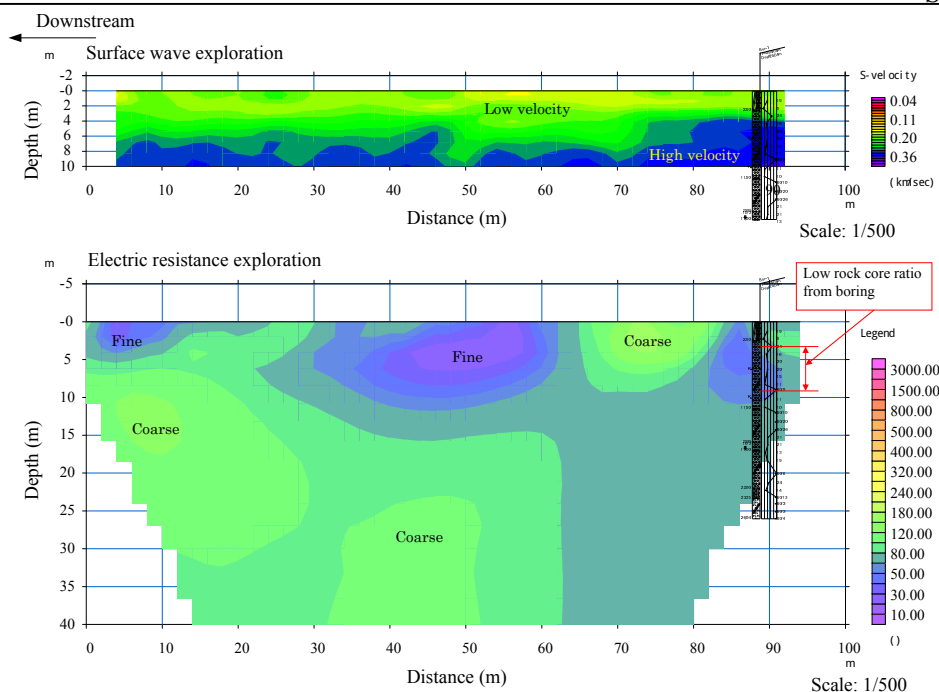
Figure 7. Distribution of surface wave velocity and resistivity

The surface wave and electrical prospecting were carried out around the borehole. Figure 7 shows the distribution of surface wave velocity and resistivity. The lower resistivity shows the lower permeability and the finer soil. The surface wave velocity and resistivity are relatively low in the shallow depth until

about 10 m. These tendencies agree with the distribution of N values and elastic wave velocities at the boring site. It is noted that the horizontal distributions of surface wave velocity and resistivity are not homogeneous.

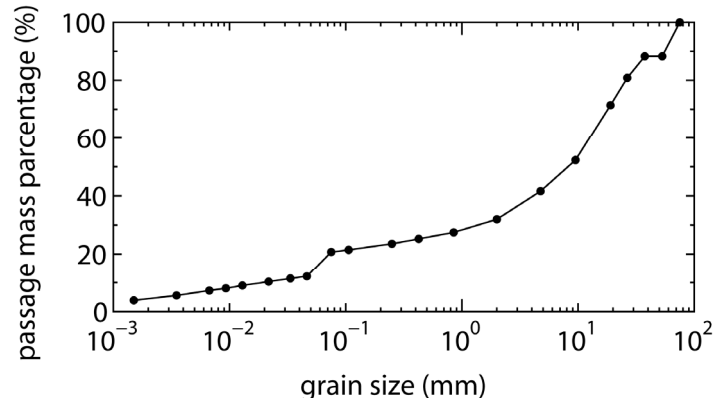
**Figure 8. Grain size distribution of disturbed sample 2**

The disturbed samples were taken from the surface or cut-off slope during the restoration works. Table 2 shows the summary of laboratory tests. Figure 8 shows the grain size distribution under 75 mm from sample 2. The Japanese classification of the sample is sandy gravel with silt (GS-F). The permeability coefficients of samples 1 and 2 by laboratory tests were from 7.6×10^{-4} cm/s to 2.3×10^{-6} cm/s about two orders smaller than than by the bore hole permeability tests. These results suggest that there are some water pathways in the landslide dam.
