## **DAMAGES OBSERVED IN THE 2010 CONCEPCIÓN EARTHQUAKE RELATED TO SOIL PHENOMENA**

**Felipe Villalobos<sup>1</sup>, Efraín Ovando<sup>2</sup>, Manuel Mendoza<sup>3</sup> and Paulo Oróstegui<sup>4</sup>**

### **ABSTRACT**

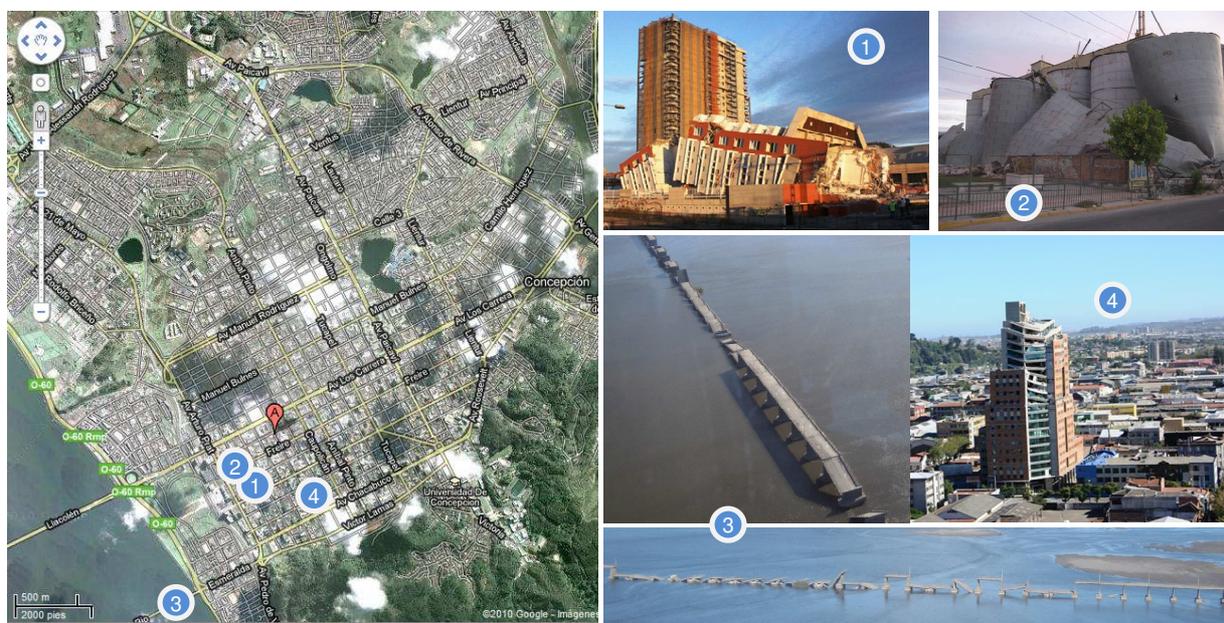
In Figure 2 circles with numbers indicate the place of collapsed structures. It has been tempting to directly blame the subsoil as the main reason of these and other failures. Circle 1 refers to the apartment building Alto Río, a two years old reinforced concrete building of 12 to 15 floors and two basements, 3:1 length and width ratio in plant, walls and slab thickness of 20 cm and 15 cm respectively. This building corresponded to the first of four similar but not attached buildings projected in this corner. The building is founded on a reinforced concrete box (the two basements), through which loads are transfer to the subsoil by a 80 cm thick slab 6 m below the surface. From the slab the building columns, shear and retaining walls arise. The soil profile consists of medium to dense Bío Bío sand deposits with layers of soft silt, having a water table from 3 to 4 m deep. Particular concern was the presence of two non plastic silt layers between 9 to 11 m deep and between 12 to 17 m deep, with values of deformation modulus  $E_u$  of 20 MPa and 30 MPa and undrained shear resistance  $s_u$  of 150 kPa and 300 kPa respectively. These values were obtained from undrained triaxial tests after applying 30 loading cycles with a constant deviator stress of 90 kPa and confining stress of 130 kPa. The silt samples underwent excess pore pressures of no more than 95 kPa accumulated at the end of the cyclic loading. No stiffness degradation was found hence no liquefaction occurrence (Petrus 2006).

Figure 2: Satellite view of Concepción showing location and pictures of collapsed structures

Circle 2 corresponds to two rows of wheat silos located to less than 100 m from Alto Río building. For that reason soil profiles and conditions can be assume as similar as in Alto Río. The first row of silos was built in the 50's and did not present damage (Figure 2b). The second row was built during the 70's and collapsed due to the failure of bolts connecting the steel silos to the footings. According to witnesses full silos burst at the based spreading wheat. The shaking densified the granular content increasing vertical stresses and therefore radial stresses as well at the base, stresses which the silo steel shell could not withstand. The authors did not find any evidence of soil failure mechanism in situ.

Circle 3 shows the old Bío Bío Bridge built during the 40s and also collapsing in the 1960 earthquake (Steinbrugge and Flores 1963; Duke and Leeds 1963). In the 60's only a couple of piers failed on the Concepción side. Due to lack of maintenance the bridge was abandoned and hence without use since 2003. In the 2010 earthquake a generalised domino effect of pier failure occurred not only on the Concepción side but also on the San Pedro de la Paz and in the middle of the bridge. It is not clear whether the bridge timber pile foundations failed or not due to, for instance, liquefaction. Liquefaction was observed downstream in the river sand banks. It has been speculated that geological faults run along the river and also cross the river exactly there, because the Caracol hill would continue on the other side in San Pedro de la Paz. Therefore, geological studies are required in the form of geophysics and gravimetric analysis for example.

Circle 4 represents the collapse of the top 10 floors of the 21 floors O'Higgins Tower. Between the 11<sup>th</sup> and the 12<sup>th</sup> floor a discontinuity in the structure triggered the collapse of structural members which in turn failed the building upwards. The authors did not find any evidence of soil failure around the tower.

Further studies need to be pursued to whether these collapses are purely related to deficiencies in structural design and construction materials and methods or there are geological and geotechnical issues such as acceleration and displacement amplification due to for example soft soil layers just under these particular sites.

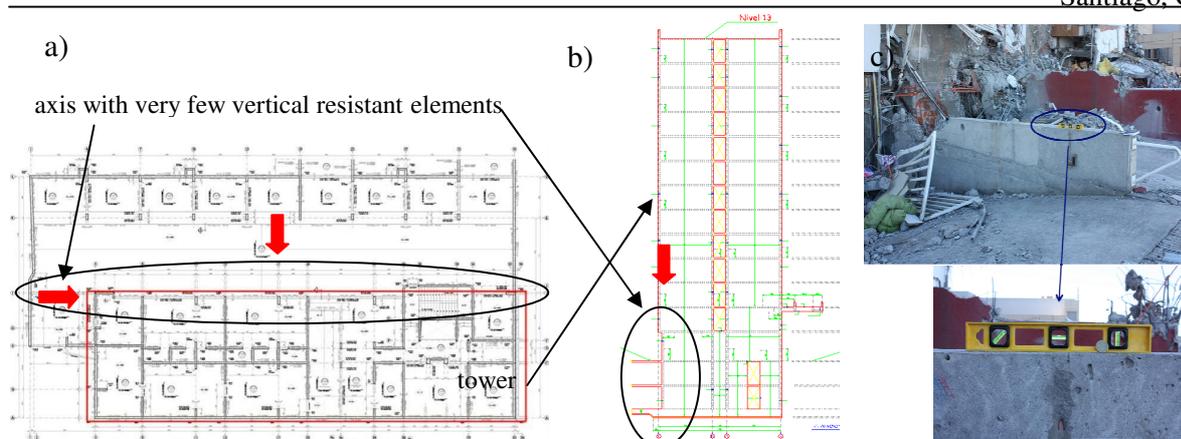
It is worth mentioning that the tower had a significant eccentricity respect to the basement since the basement extends backwards beyond the boundaries in plant of the tower (Figures 3a and 3b). Openings through the walls allowed the access to the extending basement area (Figure 3b). This gave origin to a weak line exactly at the back of the building. Witnesses indicate that the tower swung torsionally and then sunk at the back and finally the columns and shear walls in the front line were cut at the ground level to fall backwards completely after no more than 30 s from the beginning of the earthquake. The authors inspected the site and could not find serious evidence of settlement, lateral displacement (6 mm), rotation or any bulge indicating the development of a soil failure mechanisms, nor evidence of liquefaction or geological fault. Nevertheless, studies of amplification need to be carried out to find out whether accelerations and deformations were particularly high due to the presence of the soft silt layers.

Figure 3: Alto Río a) tower in an eccentric position respect to the whole basement, b) openings at the back where failure may have started and c) base without tilting

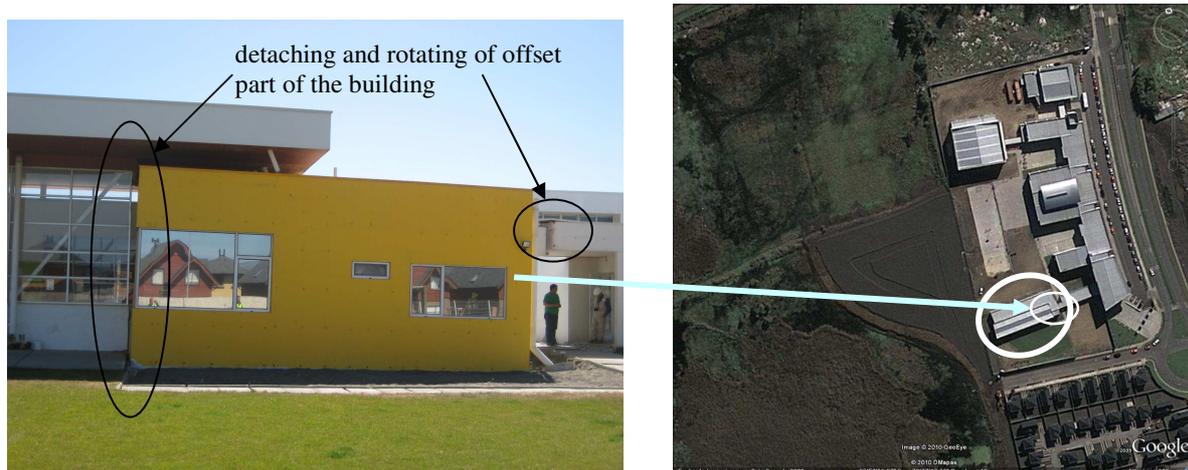
The school of San Ignacio in San Pedro de la Paz, with the same subsoil of Los Batros swamp did not suffered noticeable damage in its new facilities except ground settlements around playgrounds up to 60

cm and in an isolated one floor building, close to the swamp (see Figure 5). This rectangular reinforced concrete building of 15 m wide and 40 m long is founded on shallow footings 1.1 m below the surface with the water table between 1 and 2 m deep. Soil mechanics studies indicated that the subsoil had too poor quality to found the school. Therefore, a soil improvement was considered by using biaxial geogrids and geotextiles under compacted 80% relative density clean Bío Bío sand of 3 m thickness below the foundation level to replace a compressible silt (Sepúlveda, 2006). The only building with structural damage had to cope with ground displacement towards the swamp. The damage concentrated in a singularity of the building architecture, which could not keep the ground movement. This singularity corresponds to a separated room slightly offset from the rest of the structure, with a different roof level and on one side without solid structural connections with the main structure. As a consequence this room tilted 4°, hence openings cracks of 10 cm wide on the floor and detaching from the roof and windows. It is worth mentioning that the authors are not aware to whether the geosynthetic solution was applied on the whole area or only under some facilities. In the light of the observed cracks in the soil and in the building, it is believed that a confinement deficiency occurred towards the swamp. A natural slope exists towards the swamp and despite the compacted and reinforced sand fill, the land level at this point is approximately 1 m lower than for rest of the area. Possible solutions are to build a retaining structure or to extend the ground improvement further than the existing 8 m to the swamp.

Figure 5: San Ignacio School, San Pedro de la Paz showing where damage was concentrated

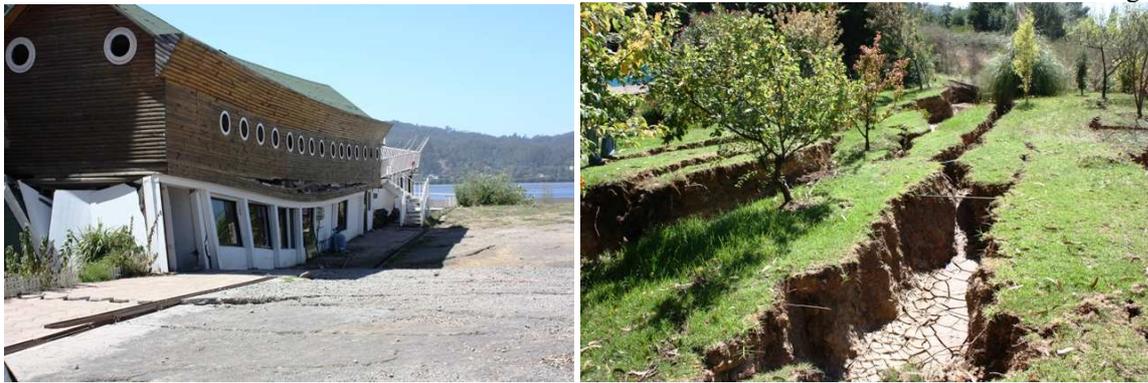
Striking crack patterns were observed along the Bío Bío River south bank also in San Pedro de la Paz, along the road to Santa Juana. Along hundreds of meters these cracks developed parallel to the river, causing serious damage to structures. A cross section sketch would show hills of 100 m on one side of the road and then a narrow land ending into the river. This narrow piece of land (50 to 100 m wide) has been reclaimed mostly with material from the hill and also from the river to avoid flooding. The authors are not aware of any type of soil improvement carried out to reclaimed ground, except under the road and under some structures closer to the road. Ground movement towards the river was considerable, destroying restaurants, houses, swimming pools, piping and gardens (Figure 6). It is believed that liquefaction occurred in deposits of saturated and loose sand below 2 and 3 m from the surface, at the level of the river (Figure 7). Above that level, reclaimed ground slid on the liquefied sand towards the river. Sand deposits were trapped, unable to dissipate excess pore pressures, since reclaimed grounds were residual soils from weathered rocks in the form of silt and clay material. Some cracks closer to the river had depths of 2 m and 1 m wide. Without intensive improvement of the natural soil deposited by the river and the soil fill deposited by the man it is not recommended to found structures, otherwise large soil displacements occur due to lateral spreading.

Figure 6: Damage in a restaurant, garden and piping due to lateral spreading along Santa Juana road

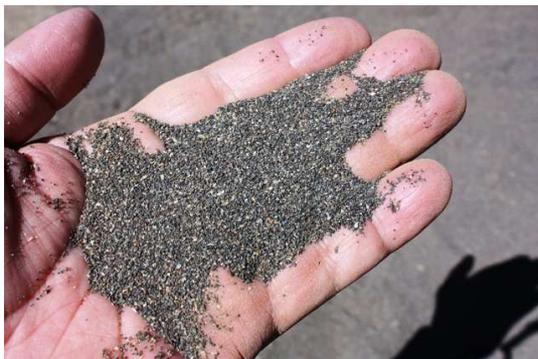
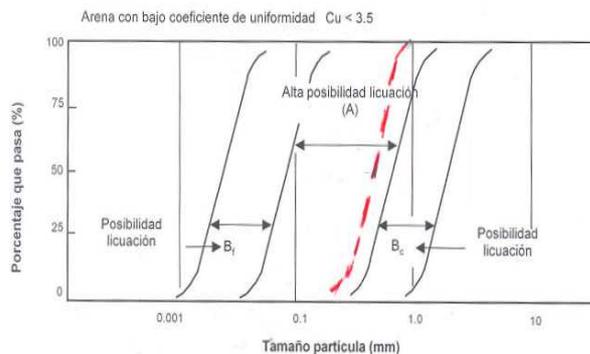
A sewage plant located between Bayona and San Ignacio School was also on ground reclaimed to Los Batros swamp. Two buried tanks (of three) floated, uplifted around 1 m and tilted 15° due to soil liquefaction. These two tanks of approximately 3 m diameter and 7 m deep had steel pipes connections broken. But soon after the earthquake the plant was working again using extension pipes with angles to accommodate the tilted, uplifted and twisted new tank geometry. There were also manholes near the sewage plant uplifted no more than 30 cm from the road surface. To find solutions to this problem it is necessary to do research about buried structures prone to uplifting due to liquefaction. Perhaps ground improvement alone is not enough and these type of structures need to be anchored.

Figure 7: Sand found at crack bottom with grain size distribution inside highly liquefiable range

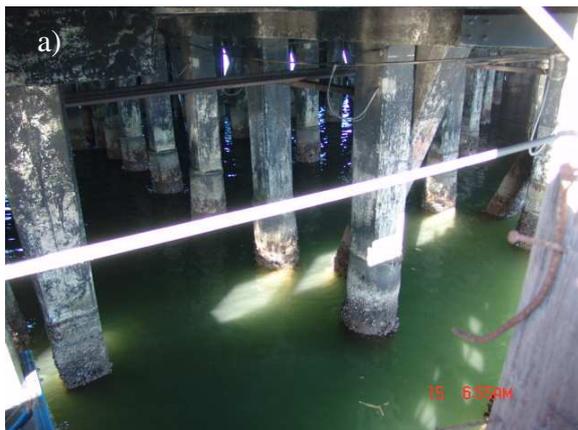
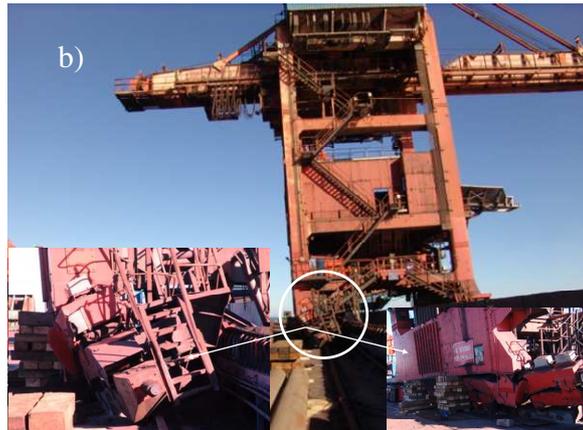
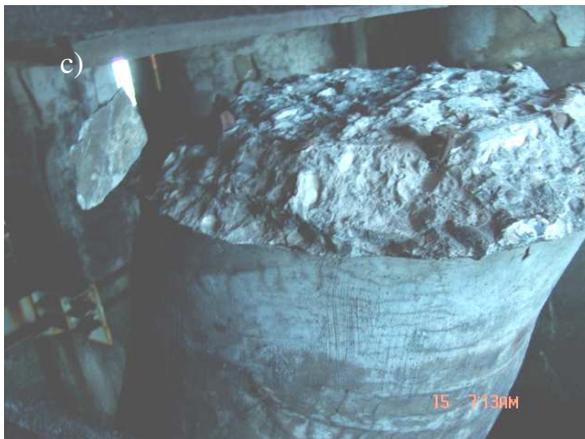
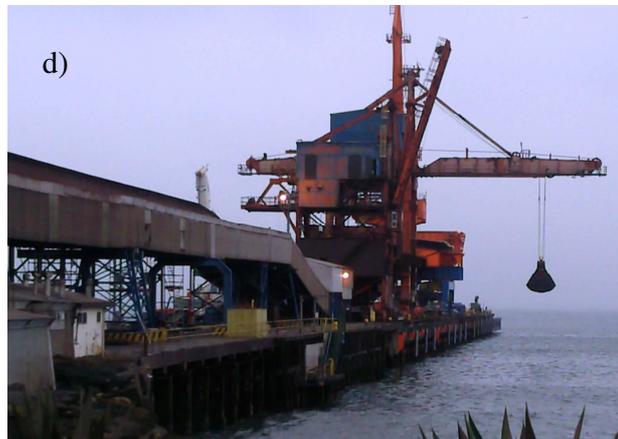
The plant's wharf was built in 1945 and extended in 1972 to the current 400 m long. The first part is founded on pre-concreted piles of 50 cm square section and reaching depths between 15 and 18 m. There is a high pile density including inclined piles to resist horizontal loads (Figure 8a). The 1972 extension rests on driven steel tubular piles 457 mm diameter and 20 mm thickness and filled with in situ poured concrete. Additionally, these piles have an external annular concrete cover of 25 mm thickness where 12 mm steel bars were in contact along the steel tube becoming pile reinforcement as well (Figure 8c).

In the wharf's access embankment settlements and lateral displacements were observed in the form of a step. Apparently pre-cast concrete piles of the 1945 part did not experience damage, although it was discovered that reinforcing elements inside the piles are in an advanced state of corrosion since they crumble easily when touched by hand. Therefore it is necessary to repair or replace as soon as possible corroded steel elements which reduce the structure resistance. In addition, several pile caps of the 1972 extension failed and a portal crane on the wharf's platform tilted because wheels on one side derailed. In these peculiarly designed piles, the welded connections to the platform were cut. These joints require stronger connection elements to withstand large seismic forces transmitted back and forth from the piles to the platform. It is not recommended to joint two stiff and heavy elements (group of piles with the platform) without a well reinforced pile cap.

Figure 8: a) Piled foundation of the wharf, b) portal crane derailed, c) pile cap broken in wharf extension and d) wharf general view

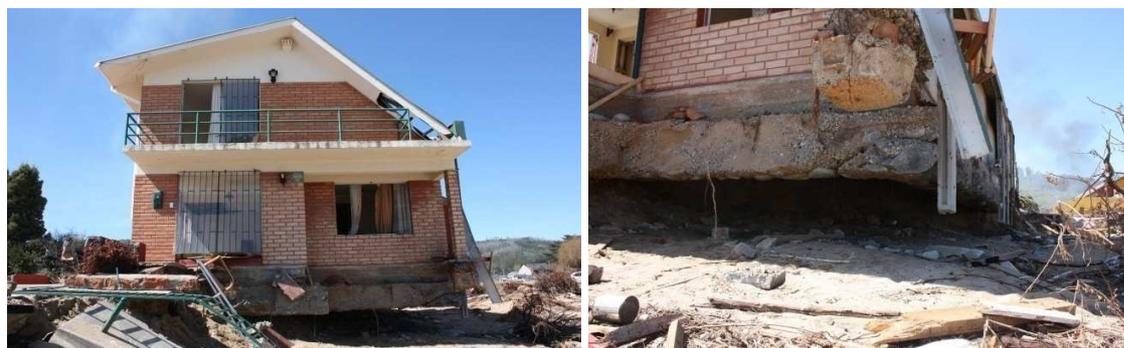
After the earthquake there was a series of tsunamis flooding some parts of the coastal area depending on the position and distance respect to the epicenter, bathymetry and topography. The seaside town of Dichato was one of the most devastated places along the coast. Several waves swept away the lower parts of the town hitting the front and the back of the town because waves entered through a stream. Dichato is located 9 km north of Tomé in the close and small bay of Coliumo. The bay shape probably caused intense rebound of currents. The few houses standing after the tsunami were made of reinforced concrete or bricks or a mixed of both. However, the authors noticed that standing houses in front of the shore had part of their foundations exposed. The tsunami attacked four or five times according to witnesses being the third and last wave the highest. High velocities and therefore large drag forces were imposed by the tsunami current when arriving as well as when retreating. The tsunami strong currents scoured the footing of the few standing houses. Figure 9 shows a house in cantilever, resting on one side since the other side was removed by tsunami currents. It is worth remembering that this house resisted a strong earthquake and a devastating tsunami. For future constructions on the shore it should be considered structures in addition to earthquake and tsunami resistant also the effect of scour. This phenomenon form normally part of bridge design for example or in structures under strong sea or river currents. A possible solution is to deepen the foundation to a depth where scour does not remove the foundation soil. The scour needs to be calculated with hydraulics methods.

Figure 9: A house in Dichato with foundation exposed due to scour by tsunami
