## CONVENTO VIEJO DAM: BEHAVIOR AFTER THE FEBRUARY 27<sup>TH</sup> 2010 CAUQUENES EARTHQUAKE IN CHILE

José CAMPAÑA<sup>1</sup>, Luis VALENZUELA<sup>2</sup>, Edgar BARD<sup>3</sup>

The Convento Viejo embankment dam is a zoned earth dam, 32 m high, founded in alluvial deposits, whose construction was completed in 2006–2008. The site is located near the town of Chimbarongo, 160 km south of Santiago, Chile's capital city, about 85 km from the coast and 220 km from the epicenter of the earthquake that took place on February 27<sup>th</sup>, 2010. This article examines the seismic behavior of the dam, compares the accelerations measured during the earthquake at three different levels in the dam with those estimated from dynamic analysis performed during the design phase. The paper also comments on piezometric levels and settlements induced by the earthquake.

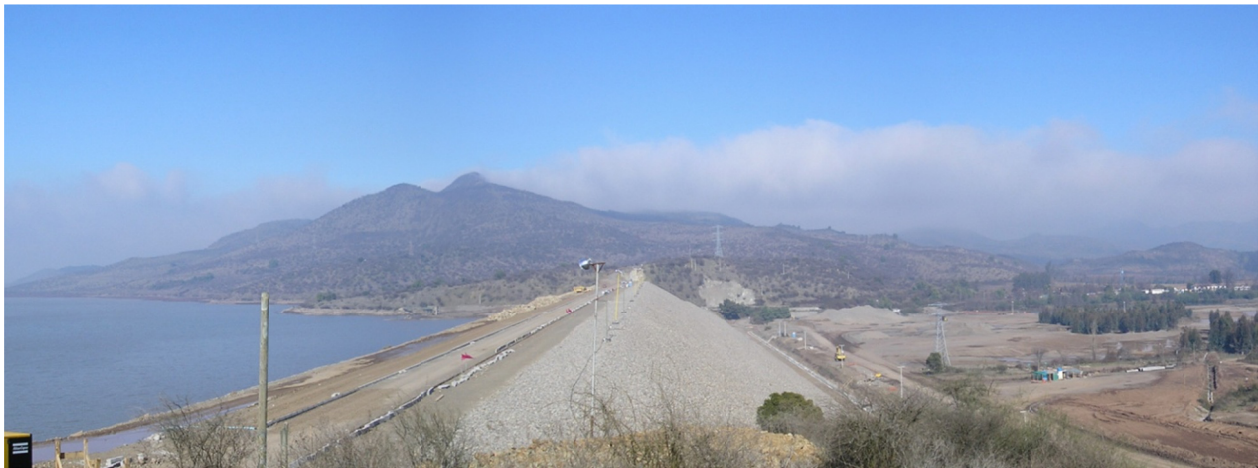
Figure 3: Panoramic view of the embankment dam (ARCADIS Geotecnica files, 2007).

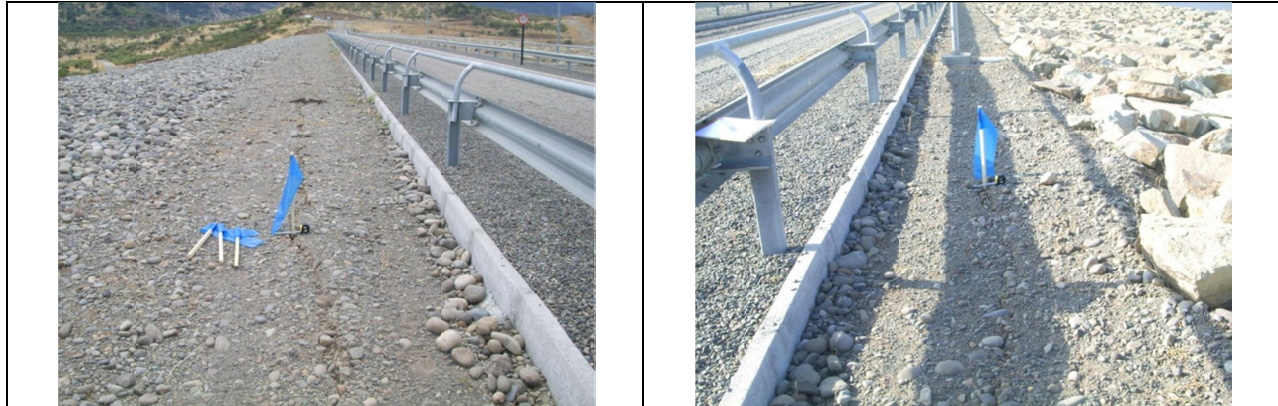
In general, the behavior of the earth dam was quite satisfactory; there were no external signs that accused significant problems. Superficial cracks were detected at the dam crest in the area where greater settlements were to be expected, according to the dynamic analysis carried out during the design stage. Nevertheless, two of the Casagrande-type piezometers presented a behavior that required a detailed analysis as well as a continuous monitoring of their evolution for at least a month.

Figure 11: Cracks observed at the crest of the earth dam: a) downstream slope, b) upstream slope.

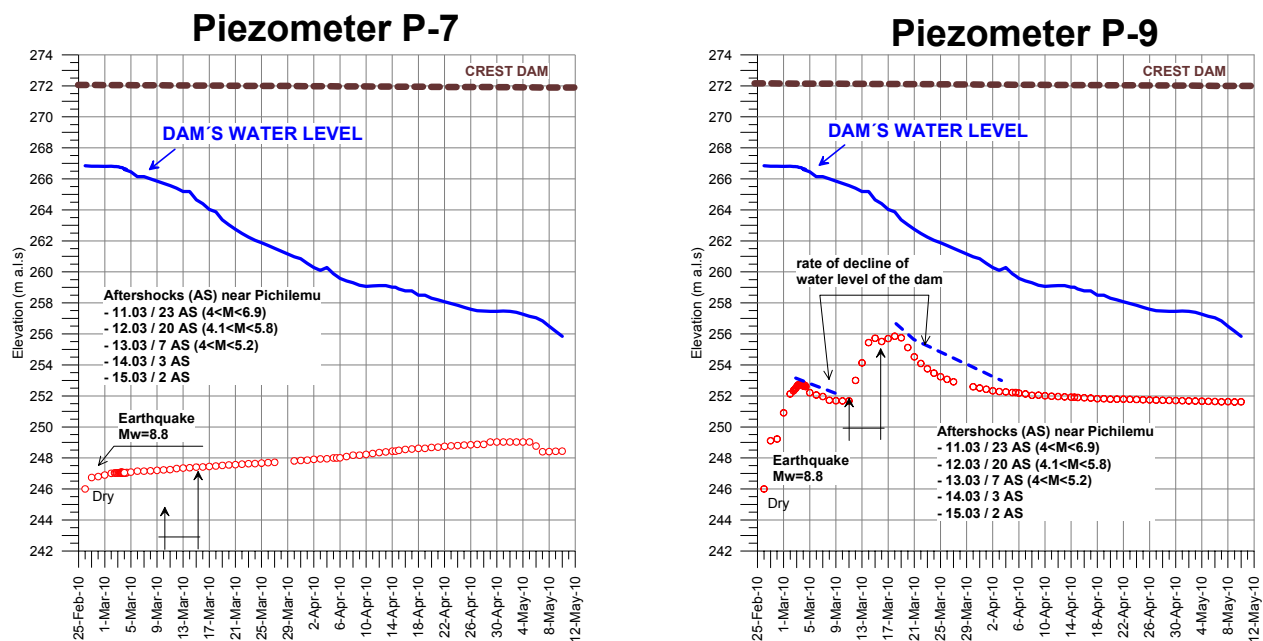
As it was previously mentioned, after the earthquake, practically all of the Casagrande-type piezometers presented an increase in their piezometric levels, but three days after the main event the piezometric level of all the piezometers descended approximately to the levels recorded before the earthquake. The only exceptions were piezometers P-7 and P-9, where the water level continued to rise. The area where piezometers P-7 and P-9 are located corresponds to the central part of the dam, the same area where the most important superficial cracks were detected, both in terms of their length and width, and also concordant with the most significant depression of the crest. This area coincides approximately with the limit of the emergency fill of the cut off trench with sandy gravels deposited under water, before 1981 when the construction of the dam was suspended.

In the case of Casagrande-type piezometer P-7, where the increase of the ground-water level was of about 2 m, it is noteworthy that the rate of increase was not affected by the aftershocks or by the decrease in the level of the reservoir.

On March 11<sup>th</sup>, an important increase in the piezometric level was once again recorded, which continued until March 15<sup>th</sup>. It is important to point out that during this same period, more than 50 aftershocks took place in the nearby Pichilemu area, with magnitudes  $M_w > 4$  and a maximum of  $M_w = 6.9$ . Between March 15<sup>th</sup> and 19<sup>th</sup>, the piezometric level at P-9 was stabilized at a constant level, and then began, for a few days, to decrease the level at a rate greater than the descent of the dam's water level. Afterwards, the level of this piezometer decreased at a rate equal to that of the level water of dam. The latter indicates that piezometer P-9 was working correctly given that its oscillations were associated to changes in the border conditions, such as cyclic loads (earthquakes) and the water level in the reservoir. Piezometer P-7, on the other hand, did not present variations during this period, which makes it possible to presume that its operation was anomalous (probably plugged). Figure 12 presents the variations in levels recorded by piezometers P-7 and P-9, up to the end of March 2010.

Figure 12: Variations in piezometric levels recorded after the main earthquake (Valenzuela, 2010)

Actually after examining the situation of these two piezometers P-7 and P-9, a few days after the earthquake, it was decided to start lowering the water level in the reservoir anticipating in a few weeks the lowering of the reservoir that had to be done anyway. Indeed, the commitment acquired in the
