LESSONS LEARNED FROM BUILDING DAMAGE CAUSED BY PADANG EARTHQUAKE, SEPTEMBER 30, 2009

Mohd. Raihan TAHA¹, Sri Atmaja P. ROSYIDI², Tajul Anuar JAMALUDDIN³

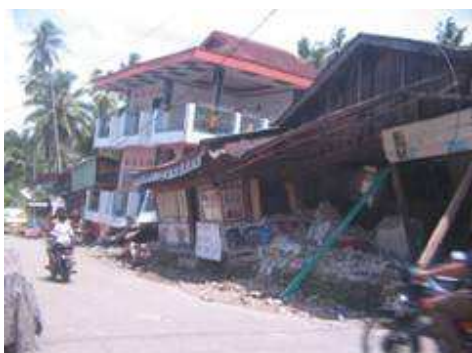
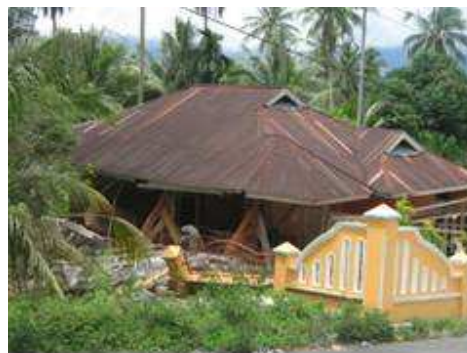
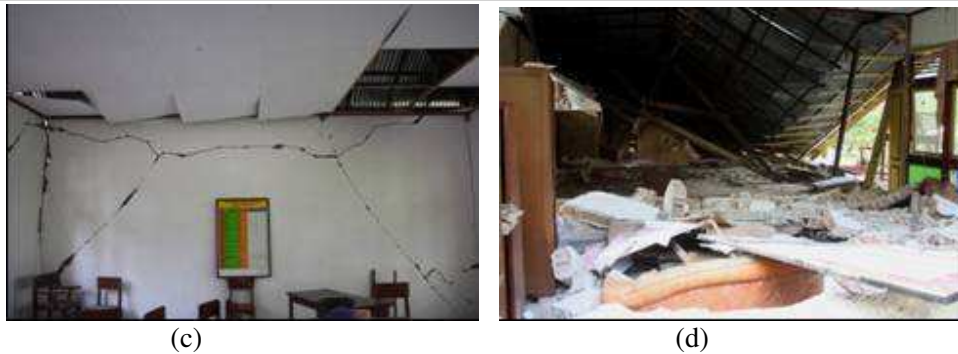
Masonry buildings with brick plaster or known as unreinforced masonry (URM) is the most totally collapsed non-engineered building type which was found in city of Padang, Padang Pariaman and Pariaman districts. Typical structural system of the URM consists of simple stone foundation, one thick brick wall, brick plasters, and roof supporting trusses (Suhendro, 2008). From our observation, it is found that this type of building structure was constructed with low quality materials and improperly anchored among the structural elements particularly from roof to the wall. Even after the government had issued the earthquake resistance building code in 2002, this type of building is still exist due to the lack of enforcement of building code and low economical status of the owners. Typical damage observed on collapsed masonry buildings with brick plaster could be described as follows: (a) roof tends to separate from the supporting wall and fell down (Figure 3a), (b) walls tend to tear apart (Figure 3b), (c) walls tend to diagonally crack in its own plane due to in-plane component of earthquake forces (Figure 3c), (d) walls tend to fall out of plane due to face loading (out of plane component as shown in Figure 3d), and (e) walls tend to separate from its supporting foundation (Figure 4).

Figure 3. Typical damage on unreinforced masonry residential house and school in Pariaman, Padang Pariaman and Agam district.

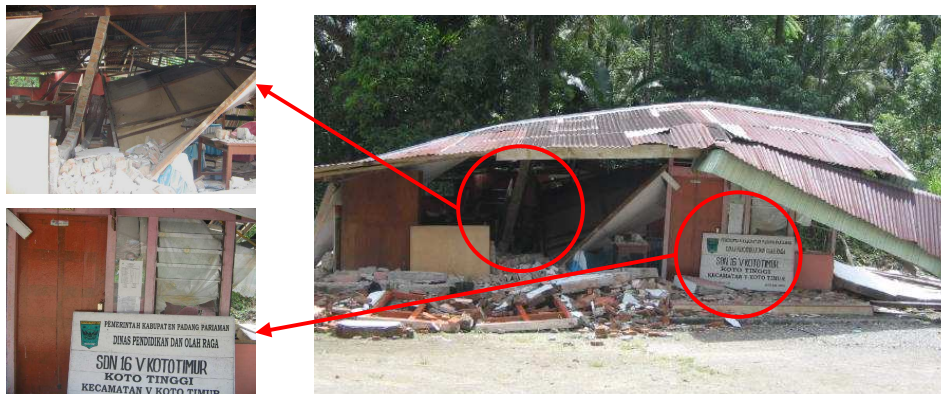
Figure 4. Collapsed school building in Koto Tinggi, Padang Pariaman district due to walls which tend to separate from the supporting foundation

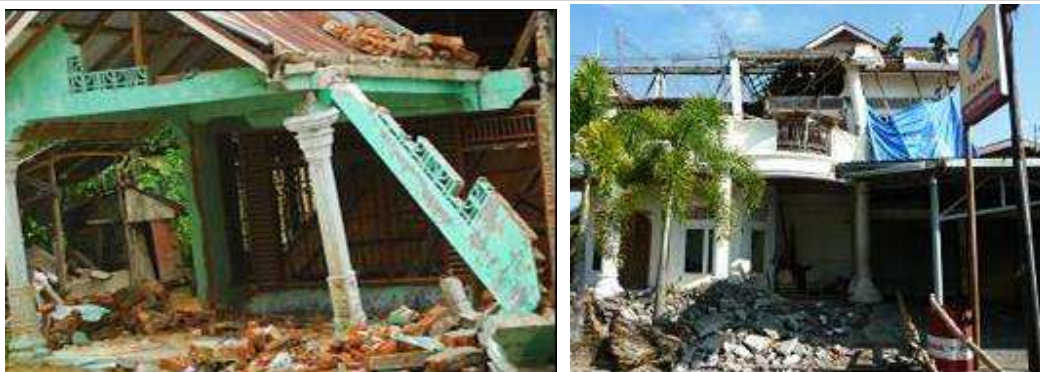
Another type of masonry buildings are made of brick wall framed with simple reinforced concrete frame system consisting of tie beam, column, and ring beam. Most these buildings might survive the earthquake compared to URM buildings. Some commonly minor to major structural damage such as diagonal cracks on the wall, vertical or horizontal cracks on the column/beam, significant out of plane deformation of brick walls, falling roof, significant dilatation damage and deformation, were found. However, there were some engineered buildings which totally collapsed probably due to the either low quality of design or material (Figure 5).

Figure 5. Collapsed and severe damage masonry building with simple reinforced concrete frame system in Padang Pariaman and Padang city district due to low quality of building design or material

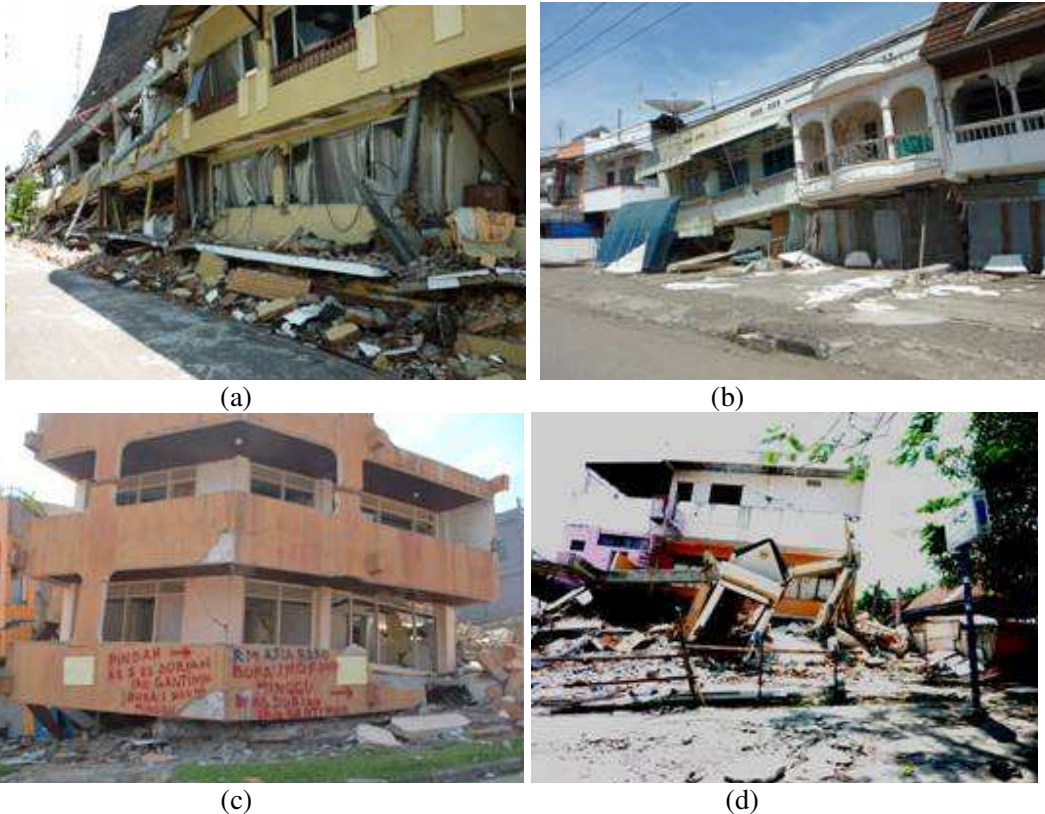
Engineered buildings of moment-resistant frames of reinforced concrete (RC) is commonly used for multi storey houses, government buildings, school buildings, university campuses, offices, hospitals, hotels, plaza, malls, shopping centers, and etc. Typically, the main structural system consist of foundation, tie beams, columns, beams, slabs, roof supporting trusses, and sometime shear wall or core, which are monolithically connected to each other for structural integrity and provide strength, stiffness, stability, and serviceability of a structure. Some buildings survived the earthquake and only suffered minor to major structural damage as well as nonstructural deteriorations. However, a significant number of engineered buildings particularly distributed in Padang city and Padang Pariaman totally collapsed and had significant structural damage (Figure 6). The predominant failure mechanism of RC structures was soft storey failure, i.e., collapsed of lower storey of a building which was less strong than the upper structure as shown in Figure 6a, 6b and 6c. Figure 6a shows the structure of the ground floor of Inna Muara Hotel in the city of Padang which was relatively less resistant to lateral earthquake motion than the upper floors. Thus a disproportionate amount of the building's overall side-to-side drift was focused on that floor. Subjected to disproportionate lateral stress, and less able to withstand the forces, the floor became a weak point that suffered structural damage or complete failure, which in turn results in the collapse of the entire building. The collapsed of 2 to 4 storey shop houses (used for both home and store) is shown in Figure 6b. The first floor is usually used as a store/shop and the second floor as residential house. Many of these buildings have public access at the street level. This access involved large openings for garage or commercial space and if not properly designed can lead to pancake-style collapses to the ground floor. Another cause of RC building damage was low material quality or poor reinforcement particularly in the column and beam joints (Figure 6d).

Figure 6. Collapsed reinforce concrete buildings in Padang city district due to low quality material and incorrect construction methods or design code

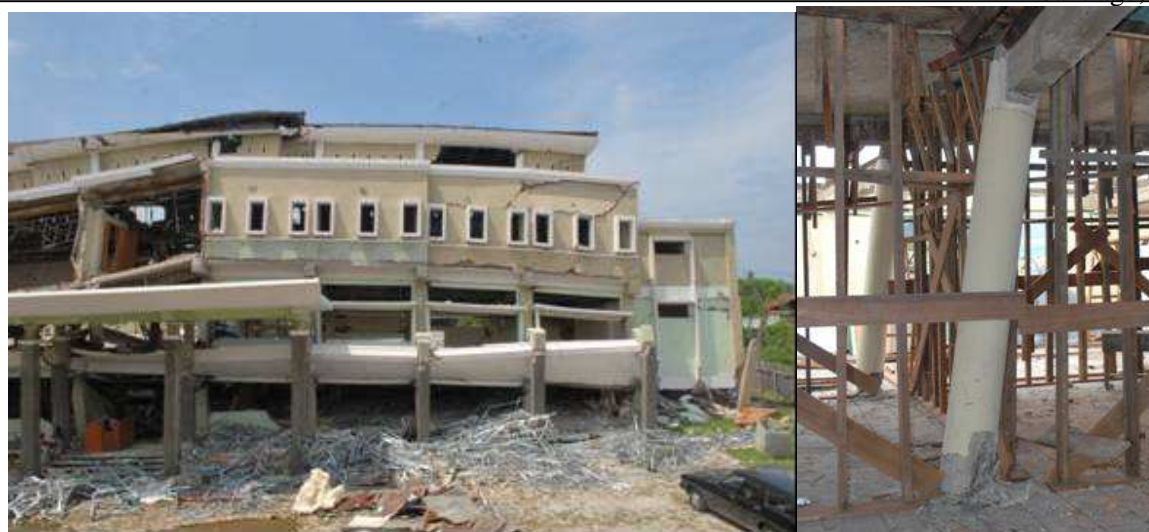
Figure 7 shows another case of the structural damage in a building with a show room in the city of Padang. The damage on RC column (Figure 7b) indicates that inadequate column detailing, i.e., inadequate column lap splices for main flexural reinforcement and a lack of adequate transverse reinforcement within the column. In addition, the column lap splices were short compared to the requirement of modern codes.

(a) (b)
Figure 7. Severe damage on reinforce concrete buildings in Padang city due to poor column detailing

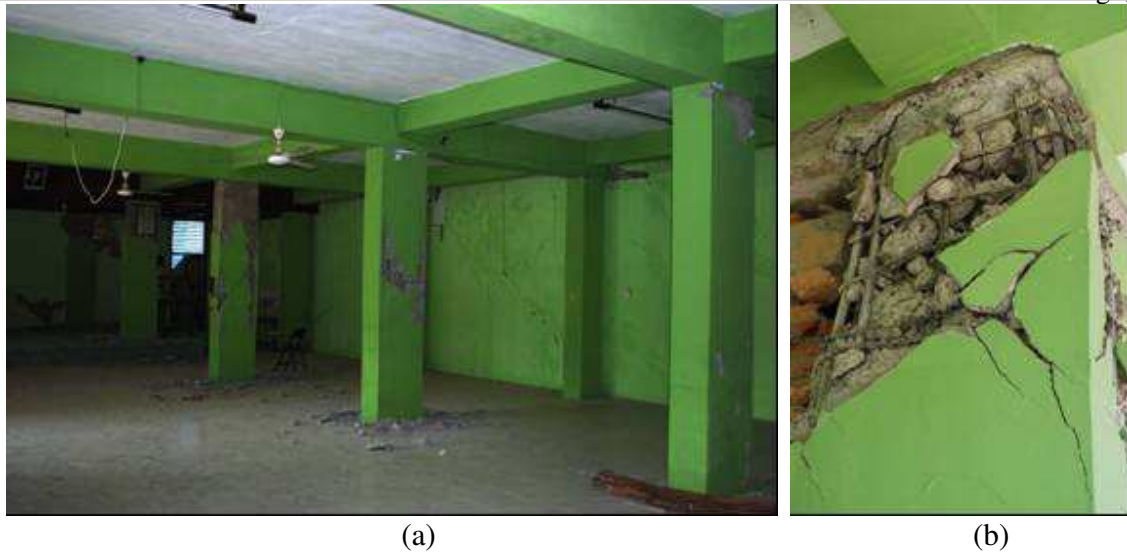
Figure 8 shows the structural damage of another RC building in the city of Padang. It indicate that the structural damage in the columns were due to the poor quality of concrete material or strength. The column reinforcement bars were still in place without any structural damage. However, the poor concrete material used caused reduction of column capacity.

Figure 8. Severe damage on reinforced concrete buildings in Padang city due to low quality of concrete strength in column

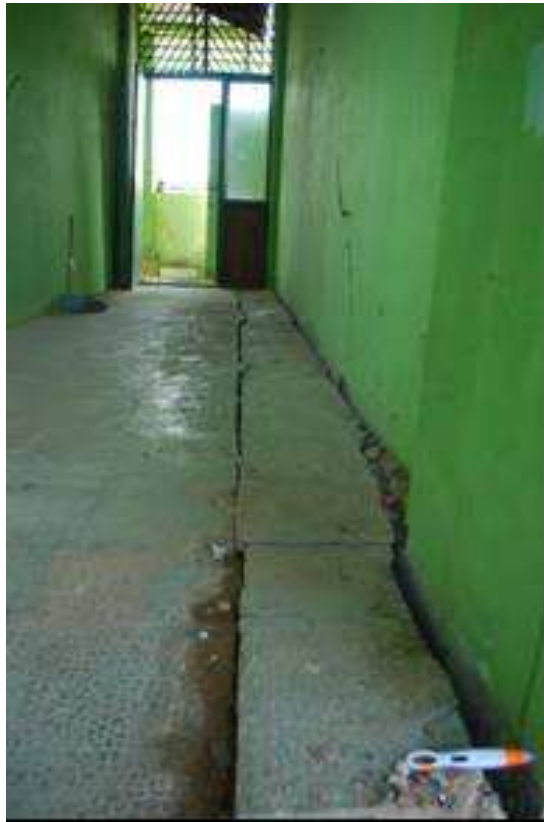
Soil settlements were the most common phenomenon of damage induced by Padang earthquake. Settlement of soft soil might have been caused by inadequate soil compaction for foundations. Figure 9 shows typical settlement and severe cracks on walls and floors found in several buildings in Padang. Damage to the soil subgrade and foundation was also found in the city of Padang with heavy ejection of water and sand in the high intensity earthquake zones. Geotechnical condition of soil subgrade and foundation comprise of medium to dense silty sand layers. Liquefaction occurred in some areas with these layers particularly close to the shoreline in which saturated loose to medium dense silty sand exists (Sengara et al. 2009).

Figure 9. Typical damage on buildings due to soil settlement

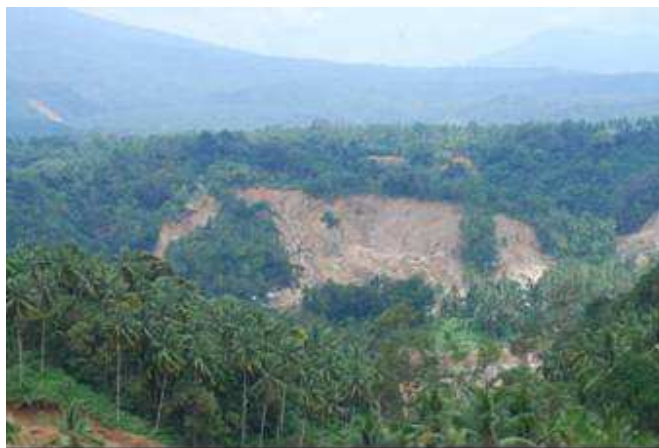
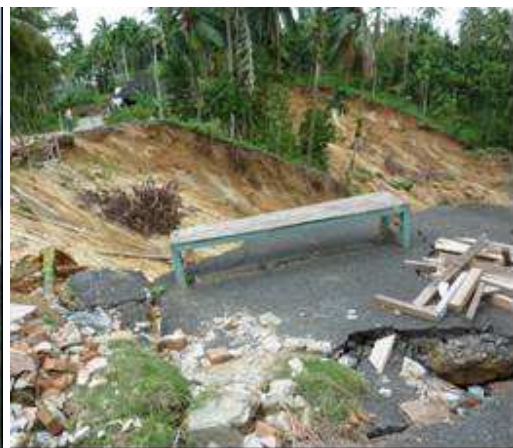
Another geotechnical failure resulting in building damage by the earthquake was landslide. Most landslides were concentrated in the Pariaman district where residential buildings and other infrastructures such as road networks, drainage, electrical power lines, etc in some villages were totally demolished. A huge landslide totally demolished one village in this area in which hundreds of people were buried alive as shown in Figure 10a. Other landslides occurred at many nearby locations which destroyed road networks and buildings as shown in Figure 10b. As a result, it cause difficulties in rescue efforts and aids deliverance.

Figure 10. (a) Huge landslides which destroyed one village in Pariaman, (b) Buildings and road network was totally collapsed due to landslide in Pariaman

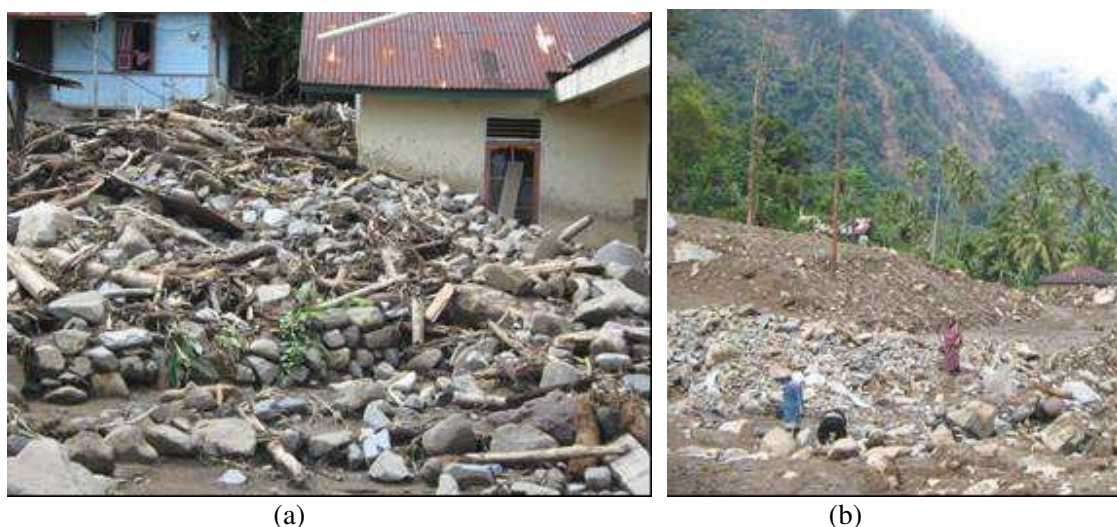
Landslides with collateral debris flow were found at the hilly area of Maninjau Lake, Agam district. The earthquake resulted in slope failures and landslides at the top of the hill, therefore, debris flows occurred after heavy rainfall. Many hamlets have been exposed to this risk during rainy season. Several buildings collapsed and road segments became inaccessible as it was covered by debris materials (Figure 11).

Figure 11. (a) Debris flow destroyed some residential houses in Maninjau Lake, Agam district, Sumatera, (b) road network was totally covered by mud from debris flow.
