The Effect of mixed foundations on the response of some buildings to excavation

J.N. Shirlaw

ABSTRACT: Many of the older parts of Singapore are built over deep deposits of near normally consolidated marine clay. Up to the 1930s buildings were typically founded on footings supported on a dense mass of bakau piles. The bakau piles were typically 3 m to 6 m in length. The typical terraced shophouses of Singapore, built on such foundations, settle with the ground surface. Conservation of large areas of Chinatown and Little India has involved the renovation of many of these shophouses. To meet modern design codes, renovated buildings often have an interior or extension that are founded on deep piles taken to competent bearing strata, while the conserved façade remains on the old, shallow foundations. The paper records examples of buildings on mixed foundations that suffered damage during excavation for the North East subway line in Singapore. The settlements, modes of deformation and final result of excavation near these structures are presented.

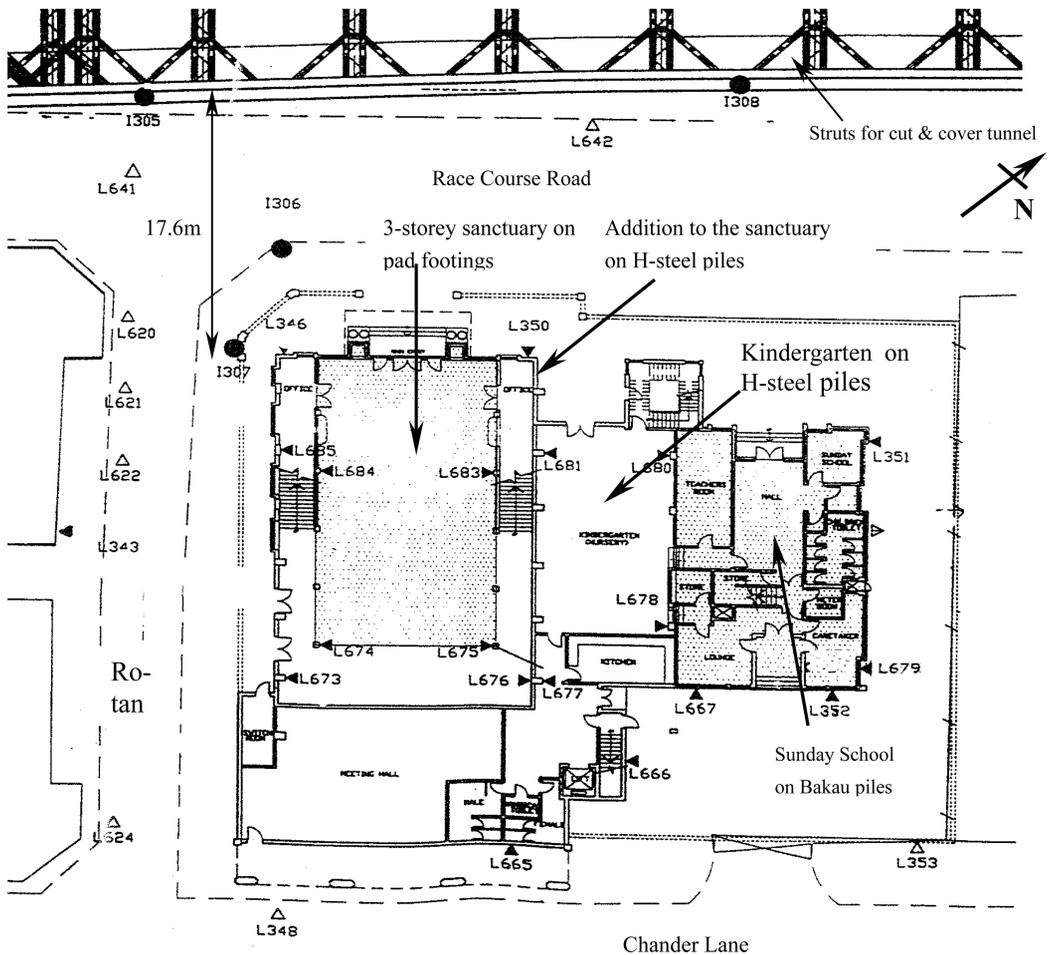
The degree of damage was high relative to the amount of settlement recorded. The amount of damage, and the pattern of damage, indicated that the building was likely to be on mixed foundations, and a detailed assessment of the foundations and building structure was then carried out. The church complex was found to be a mix of structures that had evolved over many years. The original church proper was a two storey structure that had been built in the 1930s, on shallow foundations. The Sunday school block had originally been built as an apartment building in the 1950s, and was founded on bakau piles. In the mid 1990s the church and Sunday school were integrated. This was done by constructing a linking section, used as a kindergarten school in the week. At the same time the church was extended upwards, to provide the third storey, and sideways, on the side opposite to the kindergarten. All of the newer structures, that is the linking kindergarten and the extensions to the church proper (sanctuary area), were founded on piles taken through the marine clay and into the Old Alluvium. No underpinning of the old structure was carried out; in effect, the old church building, on shallow foundations, was wrapped within the new structure on deep foundations.

Figure 2. Fochow Methodist Church, showing the location relative to the cut-and-cover tunnels and the various foundation systems within the building.

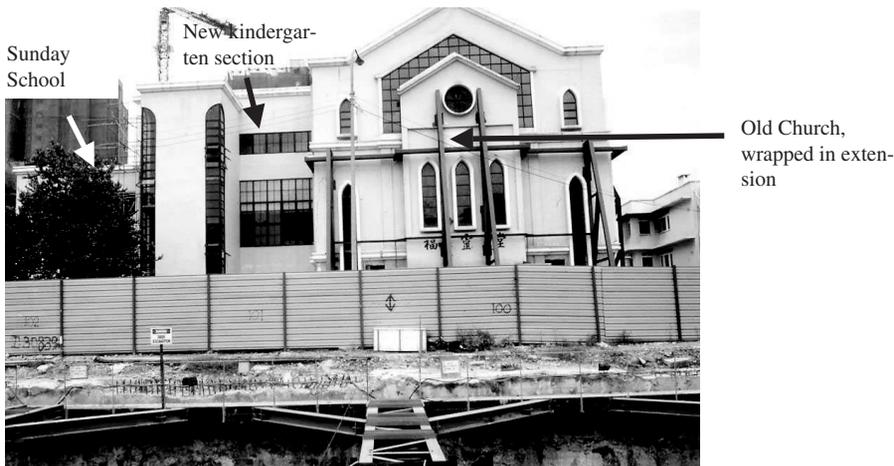
Figure 3. Fochow Methodist Church during the early stages of the construction of the cut-and-cover tunnel excavation. The façade has been propped, as discussed in the text.

allow the safety of the public to be assured. The primary concerns were with that would the main church structure, including the façade, rather than the Sunday school block where damage was first observed. It was decided to underpin the old church, including the façade, so that it was on uniform foundations. Due to the disruption involved in underpinning, the congregation was provided with alternative premises during the period of the underpinning. The alternative premises had sufficient space to house the kindergarten and Sunday school classes. The Sunday school block was not underpinned. It was planned to allow this block to move during excavation, and repair the damage that occurred. In the end, the church committee decided to demolish the Sunday school block soon after the excavation was complete, and build a larger structure in its place.

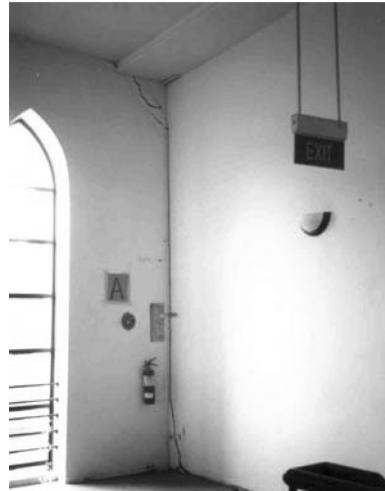
- The junction between the old church building and the new parts. A limited provision for differential movement had been allowed for in the design and detailing. Movement in excess of that provided for would result in the two structures becoming locked together. At this point further differential settlement would cause large stresses to develop in the elements connecting the two structures.
- The front façade of the church. The façade of the old church had been extended upward from the second storey level to several metres above the third storey level and had been structurally separated

Figure 4. Cracking at the junction of the old sanctuary area and the new building, on the inside of the façade.

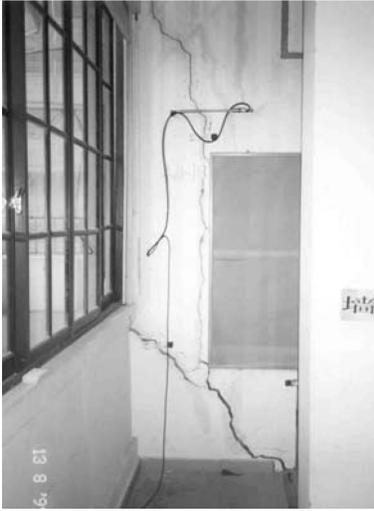
Settlements of up to 15 mm were measured on the Sunday school block, with a differential settlement of 6 mm across the frontage. This settlement caused a significant crack to open up at the junction between the Sunday school and the kindergarten. This crack was wider at the top of the building than the bottom. The crack was negligible at ground floor level, while at the top of the building the width was about 12 mm. The pattern of cracking indicated that the Sunday school

100 mm, the side nearest the kindergarten settled by only 14 mm, leading to a differential settlement of 86 mm. The Sunday school block tilted by 1:130, away from the rest of the church complex. This led to massive cracks developing at the junction between the kindergarten block and the Sunday school area. The cracks were repaired on a number of occasions, but overall were up to 50 mm in total width. Internally, ceiling tiles fell and a number of partition walls were severely damaged. Figures 4, 5 and 6 show some of the cracking that had developed by August 1999, three months after the excavation in front of the church was

Figure 5. Cracking at the junction of the Sunday School (old) and Kindergarten section (new).

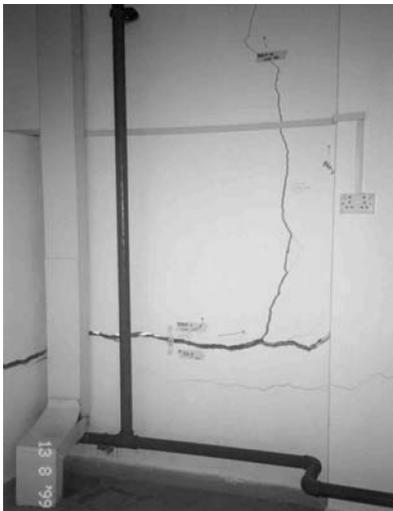
1998, before excavation for the cut and cover tunnel extended in front of the church, large cracks had appeared in the walls of the computer room and in other walls which crossed the joints between the old and new structures. This occurred because the roof of the computer room was effectively supported by the piled, newly built section, while the rest of the old building rotated away.

Figure 6. Cracking at the computer room. The roof is cantilevered off the new structure, the floor is part of the older Sunday School area.

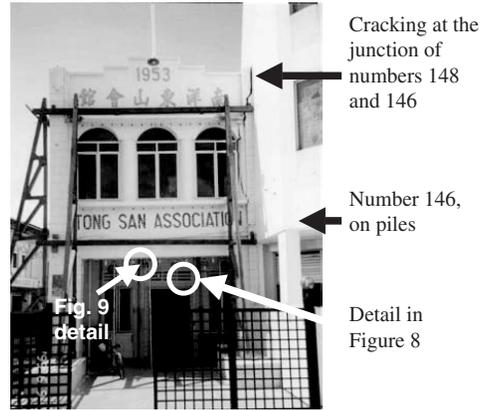
Figure 7. Number 148, showing the severe cracking at the junction with number 146, Race Course Road.

The maximum settlement of No. 148 due to excavation was 107 mm. This settlement was measured on the corner of the building facing the excavation and adjacent to Race Course Lane (see Figure 1). The opposite side of the building was held up due to the rough interface with number 146. Although the settlement on this side of the building was not measured, it can be assumed that there was little or no settlement, due to the support of the adjacent, piled building. As

The effect on the building of the differential settlement was severe damage. Figure 7 shows the front face of the building, with significant separation cracking at the junction between number 148, and the neighbouring number 146. Figures 8 and 9 are close ups of the lower part of the front façade, showing severe cracking of the block work over the doors due to racking of the building. There was similar, but less severe, separation and racking cracking in the other cross walls.

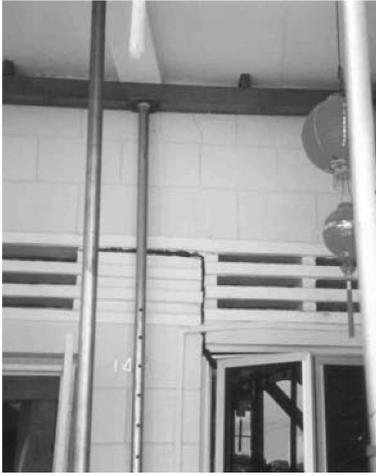
Figure 8. Cracking of the front of the building due to racking.

a result there was a differential settlement of about 100 mm across the front face of a building with a width of about 5 m, giving a differential settlement of about 1:50. The maximum settlement at the rear of the building was 58 mm. The depth of the building was approximately 30 m. The differential settlement between the front and back of the building was 49 mm or about 1:612. Across the building, at the back, the differential settlement was about 50 mm, with or 1:100.

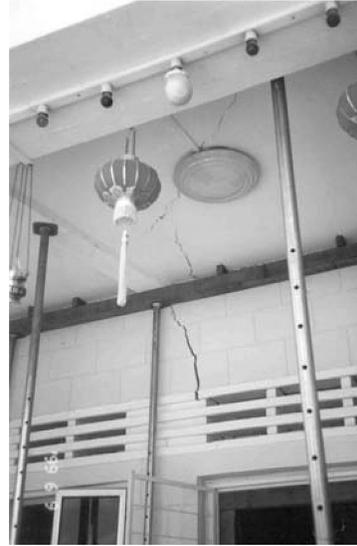
Figure 9. More details of the cracking of the front of the building.
