Detection of imperfections in diaphragm walls with geophysical measurements

R. Spruit

V. Hopman

A.F. van Tol

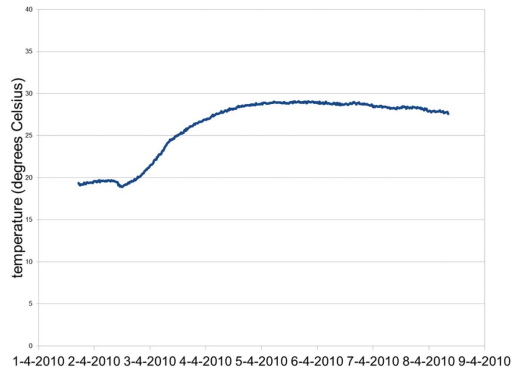
Figure 3. Temperature development in the previous joint.

Figure 3 shows that along the joint with the previous panel (previous joint, concrete 1 week old), the temperature of the bentonite in the joint is around 20 °C. When the concrete level approaches, a slight drop of around 1 °C–2 °C occurs, possibly indicating stirring of the bentonite and/or replacement of bentonite for concrete. When this drop in temperature consistently occurs along the vertical profile of the wall, it seems plausible that (almost) no bentonite has stayed behind in the joint.

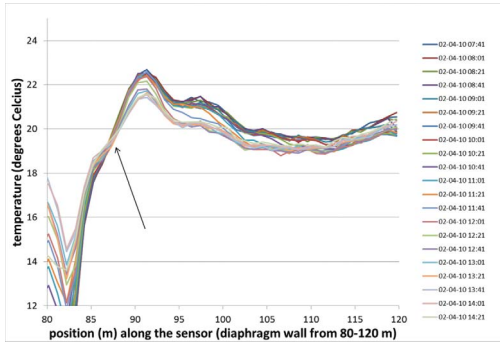
Figure 4. Temperature graph in the previous joint.

In Figure 4 at sensorposition 88, all subsequent temperature measurements show 19 °C, possibly indicating an area where bentonite stayed behind in the joint.

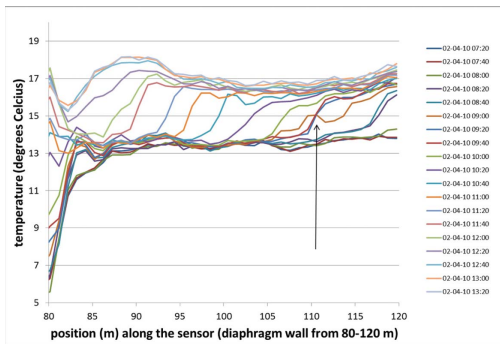
Figure 5. Temperature profile during concreting.

On the sensor along the next joint, the steady change from bentonite temperature to concrete temperature indicates a decent joint. This is illustrated in Figure 5.

At position 110 in Figure 5, a slight delay in the concrete pouring process can be seen. As each line indicates a measurement 20 minutes later, the 2 almost identical measurements at position

110 indicate a stop of 20 minutes during the concrete pouring.

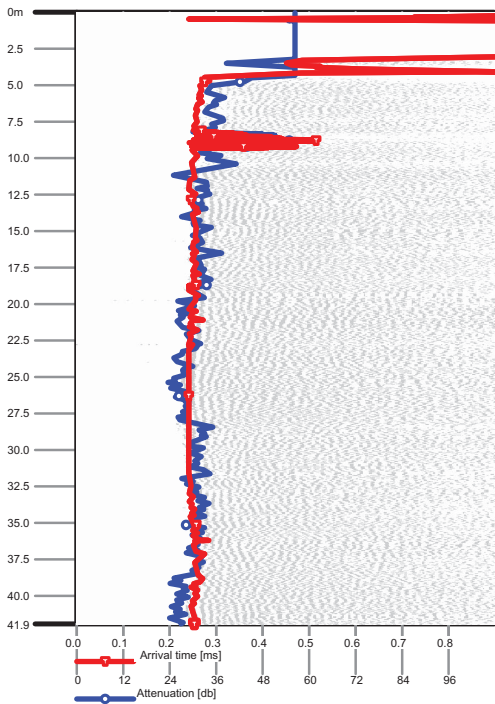
Figure 6. Cross-hole seismic profile.

Only in one joint an anomaly was found. At the depth at which this anomaly was found, clayey layers are expected outside the excavation. Therefore no further measures are taken to prevent leakage as the soil itself functions as a barrier. As excavation is still in progress no verification of the size of the anomaly can be made yet.

In Figure 6 the anomaly at 8–9 m minus surface level can clearly be seen. The upper 4 m consists of low grade concrete due to pollution with bentonite.

The anomaly found in the in-situ profile of Figure 6 shows 0.25 ms extra arrival time combined with 24 dB damping. If the laboratory samples

prove to be representative, the size of the anomaly could be in the order of 0.25 m (based upon arrival time) and 0.35 m (based upon damping). When we combine the extra arrival time with the damping, we expect around 0.3 m of bentonite in the joint. In October the excavation will reach the anomaly. As the anomaly was only found in the cross section of the side to be excavated, we expect to get an in-situ confirmation of the laboratory tests.

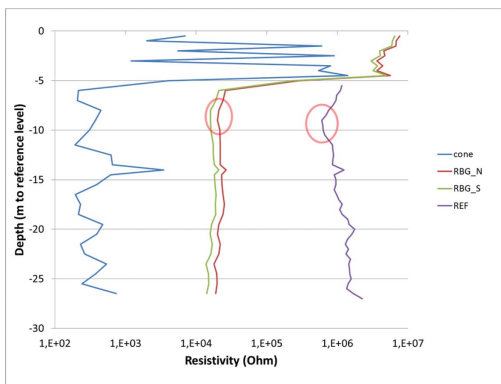
Figure 9. Resistivity profile.

The resistivity profile was measured at the same joint as the CHST profile of Figure 6 in which an anomaly was detected at 8 to 9 m minus reference level. In Figure 9, at the same depth, there is a 30% (relative to the average 1 MOhm resistance) decrease of the resistivity over the diaphragm wall (REF in Fig. 9). The resistivity from the cone to the rebar grid north of the joint (RBG_N in Fig. 9) also shows a slight dip in resistivity. It can therefore be concluded that there probably indeed is an anomaly at this depth, only occurring in the panel

north of the joint. The anomaly probably reaches to 1/3 of the wall thickness, based upon a decrease of the resistivity of 30%.

- there will probably be a defect on the side of the excavation with rough dimensions of 1 m high, 0.3 m wide at the maximum (from CHST measurements).
- the defect will probably extend 0.4 m into the wall (1/3 of 1.2 m) and will be only present in the panel north of the joint (from resistivity measurements).
- the temperature measurements of this specific joint (Fig. 4) do not clearly show a drop in temperature during the pouring of the concrete, especially at the depth of the anomaly found in figure 6 which is an extra indication that a bentonite inclusion could be present.
