Performance of remedial treatment for cave-in collapse of a subway tunnel

SYNOPSIS : This paper reports a case study for a cave-in incident which took place during construction of a subway tunnel. The project site is located close to two rivers, and the ground water level is about 8m below the ground surface. Two major possible causes of collapse were evaluated with regard to the stability condition. The first possibility considered was the appearance of a slickenside and its unfavorable geological structure. The second evaluation was made based on the field records. The remedial treatment has been suggested. The performance of the remedial treatment is monitored by means of instrumentation. Discussions are made on how effectively the treatment was performed at the site. The excavation was stopped and the face was reinforced 6m before the collapse location. A construction method was suggested to maintain the stability for the continued excavation.

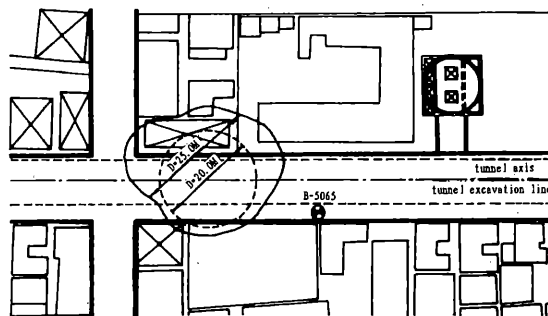
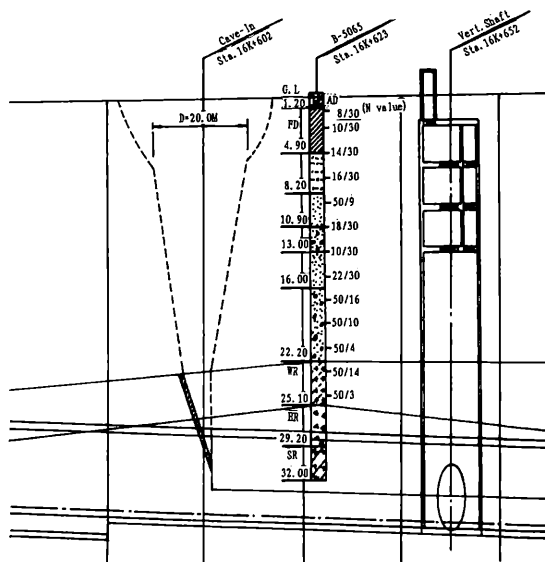
Figure 1. Plan and vertical view of the project site.

The site plan is shown in Figure 1 together with the vertical section. The location of the collapse is 16K+602, 50m away from the vertical shaft. Right above the crown of the last facing, there existed a thin layer of weathered granite rock overlain by a thick alluvium deposit. When the facing was collapsed, the works of shotcrete and steel support had been finished 1m behind the facing, and the rock bolt installation had been finished 2m behind the facing. And 17 fore polings had been installed against the crown of the excavated face.

The site is located in the conflux zone of Han River and Anyang River. The geological strata are composed of river deposits including sands and gravels of medium to dense state. The ground water level is about 7 to 8m below the ground surface, which is similar to the water level of Han river. There exist a depth of fill soil above the river deposit layer, and layers of weathered granite soils or rocks and soft or hard rocks in varying thickness below. The boring data of the vicinity area are recorded in Table 2 and the locations are shown in Figure 1.

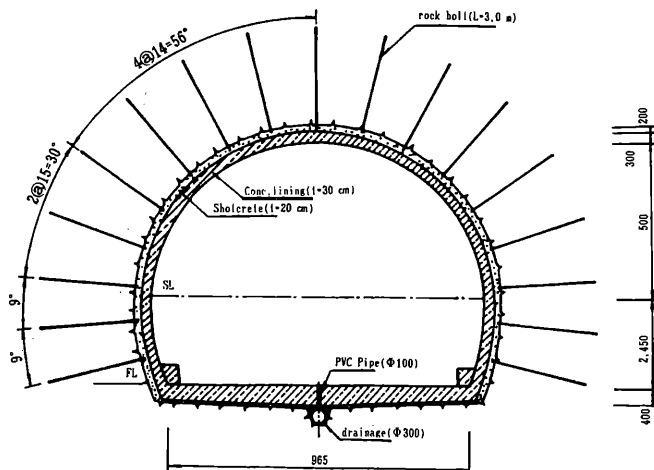
Figure 2. A typical section of the tunnel designed.

The tunnel section employed in the project is shown in Figure 2. It is one of the typical subway section suggested for the excavation in a weathered granite rock zone. Followings are the construction details for the support work in sequence.

- (1) Upper and lower part of facing are excavated.
- (2) The first wire mesh (ϕ 3 x 50 x 50mm) is installed with the first shotcrete (t=5cm).
- (3) Rock bolts (L=3m) are installed; 13 for the upper part and 4 for the lower part.
- (4) Steel ribs are installed.
- (5) The second wire mesh (ϕ 5 x 100 x 100mm) is installed with the second shotcrete (t=10cm).
- (6) The third shotcrete (t=5cm) is poured.

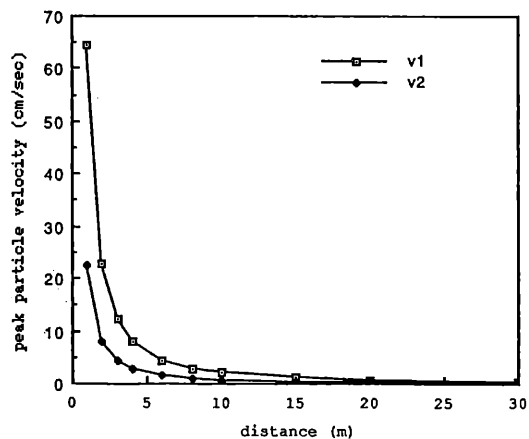
Figure 3. The peak particale velocity and the travel distance.

The influence of blasting impact was evaluated according to Figure 3 showing the relationship between the peak particle velocity and the distance from the shot hole. The peak particle velocity was calculated based on the following equation.

With these values used, the peak particle velocity was calculated for the two cases; V = 5.71cm/sec for the cut-holes and V = 6.7Gcm/sec for the roof holes. According to the standard employed for the subway construction, the calculated level is in the relatively safe range. Furthermore, the field record shows that they reduced the charge weight in consideration of the poor rock quality to about 60% of the originally designed value, and consequently the velocity would have been reduced to

approximately 77% of the above calculation. From these calculation data, it can be conclusively judged that the blasting impact would not have caused any significant damage to the upper rock strata. However, this can not completely exclude the possibility of the local damage of the rock strata right above the tunnel crown.

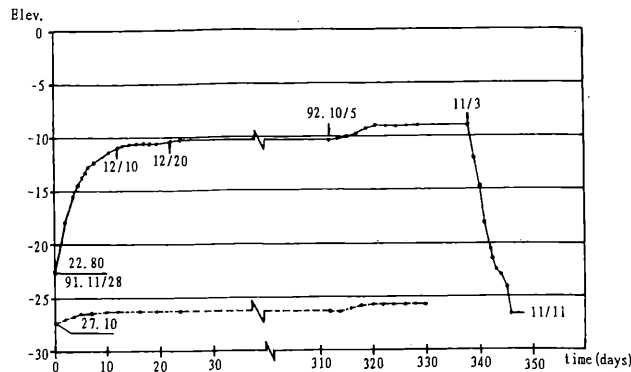
Figure 5. Levels of the ground water and the slime.

Figure 5 shows the ground water level changed from the moment of the incident including the pumping record. The curve indicates it took about one month until the water level reached to about -10.0m . And it began to rise as the grouting work started and increased about 0.8m . This trend of rise is also shown in the curve of slime level. This indicates the grouting slime was accumulated in the tunnel to raise the ground water level. The pumping work was continued for 8 days to lower the ground water level about in 2.0m per day. During the pumping, there was no drop of water head detected in the grouted zone.
