Case history of a ruptured multi tied-back retaining wall

C.E.M. Maffei

ABSTRACT: Excavation of a São Paulo Metro Station was performed in residual soil. During excavation a tied-back retaining wall broke off. The rupture is analyzed from a soil-structure point of view. As a consequence of the failure, the construction method was changed to allow catching up with the lost time due to the accident. Reconstruction details are presented as well as re-calculations.

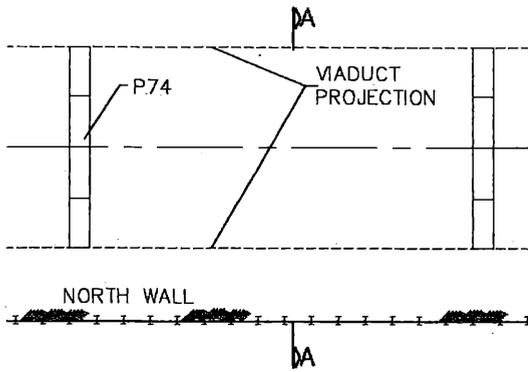
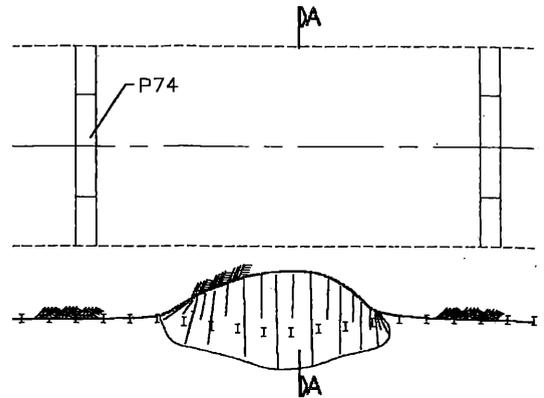
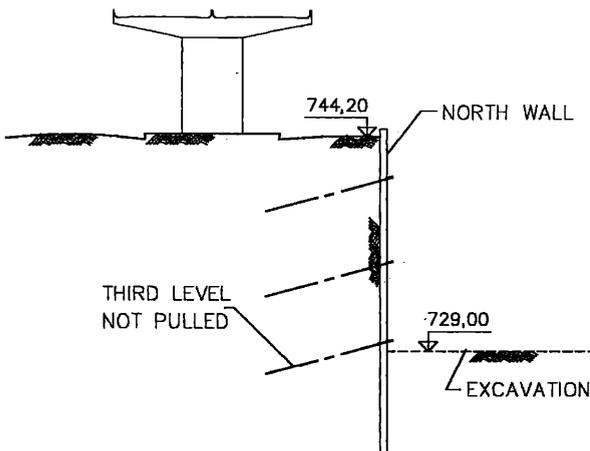
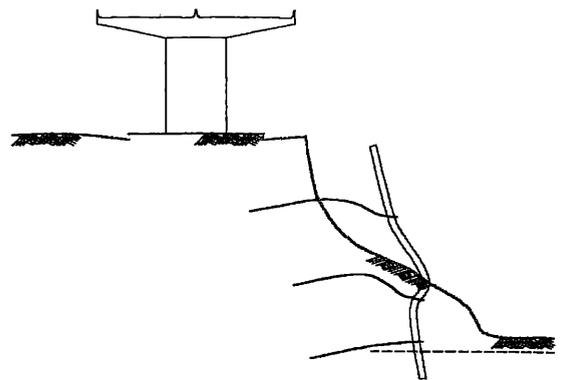
Early in the morning of day 13, in July 1985, the North retaining wall failed in an extension of approximately 13 m, in a semi-circle failure surface with radius of approximately 5 m, forming a depression toward the excavation interior. At the time, the excavation was approximately 12 m deep; first and second tie-back levels were already installed, the third tie-back level was not yet pulled. As shown in figure 3, six piles had great displacements toward the excavation area, with failure of the second tie-back level (due to bulb sliding). Even with fully deformed pile, the remaining embedding depth and the lasting resistance of the tie-backs on the first level prevented further damage. The failed part of the wall slid down in 1,5 m and its lower part displaced 3,0m toward the excavation. The wales were extremely deformed or even broken. The soil adjacent to the broken wall slid down 3,0 to 4,0 m, resulting in a vertical slicing surface with a semi-circle shape with radius of 5.0 m. The failure process took about 2 hours to occur, with slow pile motions, only detected at the beginning by noises coming from the wood lagging, then by dropping wedges and surface fissures increasing. Therefore there was enough time to take the equipment out of the excavation area, and to isolate it.

Continuing the failure process, the wood lagging dropped from the piles, and the soil slid inside the excavation up to the point when the tie-back on the second level failed, resulting in sudden and abrupt pile deformations.

Following the wall failing process, and the soil sliding, the situation turned apparently stable, without any signs of any other mayor sliding. Concentric fissures on the surface advanced near 10 m, and at the wall base, a berm with slid material was formed, as shown by figure 3. It must be observed that before the failure occurred, some

fissures on the pavement, and water flowing through the lagging at the second tie-back level had been noticed.

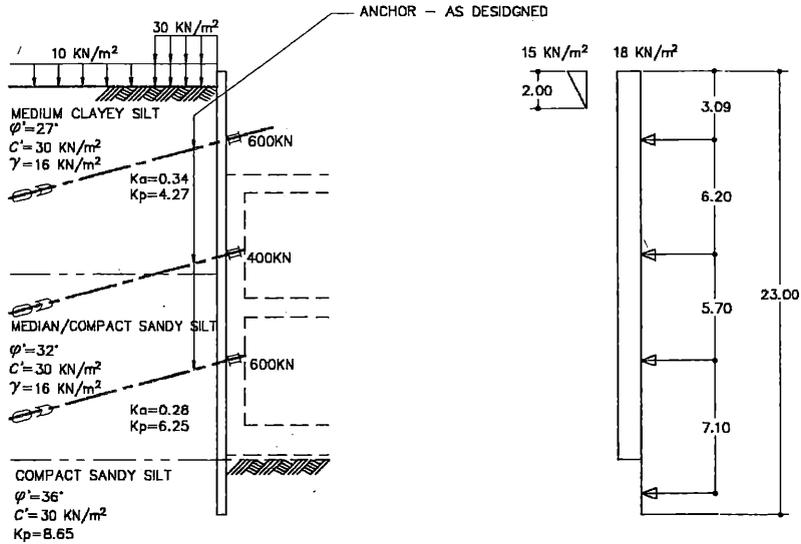
FIG. 8
INITIAL CALCULATION METHOD—NORTH WALL

The original wall dimensioning was made with the classical semi-empirical method of continuous beam, assuming fixed hinges at the tie-back levels and at the embedment depth zone. The active earth pressure was determined as Rankine and redistributed as shown in figure 8, due to wall flexibility.

The initial soil parameters were adopted $c' = 30$ kN/m² and $\phi' = 32^\circ$ for the residual soil, and were modified for $c' = 25$ kN/m² and $\phi' = 20^\circ$ after the occurrence of the accident, as a precaution.

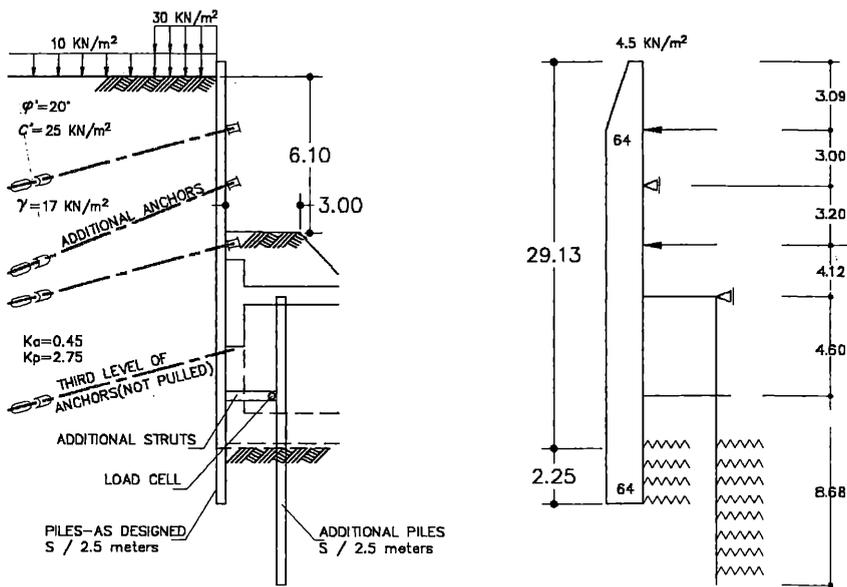
FIG. 9
CALCULATION METHOD—NORTH WALL (AFTER FAILURE)

The computation method is indicated in figure 9, emphasizing the following aspects: the "springs" which represent the soil in the embedment depth zone have as limit the correspondent passive earth pressure; parametric studies were made to evaluate the influence of the spring coefficient value; the computation method should be evaluative, i.e, it might be considered the excavation history regarding the following cycle: excavation - back filling - installation of the additional tie-back level - excavation - concreting of the "c" slab, etc.; however, it

was considered that the non-evolutive method of continuous beam gives a statically admissible bending moment diagram, which is enough from the safety point of view. It must be pointed out that some plastic hinges on piles were assumed.

Above the "c" slab, that region had the pressure on the wall increased, demanding an additional tie-back level to be installed between the 1st and the 2nd original levels. Below the "c" slab, it was observed that the 2,26 m embedment depth of pile was not enough for the new increased pressures. Since it was very difficult to reinforce the original soldier pile, this was accomplished by the installation of an additional piling system with double function: to resist the slab weight and other surcharges, and to reinforce the North wall with small additional struts- figures 3, 6 and 9.
