Building collapse and ground subsidence in northern section of Calcutta Metro Construction

N.N.Som

ABSTRACT : The paper presents the case history of a building collapse in contract section 7 of Calcutta metro construction. A 5-storey building adjacent to a braced cut with R.C.C. diaphragm walls and struts collapsed after a 600 mm dia unfiltered water main gave way and water began to flow into the excavation under high pressure with consequent soil loss through openings in diaphragm walls. Extensive soil stabilization was done by cement / cement sand grouting before work could be resumed and the underground construction completed in the affected area.

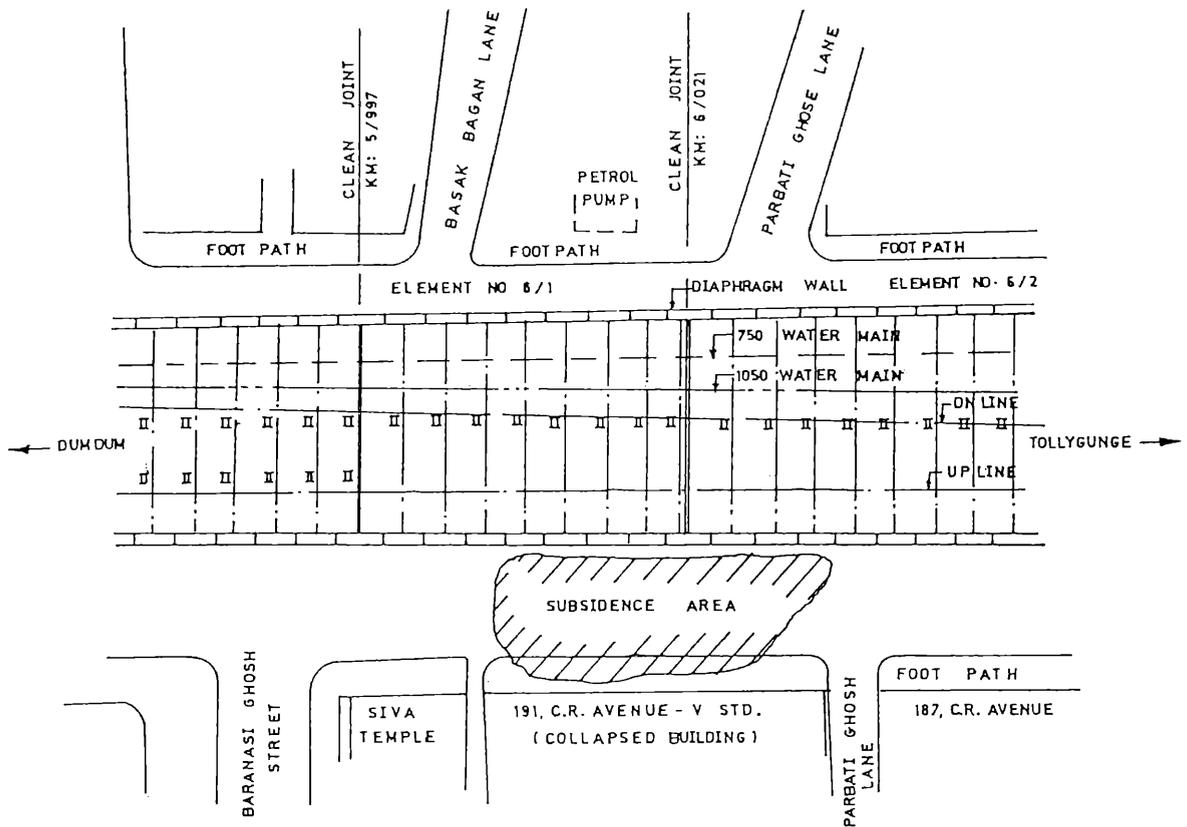
Fig. 4 Subsidence area in front of collapsed building

A zone of subsidence in the collapsed building area measuring about 20 m x 10 m x 2 m deep was noticed between the diaphragm wall and the collapsed building after the removal of debris. This means that a volume of earth measuring 400 cum had subsided in the collapsed zone. This loss of soil did not take place in a single day. There was no evidence of upheaval of soil at the bottom of cut, nor did the diaphragm wall or struts show any major movement. The diaphragm walls appeared to stand well vertically and the struts also maintained their lateral position quite well. It was, however, gathered that there was persistent flow of water and soil loss through the gaps in diaphragm walls over a period of time. The gaps appeared to widen in deeper locations and lagging plates had been provided to close these gaps. But, the process of fixing lagging plates did not necessarily give a fool-proof system of preventing soil loss because the plates could not be fixed to the wall till the excavation had already progressed to that depth.

All these factors led to continued loss of earth through the diaphragm wall as could be evidenced from the deposition of soil at the bottom of the cut. Grouting was done in adjacent areas on either side of the collapsed zone to close the gaps in the diaphragm wall and to stabilize the soil for minimising the loss of earth from the side of excavation. Cement grouting was reportedly done in November, 1993. This was followed by polygrouting. Subsequently, cement grouting had been commenced near the collapsed zone. The latter was in progress when the incidence of collapse took place. Considerable soil loss appears to have occurred even before the stabilization measures could have any major impact. Such soil loss into the excavation would have led to perceptible subsidence on the ground surface. However, the existence of hard road / pavement crust did not make void formation immediately apparent from outside. Voids created in the soil could have been retained by arching action. With progressive soil loss the earth supporting the pipelines finally caved in thereby causing the joints of the 600 mm pipeline to burst open. Water began to flow under high pressure causing rapid soil erosion close to the building. Normally, water from an underground pipe burst finds its way to the road surface. But, in the present case, possibly due to the prior formation of voids in the underground, the water from the collapsed pipeline forced its way down under high pressure leading to heavy soil erosion close to the building. This probably

- (b) There was still some water coming into the excavation through the gaps in diaphragm walls. This was a source of potential danger as the water continued to wash away the fine soils and cause further ground subsidence. The most immediate task, therefore, was to stabilize the soil outside the diaphragm wall and to reduce the flow of water into the cut. This would be done by grouting on both sides of the cut near the collapsed zone. Cement or cement-sand grouting would be done to close the voids within the soil and strengthen any zone of weakness that still existed in the soil. The grouting would be done between the diaphragm wall and the building lines from outside the wall or by drilling holes from inside the diaphragm wall down to a depth of about 20 m below ground level. During grouting cement / cement-sand would be plumped into the soil and the grout would spread into the soil through the void space and finally set in the soil to give it greater strength. Difficulties would occur in grouting under flowing water condition because of the chances of the cement being washed out. In such cases quick-setting additives would be added to the grout. Grouting would be continued at each place till refusal to accept cement and sufficient pressure was built up to indicate closure of voids / cavities.

- Grouting on both sides of the alignment near the collapsed zone should be continued till the soil stabilization work in the affected area was done. Till the stabilization work was substantially over, excavation and underground construction would not be resumed in the 65 m affected stretch.

- After the demolition of the collapsed building was over, grouting should be extended to this area to stabilize the soil in the affected zone.
- The 450 mm dia water main on the eastern side

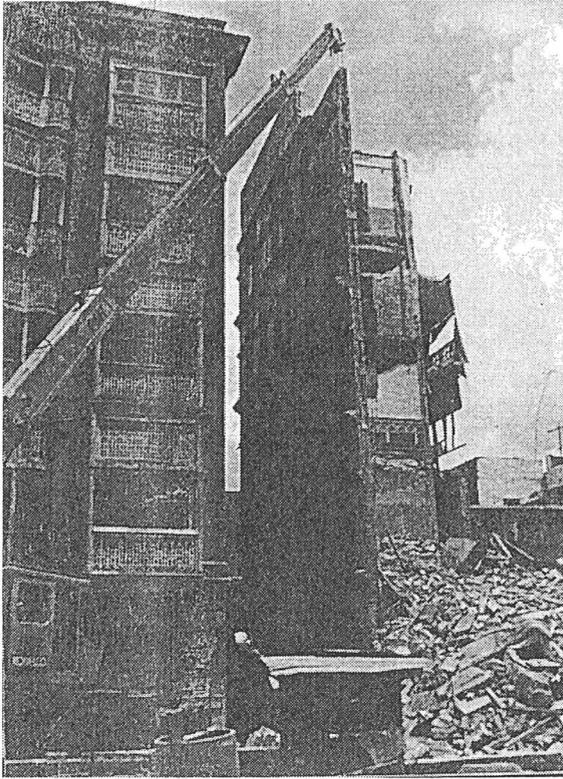
Fig. 5 View of Building after collapse

weakened the foundation and led to rapid tilting of the building. Although immediate action was taken to shut down the water from the pumping station residual water in the pipe continued to flow at high pressure for 5-6 hours. In the absence of isolating valves this flow of water could not be controlled earlier. By the time the rushing water was stopped sufficient tilting had occurred in the building to take it beyond the limits of stability. Continuous tilting caused further instability and the building finally collapsed when the deformation became excessive. (Fig. 5)

The building collapse in construct section 7 of Calcutta metro construction was caused by seepage of water into the excavation and consequent soil loss through the opening in diaphragm wall. Leakage in a 600 mm water main caused continuous flow of water into the excavation. Further construction in the area was done after extensive soil stabilization by cement / cement - sand grouting.
