Measures to prevent heaving during the excavation of soft ground

N. Kubota

ABSTRACT: This paper describes the heaving phenomenon and the cause of that during the large-scale excavation in the soft ground which has been reclaimed just recently in Haneda area. In spite of efforts to stabilize the earth retaining wall by means of ground improvement of the excavation bottom, the symptom of heaving was observed. By early detection of such symptom and adequate mesures, the work could be completed without incident.

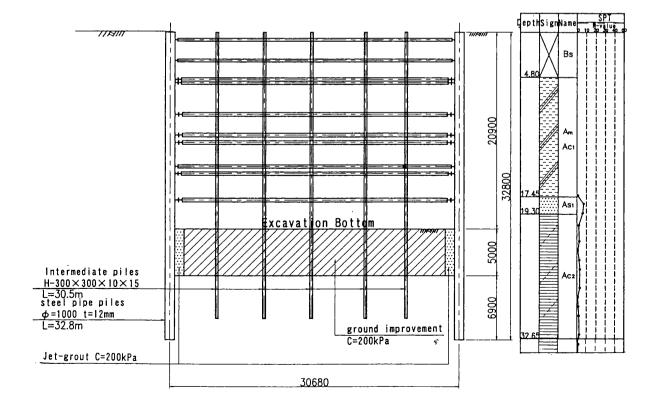
Figure 1. Standard section of the earth retaining structure.

The earth retaining wall were steel-pipe sheet piles (φ1000, t= 12mm, L=32.8m) with struts arranged in seven stages.

The safety against heaving was checked according to Metropolitan Expressway Public Corporation's method and Peck's stability factor. As a result of the calculations, the safety factor of MEPC's method was 1.47 (>1.2:required safety factor), but the Peck's stability factor was 5.9 (>5). Therefore, soil improvement was performed at a depth of 5m below the excavation bottom.

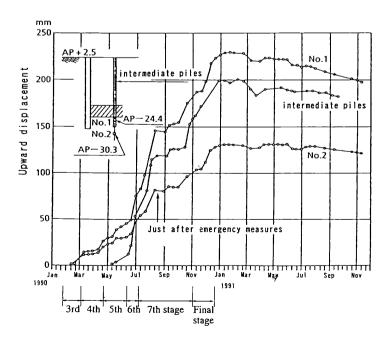
Figure 3. The upward displacement data.

Excavation work proceeded carefully and smoothly up to the sixth stage. The upward displacement of the excavation bottom due to the rebound by the removal of the excavation load was observed and the deformation of the earth retaining wall was suppressed in the bottom immprovement section as shown in Figures 3 - 4.

As the seventh stage of excavation proceeded, the upward displacement rate rose up and the bottom edge of the earth retaining wall was displaced to the excavation side. Then we stopped the excavation work temporarily, but the displacement did not slow down.

We considered these problems to be symptom of heaving, and carried out removal of the soil from the back of the walls (up to GL-4m) and water injection into the excavated area (to a depth of 3.5m) as emergency measures. As a result, the bottom of the excavation ceased its upward displacement and the earth retaining wall stopped deforming.

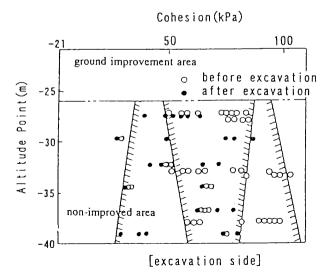
Figure 6. Comparison of soil strength between before and after excavation.

On the other hand, the non-improved soil strength was also reduced to 50-80% of the original strength according to the results of the investigation executed after occurrence of heaving (Fig.6). We assume the strength decline in the excavation side to have been caused by reduction of effective stress due to removal of the excavation load and by swelling due to that. And the bigger decline of strength at the bottom edge of the wall was caused by shear deformation of the soil due to heaving. Then this strength decline furthered the occurrence of heaving.
