The influence of unsaturated phenomena in the failure of an ancient (upstream raised) tailings dam

Luciano A. Oldecop¹, Rubén D. Rodari¹, Lucas Garino¹, Gustavo Navarta¹

¹*Instituto de Investigaciones Antisísmicas "Ing. Aldo Bruschi", Facultad de Ingeniería, Universidad Nacional de San Juan, Argentina.*

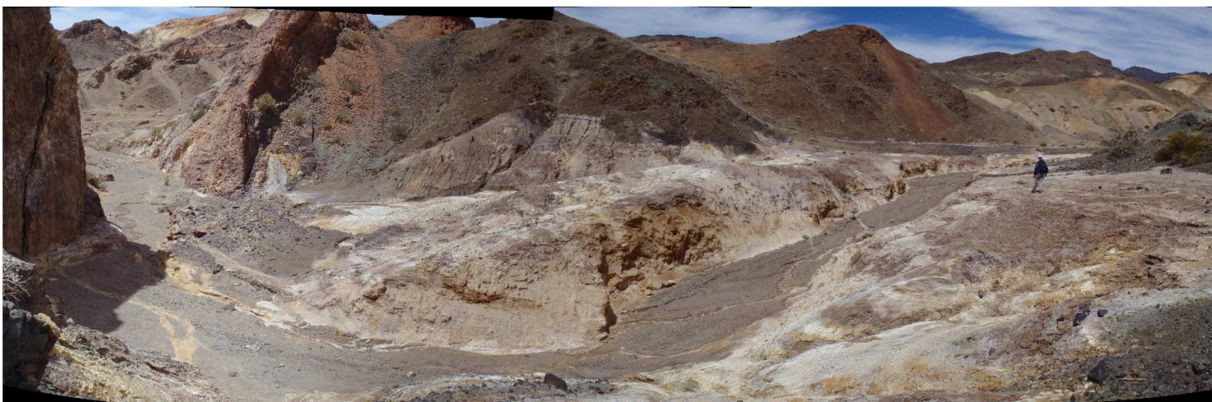
Figure 1: Photo of the Upper Castaño Viejo Dam site. Extreme left: starter dam location. Center: sliding surface. Extreme right: decant pond location.

The starter dam was placed taking advantage of a natural narrow, owing to the presence of an igneous dyke (extreme left of the photo in Figure 1). The dam main slope was raised by

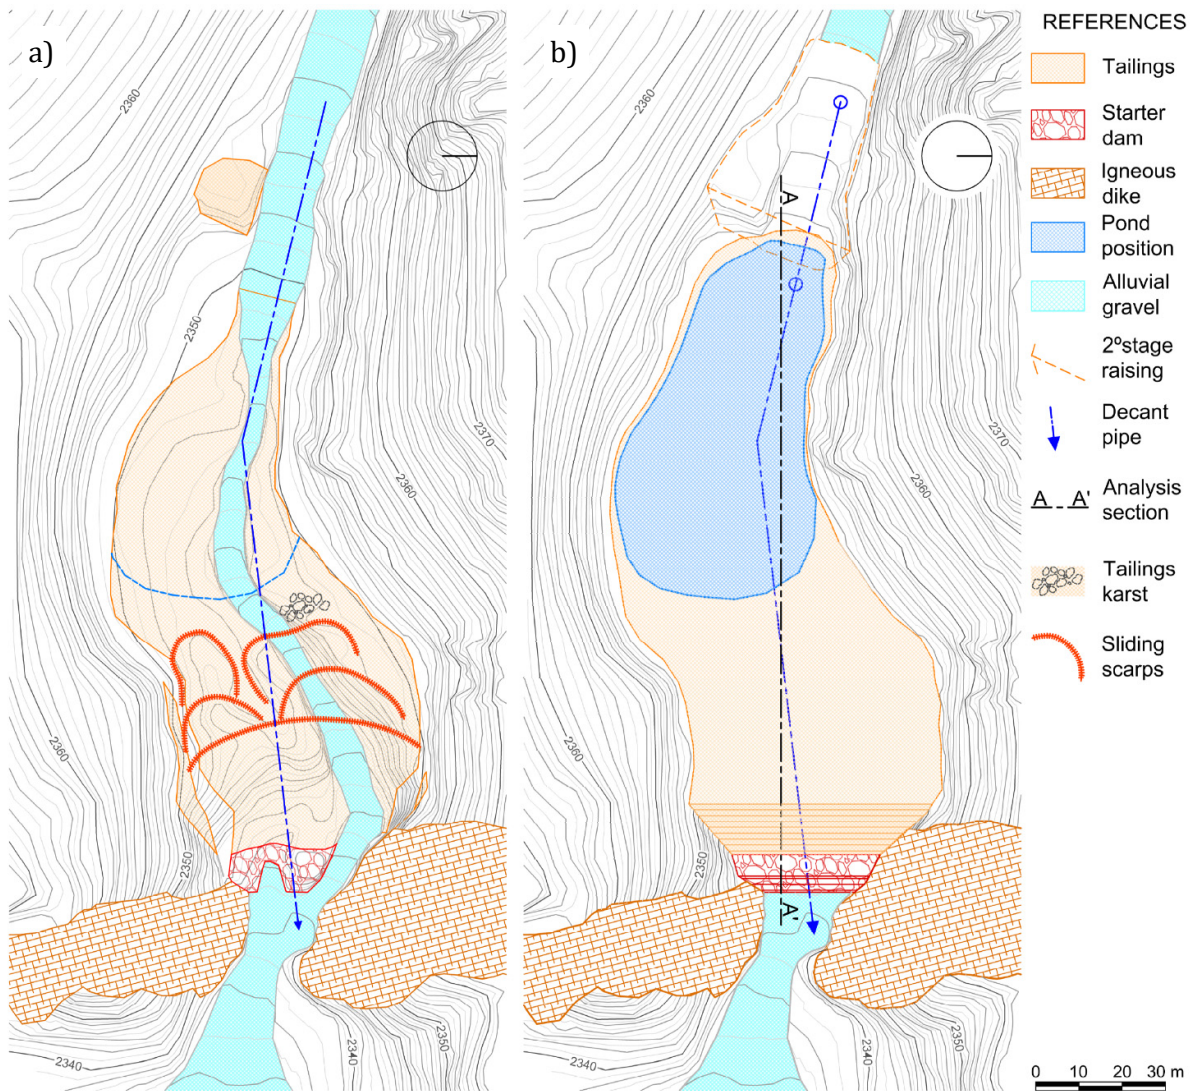
Figure 2: Plan view of Upper Castaño Viejo Dam. a) Current state of the relicts. b) Geometry of the dam before the accident restored from the field surveys.

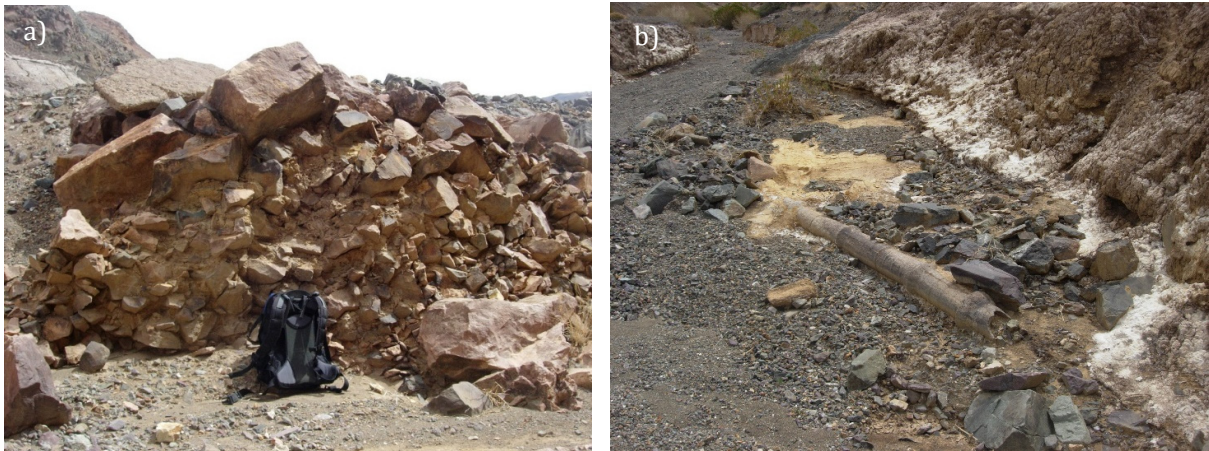
The 2.7-meter-high starter dam was built with rock blocks ranging from 3” to 20” in diameter. Within a zone located upstream, the rockfill voids appear totally clogged by the

tailings (Figure 3a). The mechanism which led to this is not clear. Either the fluid tailings of the first pours seeped through the rockfill large voids, owing to the lack of filter, or rockfill and tailings were co-disposed on purpose.

Figure 3: a) Starter dam. Note the rockfill voids invaded by tailings. b) 200 mm precast concrete pipe laid in the valley bottom as decant pipe.

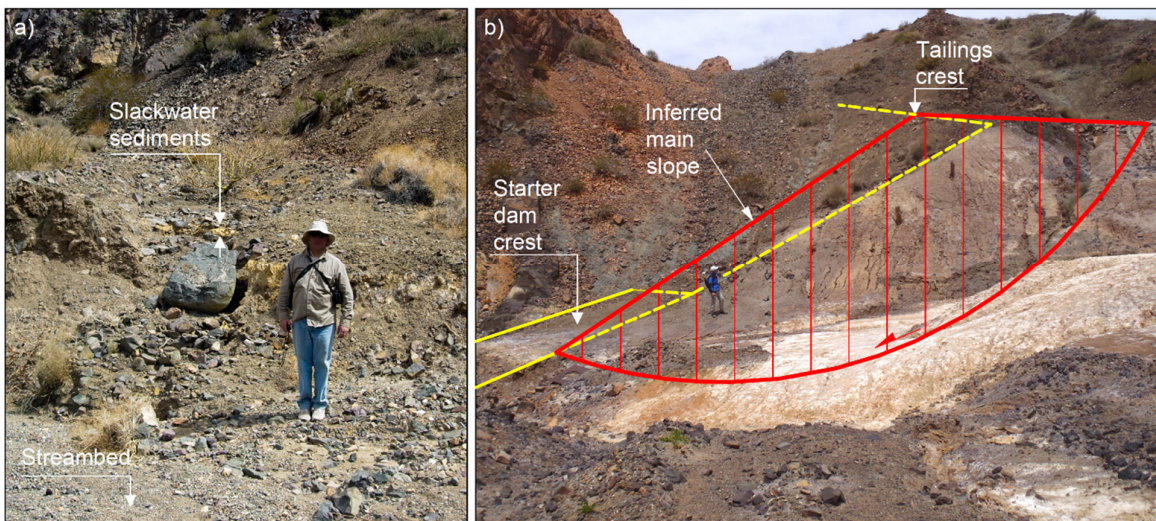
an avalanche of liquified tailings that moved at least 3 km downstream, according to both the field observations and the oral reports. Several tailings slackwater deposits (Figure 4a), still discernible along the river's course, indicate that at some sections the mud flood reached at least 2m above the streambed. The steep slope of the valley also suggests that the escaped tailings mass has travelled downstream at high speed. Tales are that a truck travelling on the mine access road was engulfed by the avalanche. Some versions suggest that three people riding the vehicle died, while others say they narrowly escaped by climbing the riverside slope. An estimation of the tailings volume escaped in the accident, based on the topographical data gathered in the field, yielded an approximate figure of 11000 m³.

Two mechanisms are the most likely triggers of the dam failure: 1) overtopping during a flood or, 2) slope instability triggered by a malfunction of the decant system. Regarding the first mechanism, flash floods are likely to occur upon summer convective storms. Moreover, to our knowledge, the facility had no spillway or other discharge structure than the decant pipe. However, some details make the overtopping hypothesis less likely. For instance, in a case of overtopping, a breach localized in a limited width of the dam would be expected rather than the observed circular sliding surface spanning all the dam width (Figure 4b).

Figure 4: a) Slackwater deposits from the tailings avalanche located some 750m downstream the dam site. b) Main slope zone, with indication of the inferred initial sliding surface.

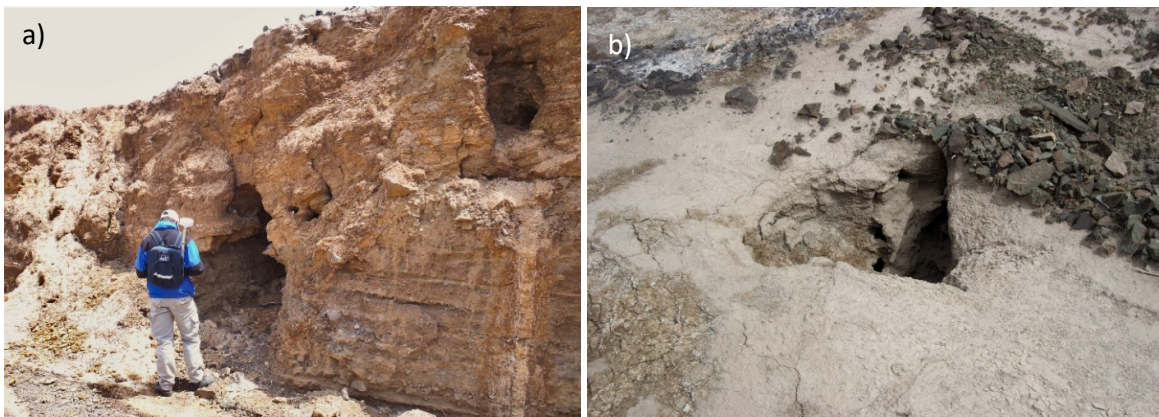
Otherwise, there is compelling evidence supporting the second hypothesis. The type of connections between the sections of the precast concrete decant pipe are rather weak and prone to leak. This type of conduit is designed to work as an open channel. Given its observed location, it is highly probable that a large section of the pipe was permanently embedded in saturated tailings. Leaks from the tailings into the pipe could lead to the migration of solid particles and hence the possibility of developing piping and the eventual formation of caverns and sinkholes. These are indeed the type of features found at the location indicated in the plan shown in Figure 2.a. A network of caverns and sinkholes (Figure 5) was found a couple of meters away from the decant pipe trace and about 60 m upstream of the starter dam axis. The karstic features cover an area of no more than 50 sqm. It is worth noting that

there is no other place within the deposit with such characteristics, which reinforces the hypothesis that the observed piping signs were related to leaks into the decant conduit and not by other causes (dissolution, for instance). Although failure seems neither to have been caused by the piping process itself.

The escaping solid particles from the decant pipe could have led to pipe clogging downstream of the leaking point. A partial obstruction would have increased the water depth within that pipe section, causing a decrease in flow velocity. This, in turn, would have enhanced particle sedimentation, continuing the clogging process until the upstream pipe cross-section was put under pressure. At this point, the leak was reversed, and the pipe started injecting water into the tailings. The pressure within the pipe could have risen to the pressure head determined by the pond level. This meant a shortcut of the hydraulic head dissipation path, which eventually destabilized the deposit. Importantly, an observer would have had no notice of these ongoing events, as the flow at the downstream end of the pipe would have always appeared normal.

Figure 5: a) Caverns presumably formed by piping due to leaks into the decant pipe. Note bending of the strata above the cavern roof. b) Sinkhole found at the top of the tailings beach in correspondence with the caverns shown in Figure 5a.

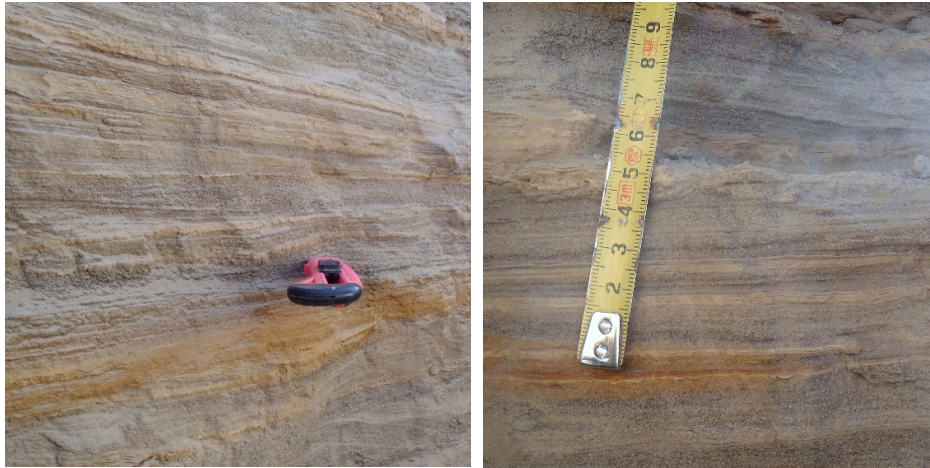
Tailings have a marked stratified structure (Figure 7). This makes their hydraulic properties particularly challenging to characterize. The saturated permeability was measured with in-situ measurements using a Boutwell permeameter (ASTM D6391-11, Method B) [16] at the points indicated in Table 2, along with their distance from the discharge point (dam crest). Moreover, bulk samples were also collected at the same points and laboratory permeability tests were conducted on remoulded specimens using a flexible wall permeameter [17]. Laboratory specimens were prepared by wet tamping at the mean dry unit weight measured in the field (indicated in Table 1).

Figure 7: Stratification of Castaño Viejo tailings. Photos taken in exploration pits. Millimetric stratification alternates fine sand and silt layers. Some layers exhibit oxidation.

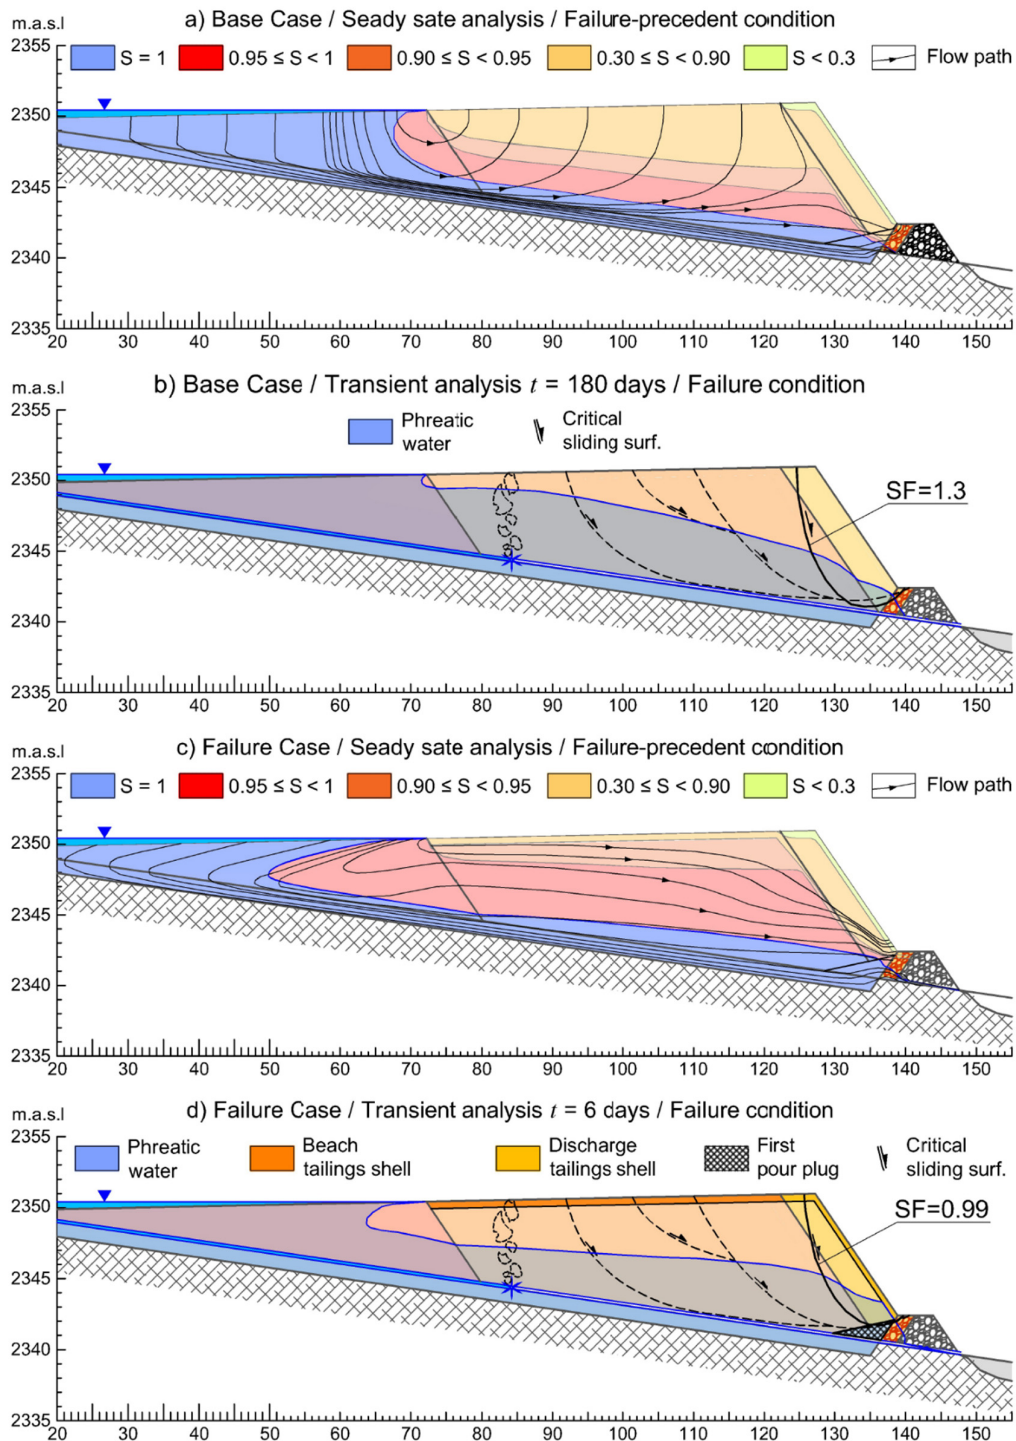
The incorporation of the three factors discussed above into the model allowed reaching a sliding failure within 6 days after initiating water injection from the leaking pipe (Figure 12.d). Moreover, six additional cases were run in which the factors were removed one by one (Cases A, B, and C) and added one by one (Cases D, E, and F), respectively. The hypotheses and results of all the analyses performed are summarised in Table 6. For instance, removing factor 1 (Case A) or factor 3 (Case B) increases the time-to-failure to 10 or 15 days, respectively. Removing only factor 2 (Case C) from the model yields no failure. Otherwise, leaving only factor 1 (Case D) or factor 2 (Case E) yields no failure, while the single influence of factor 2 leads to failure, but delayed 40 days after initiating water injection. Hence it can be concluded that including the strong anisotropy of tailings is necessary and sufficient for failure, the other two factors acting as accelerators of the failure process. From the safety perspective, the shorter the time-to-failure, the more dangerous the incident is.

Including the low permeability plug next to the starter dam (Factor 1) delays the drainage in a zone right beneath the main slope, enhancing the rise of pore pressures, which will eventually trigger the slide.

Stratification, included in the model as a strong anisotropy of permeability (Factor 2), has a double effect. Regarding the failure-precedent condition, the permeability anisotropy causes the beach tailings to be fed by capillary water coming directly from the pond zone (compare Figures 12.a and 12.c). This means that the beach tailings body is permanently kept close to saturation, no matter if the phreatic surface has a low position. The analysis of the Correio de Feijao accident [3] arrived at similar results. Having a beach zone almost saturated as a failure-precedent condition means that injection (or seepage/infiltration) of a relatively small amount of water is enough to bring the liquid pressures to positive values and hence facilitate the development of the unstable conditions. A second effect of permeability anisotropy in the particular failure mechanism analysed here is that the injection pressure from the leaking pipe is more readily transmitted to the downstream zone close to the main slope (Figure 12.d).

Finally, the harsh drying boundary condition and the development of a dry and low-permeability shell (Factor 2) also have a double effect. During the steady-state analysis, the low permeability shell also contributes to the formation of a close-to-saturated body of beach tailings, as explained in the previous section (Figure 12.c). During the transient analysis, the dry shell delays the seepage at the toe of the main slope, hence accelerating the development of the unstable conditions and excluding the possibility of the operator to have a hint of the incident evolving (Figure 12.d).

Figure 12. Model results. a) Base Case: steady-state seepage analysis. b) Base Case: Transient seepage and limit equilibrium analyses. c) Failure Case: steady-state seepage analysis. d) Failure Case: Transient seepage and limit equilibrium analyses (refer to Figure 11 for missing references). Vertical scale exaggerated by 2.
