Construction failure of X Dam: the importance of field monitoring

Andhika SAHADEWA^{1,3}, Haris SETYAWAN¹, Mahdi TANJUNG¹, Astyka PAMUMPUNI^{1,3}, Abi HAKIM², Jagad LANGIT³, Pebri HERRY^{1,4}, Aris WIBOWO^{1,4}

X Dam, located in Jawa, Indonesia, experienced catastrophic failure during its construction in 2021. This manuscript describes failure incident, investigation, and post-failure mitigation of the dam. Disordering field monitoring execution was one reasons of the collapse. Authors believe that investigation report of such failures can contribute to advances in design, construction, operational and monitoring of dams.

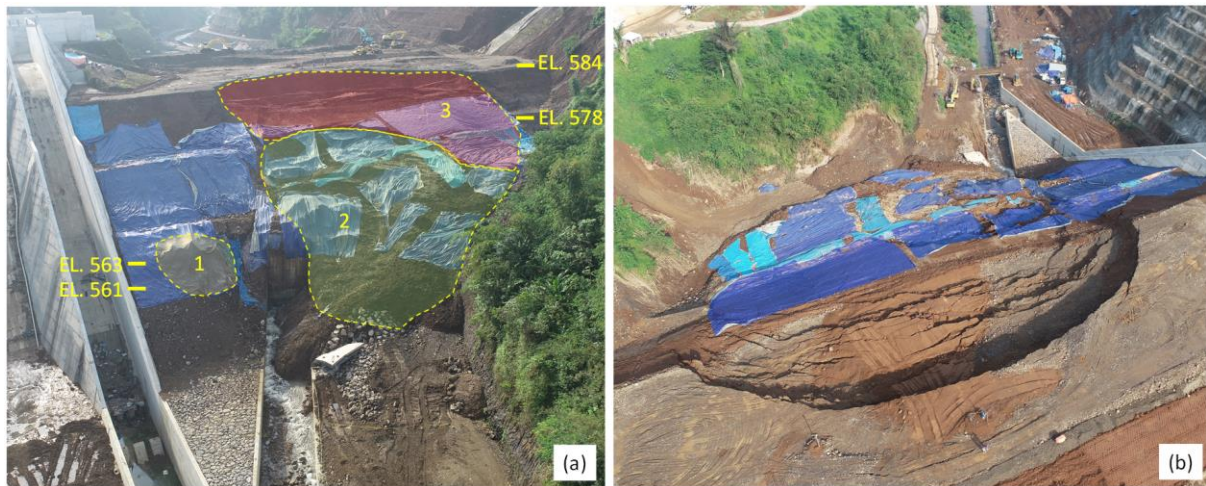
Figure 4: Downstream slope failures in Dam X: (a) view from downstream and (b) aerial view.

During random fill construction stage, the downstream slope of Dam X experienced 3 progressive slope failures within 2 weeks (Figure 4). This event was started by a 2-m shallow failure surface (EL. 563 to EL. 561.7) occurred on 30 September 2021. This incident was followed by much deeper slope failure with slip surface from EL. 578 to EL. 561.7 on 5 October 2021. The last incident was the greatest one comprising a 22-m deep seated failure (EL. 584 to EL. 561.7) on 13 October 2021.

Post-failure investigation showed that the failure was attributed to multiple reasons, including an excessively fast embankment construction, challenging fill compaction, halloysite fill material, high rainfall intensity, and very optimistic design parameters. Additionally, inadequate field monitoring performance resulted in unobserved embankment movement. Many Lessons can be learned from this incident, including:

Post-failure mitigation for X Dam included immediate remediation and dam redesign. The immediate mitigation steps were removing collapsed material and constructing temporary drainage to avoid unfavourable condition. The following design alternatives were proposed to continue X Dam construction:

- Alternative 1: Reducing downstream slope to 1V : 2.5H in EL. 551 to EL. 576, reducing downstream slope to 1V : 2H in EL. 576 to EL. 601, constructing counterweight at downstream toe using stone, and relocating V-notch system
- Alternative 2: Changing downstream embankment material to stone, and maintaining the downstream slope as 1V : 1.7H
- Alternative 3: Changing downstream embankment material to stone (40%) and gravelly sand (60%), and maintaining the downstream slope as 1V : 1.7H

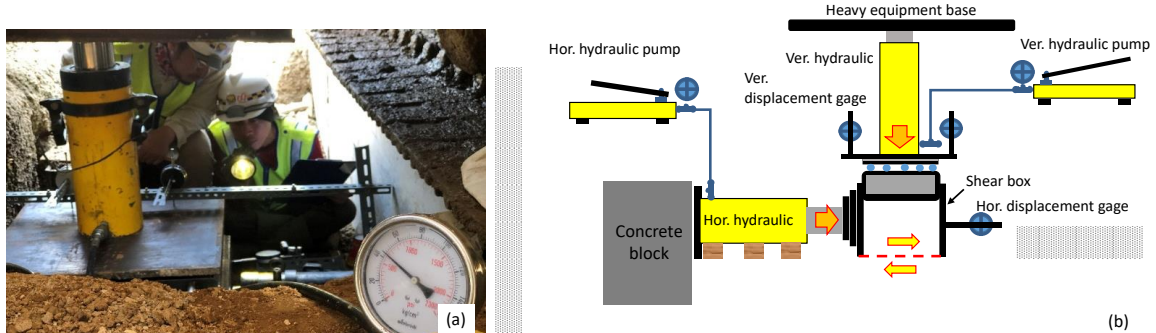
Figure 5: In-situ large scale direct shear test on random fill material: (a) field test and (b) testing setup

Prior to the failure incident, the random fill compaction was very challenging. The X Dam is located in high rainfall intensity region leading to compaction work results that generally exceeded the wet optimum side. Thus, the optimum density was difficult to achieve. Nevertheless, the compaction work quality control using sand cone test showing very promising results, which was in the order of 120% of maximum dry density. In fact, walking on the compacted random fill indicated that the ground was still very soft. To investigate this discrepancy, Indonesian Geotechnical Institute performed 3 in-situ large scale direct shear tests in the random material to evaluate the shear strength of random fill material (Figure 5 and Figure 6). The direct shear test suggested that the strength was relatively low. X-Ray Diffraction test showing that random fill material contained Halloysite which belongs to the kaolin group. This mineral is well known for rapid water sorption (White and Pichler, 1959). The presence of Halloysite explained reason compaction results that easily exceeded wet optimum.
