The paper was published in the proceedings of the 11th International Symposium on Field Monitoring in Geomechanics and was edited by Dr. Andrew M. Ridley. The symposium was held in London, United Kingdom, 4-7 September 2022.

Utilization of Instrumentation Data for Averting a Potential Support Failure in a Deep Excavation Project

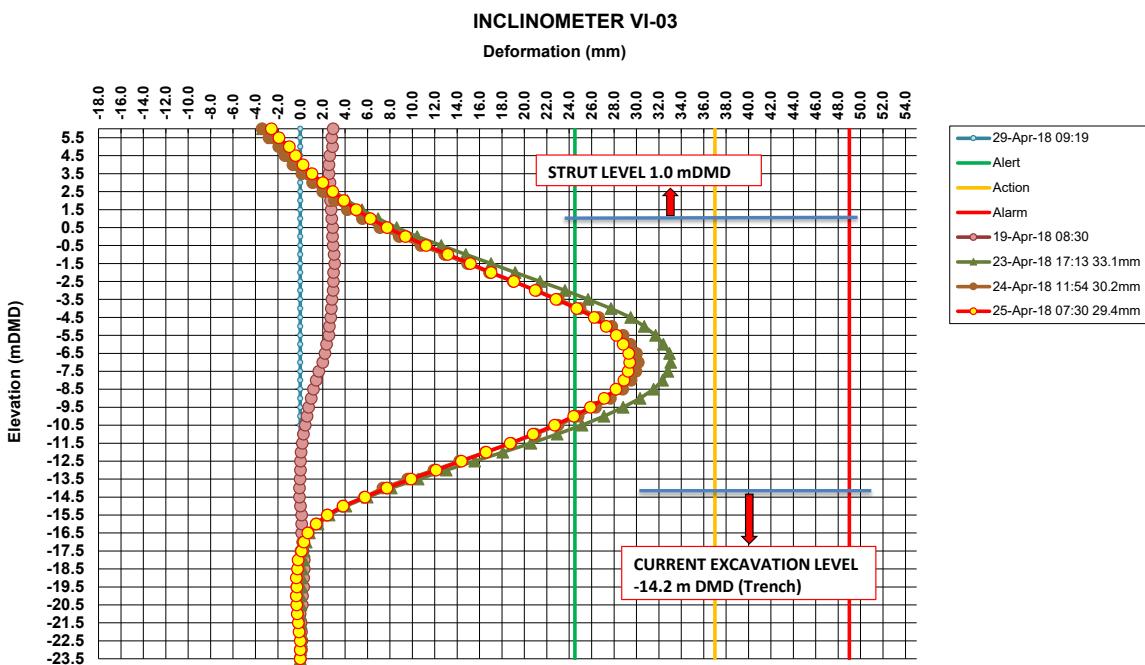
From the monitoring results, it was observed that the diaphragm wall was sensitive to any excavation below -11 m DMD. It reacted with a sudden increase in deflections when excavation was carried out below this depth. The movements were also observed with an increase in water level in that zone. Data from inclinometers, water level, prism targets, and strain gages were all correlated and confirmed the movement of the diaphragm wall. A close view of the location where the incidence took place is shown in Figure 2, with all the instruments marked.

During the excavation period from April 19 to April 24, 2018, the recorded deflections in the inclinometer VI-03 showed sudden “jumps” up to 33 mm, as shown in Figure 3 below.

Figure 3: Inclinometer VI-03 data showing D-wall movement from April 19-24, 2018.

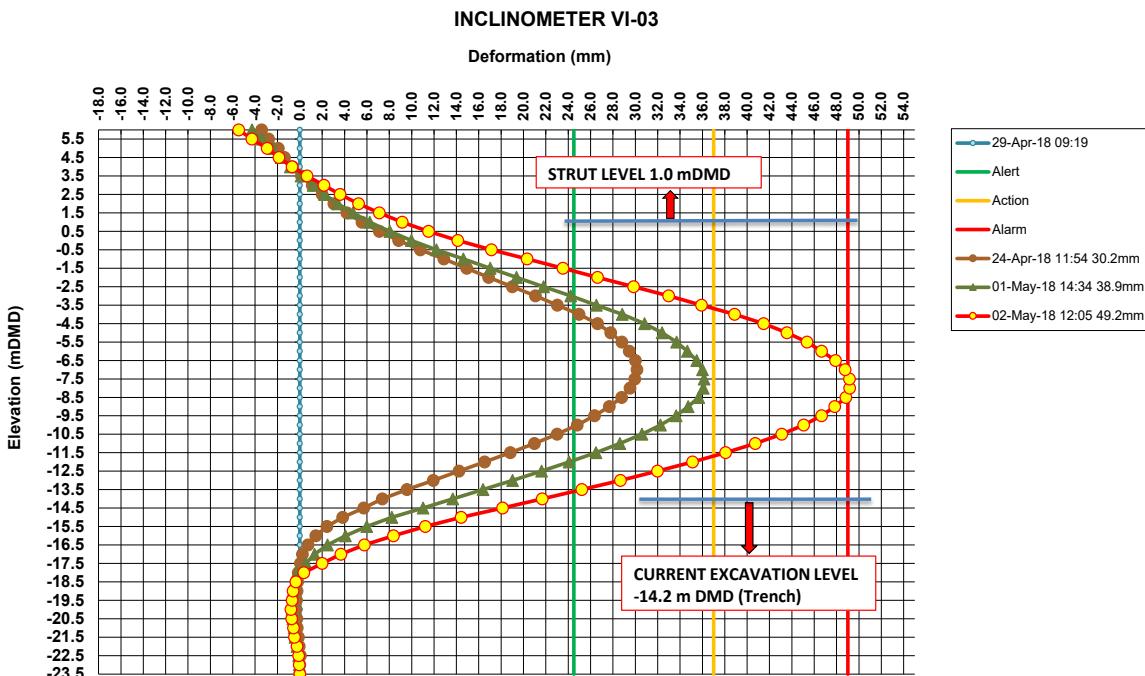
On May 1, 2018, the dewatering well ADW # 01 (location shown in Figure 2 above) was damaged by the nearby works and it was out of order for a few hours. During that time a rise in the ground water level of 2 m was recorded on the East side which caused the wall to deflect further. Inclinometers VI-03 and VI-05 recorded an increase of deflection of approximately 19 mm and 16 mm respectively as the water level reduced to the previous level after almost 24 hours. Refer to Figure 4 and Figure 5.

Figure 4: Inclinometer VI-03 data showing D-wall movement on May 1, 2018.

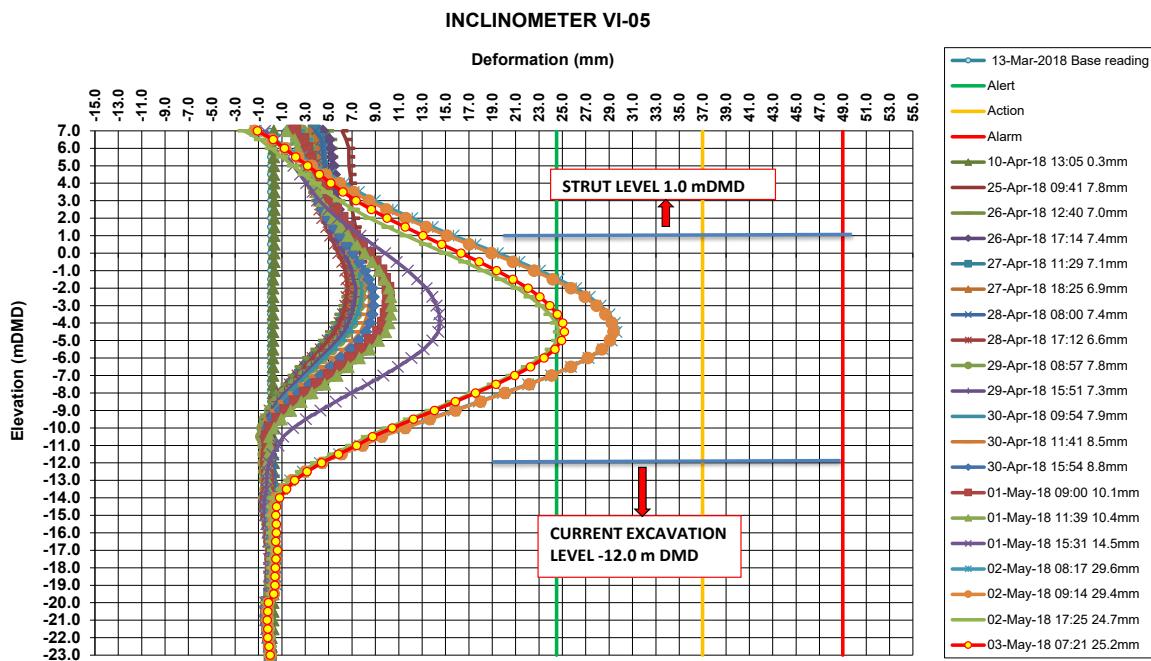
Figure 5: Inclinometer VI-05 data showing D-wall movement on May 1, 2018.

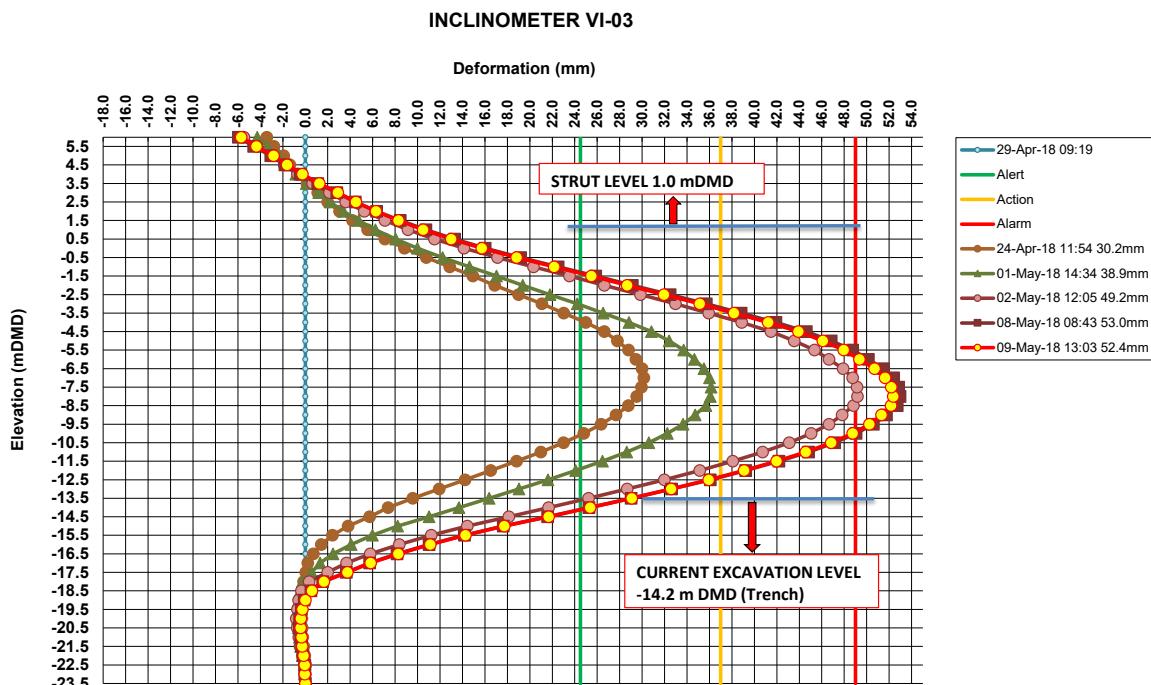
The inclinometer data of VI-03 showed a deflection of 4 mm and inclinometer VI-05 showed a deflection of almost 14 mm as can be seen in Figure 6 & Figure 7 respectively.

Figure 6: Inclinometer VI-03 data showing d-wall movement on May 8, 2018.

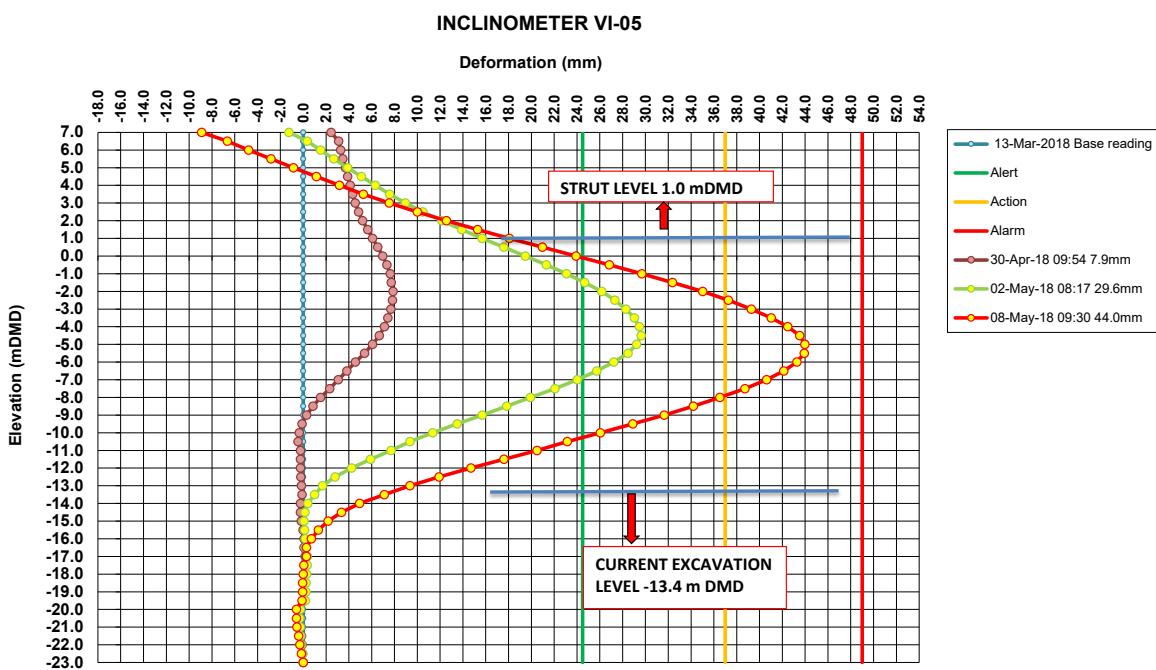
Figure 7: Inclinometer VI-05 data showing an increase in D-wall movement on May 8, 2018.

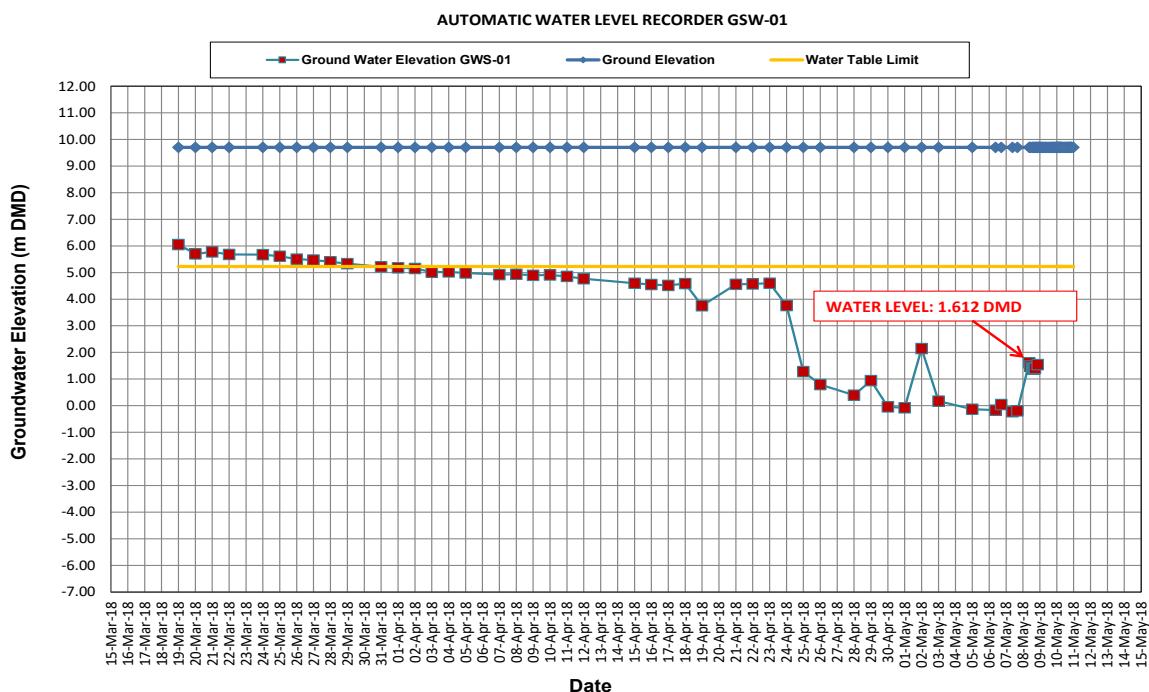
On May 8, 2018, morning, the dewatering well ADW# 14 on the East side got damaged and the repair lasted for approximately one hour. During this period the water level raised by almost 1.5 m as shown in water level data from the automatic water level recorder GWS-01 in Figure 8.

Figure 8: Water level data from automatic water level recorder GSW-01.

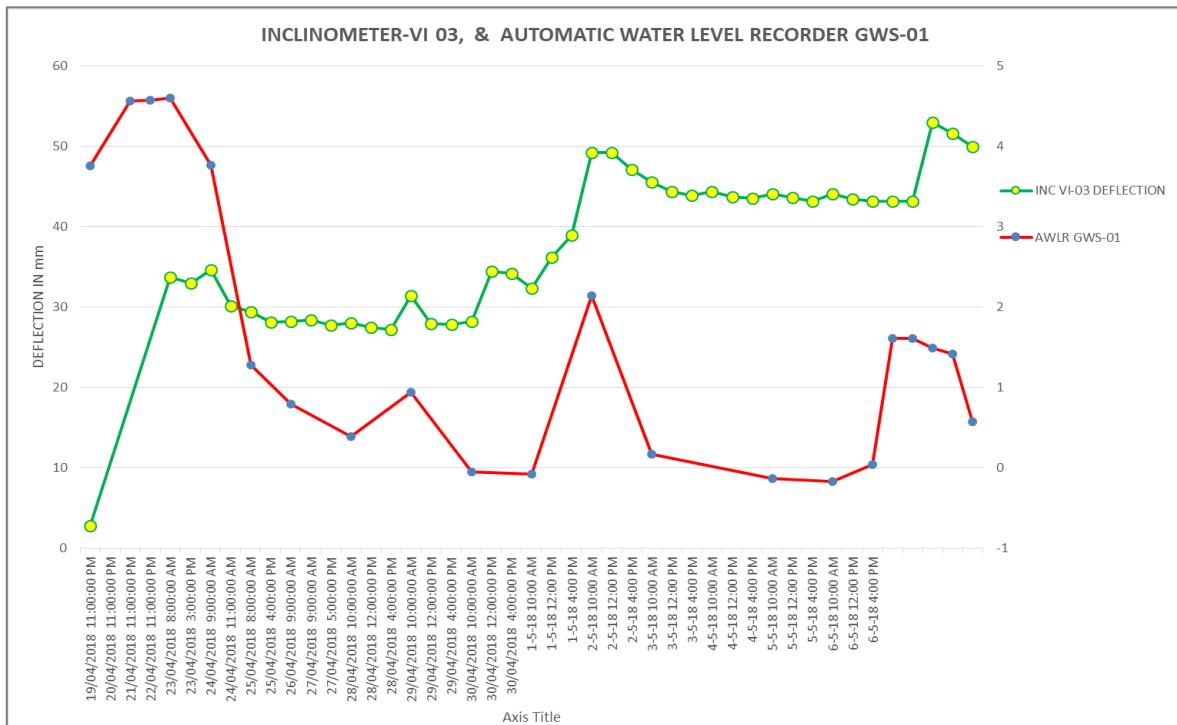
In Figure 9 below, a combined chart is plotted for data from inclinometer VI-03 and automatic water level recorder GWS-01. It shows that the diagram wall movement increases as the water level rises, although with a time lag. It also decreases as the water level decreases.

Figure 9: Combined chart for data from inclinometer VI-03 and water level data from automatic water level recorder GWS-01.

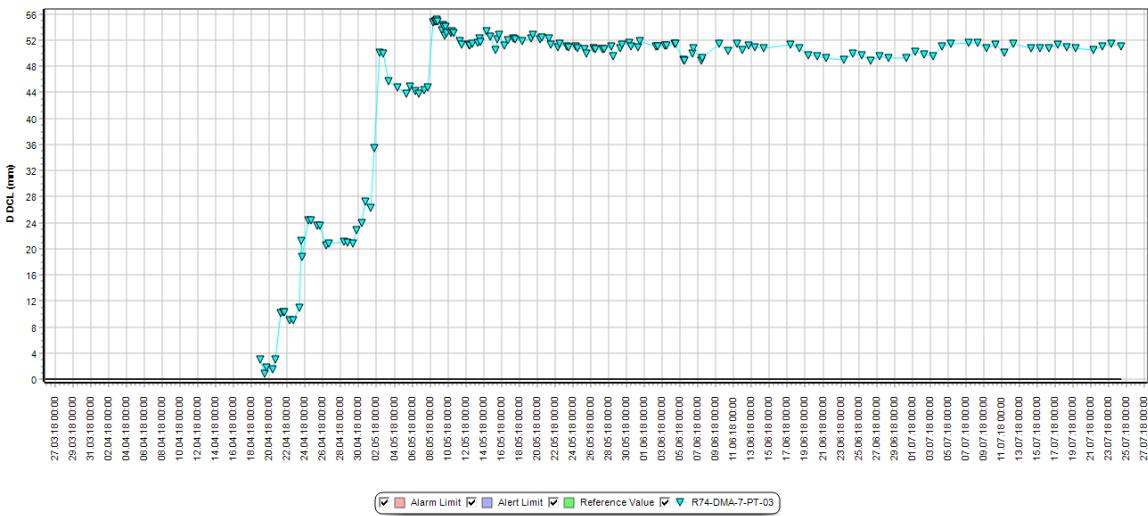
The data recorded from the prism targets, installed in close vicinity of VI-03 & VI-05, also showed the movement of the diaphragm wall on May 1, 2018, and May 8, 2018, as shown in Figure 10.

Figure 10: Prism target data showing movement on May 1, 2018, and May 8, 2018.

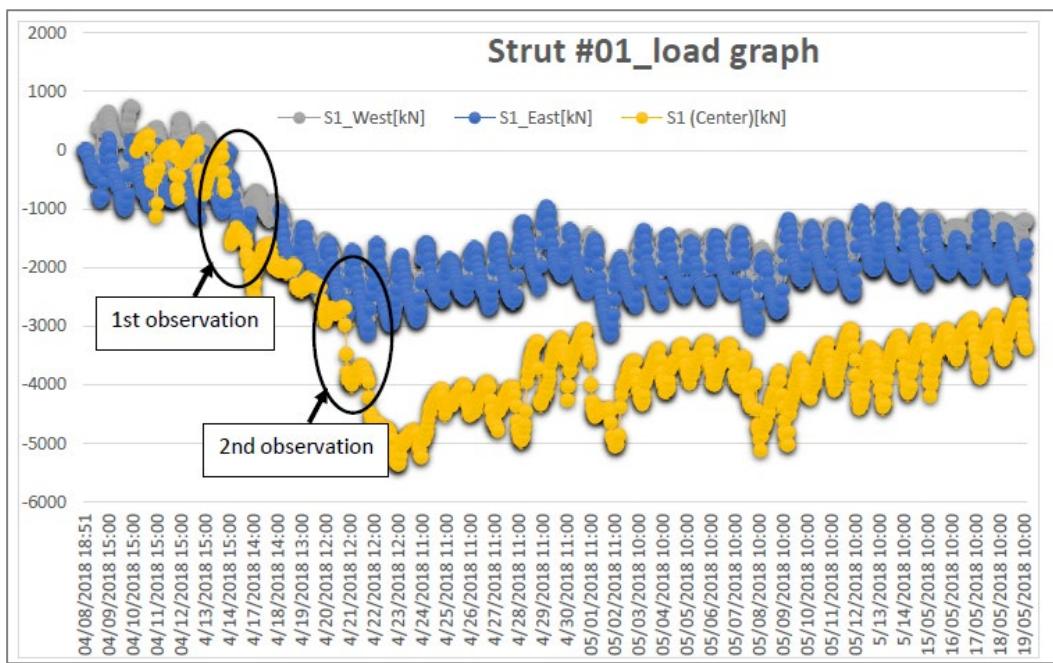
Strain gages installed on struct STR-1, supporting the East and West diaphragm walls, showed an increase in load on the same dates when inclinometer readings observed deflection with the rise in water levels. The strain gage data from strut STR-1 is shown below in Figure 11.

In the strain gage data, a high-velocity change in the strain values was also observed from 13th until 23rd April 2018. According to the daily site report, the mentioned velocity reflected the excavation activity.

Figure 11: Data from strain gages installed on strut # 1, showing an increase in load.

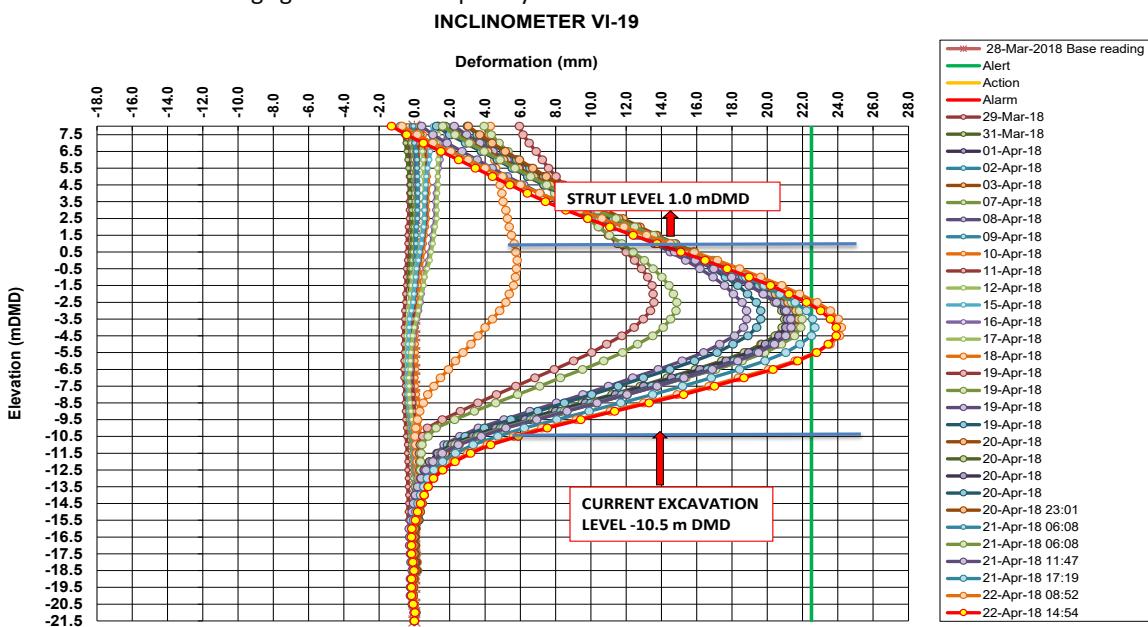
April 19, 2018, onwards the inclinometer VI-19 installed at the North headwall, started to show a rapid deflection while the excavation was at -9 m DMD. Refer to Figure 2 for the location of inclinometer VI-19 and Figure 12 for the data showing the movement.

During the site inspection, it was found that the dewatering well was not constructed on this side of the diaphragm wall. After studying the inclinometer data, the civil contractor decided to construct and install the dewatering system behind the North wall on an urgent basis. The readings reached up to 25 mm before the dewatering system was functional. The readings got stable subsequently.

Figure 12: Inclinometer VI-19 data showing D-wall movement on April 19, 2018.

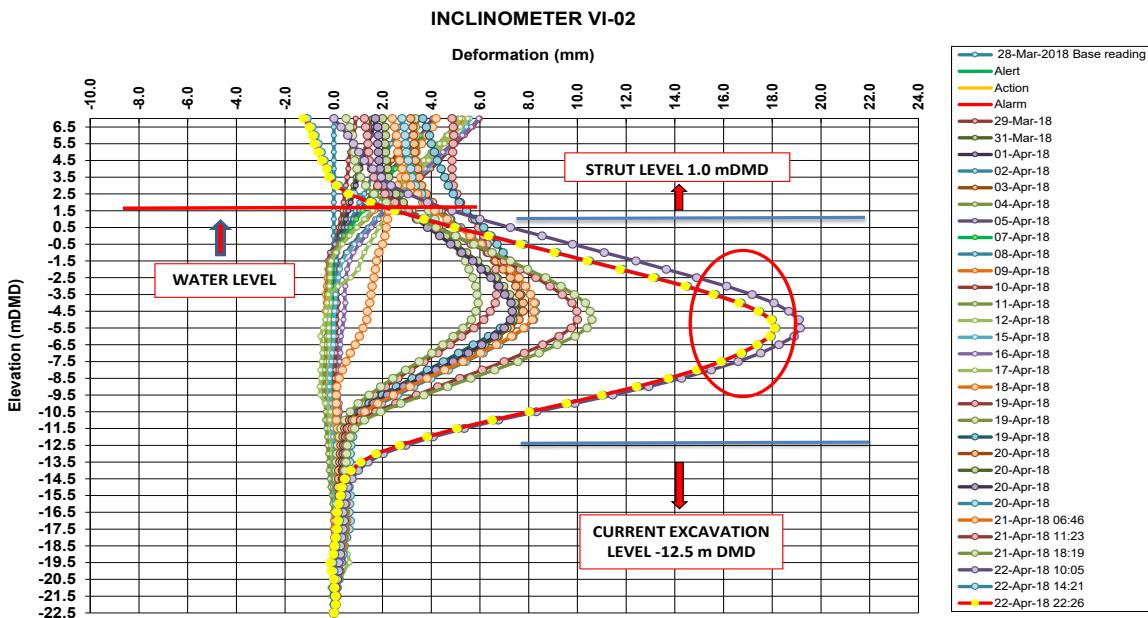
On April 22, 2018, during the excavation works on the West side of the station, a sudden increase in movements was observed in inclinometer VI-02 i.e. from 10.5 mm to 19 mm approximately due to the high water level on the West side of the station area. Refer to the data shown in Figure 13.

Figure 13: Inclinometer VI-02 data showing d-wall movement on April 22, 2018.

Looking at the readings of inclinometer VI-02 which observed a good amount of deflection in D-wall, the consultant and contractor concluded that this was occurring due to an increase in water pressure in the region. They thus decided to drill one dewatering well close to the inclinometer VI-02 location, to reduce the load (water

pressure) at that location. Once the dewatering well became functional, the readings of inclinometer VI-02 stabilized.

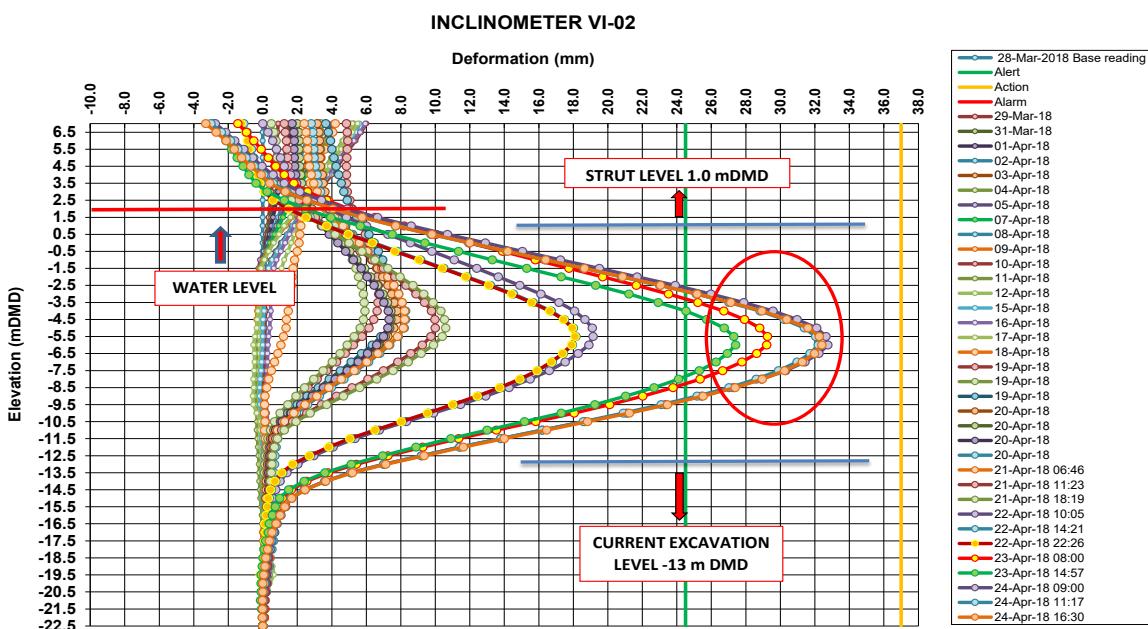
The next day, on April 23, 2018, up to 29.3 mm movement was recorded from inclinometer VI-02. Refer to inclinometer VI-02 data shown in Figure 14 below.

Figure 14: Inclinometer VI-02 data showing d-wall movement on April 28, 2018.
