# Landslide During Construction Of A Rockfill Breakwater In The Coast Of Sergipe, Brazil

**SUMMARY:** On October 12<sup>th</sup>, 1989, a rockfill breakwater under construction in Sergipe state, Brazil, situated some 2,4 km from the beach, suffered a foundation slide failure. The breakwater had a total height of 16 meters, with 6 meters above sea. The soil profile, from sea bottom down, was 4 meters of sand, 7 meters of soft clay and below the soft clay, sandy layers to great depth. During the construction period that anteceded failure there was monitoring of displacements and pore pressures. A modified design has been conceived and construction was completed in October, 1992. Geotechnical instrumentation has been used to monitor the construction of the breakwater before and after failure. This work reviews the sequence of events, briefly presents the geotechnical characteristics of the foundation, including the fact that there was artesian pressure of unsalted water at the base of the soft clay, describes the instrumentation results before and after the failure, discusses its possible causes and, at the end, presents the criteria used to ascertain acceptable safety.

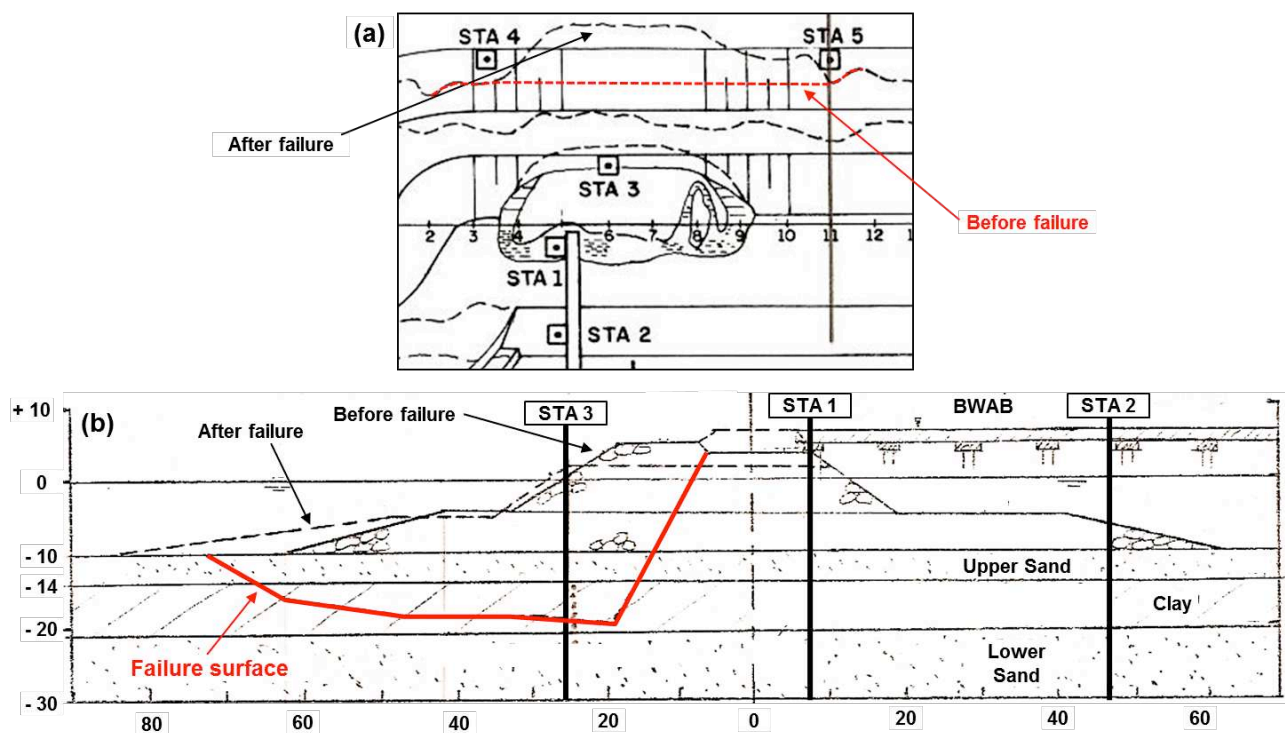
Figure 4. Initial design and failure surface: (a) plan view; (b) section.

- Failure took place on October 12<sup>th</sup>, 1989 when about 100 meters of the terrestrial phase had been built (see figures 3 and 4);
- Before failure, the (initial) design was developed by a Design Firm and checked by consultants hired by the Contractor;

The horizontal displacements measured at STA3 are presented in the left hand side of figure 11, and (together with topographic and bathymetric surveys) helped to establish with confidence the position of the failure surface shown in figure 4b (and also the extent of the failed area shown in figure 4a.

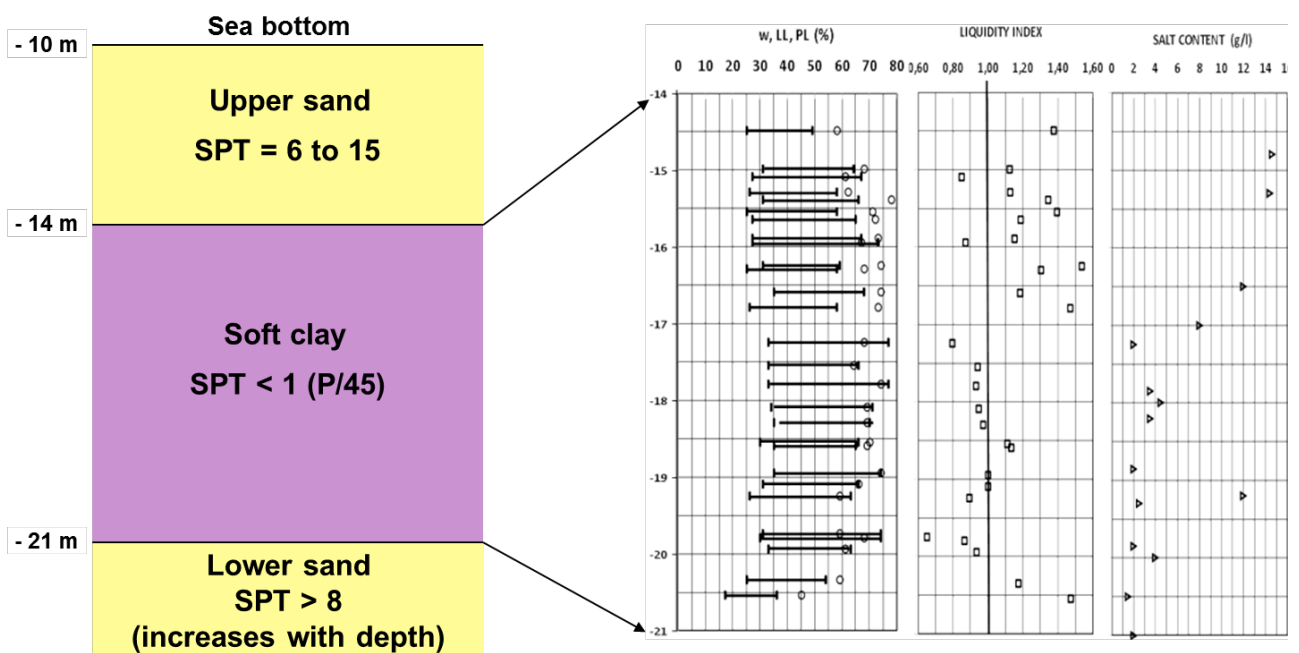
Figure 7. Simplified geotechnical profile and geotechnical characteristics of the clay under the breakwater.

The material of main interest is the soft clay layer between elevations -14 m and -21 m that controlled the failure. A typical geotechnical profile under the breakwater is shown in figure 7.

The soft clay layer has SPT typically equal to 1/45 cm and grain size composed of 42% clay size, 40 % silt and 18% sand. Figure 7 also presents characterization tests of the soft clay layer (water content, liquid limit, plastic limit, liquidity index and salt content). Liquid limit has been determined without pre-drying the samples. The plasticity index ( $PI = LL - PL$ ) of the clay has a mean value of 35 % and varies between 19 % and 46 %. The liquidity index values are above unity in several points. Pore water salt content varies from low values (2 to 4 grams/liter) in the bottom half of the layer to higher values (10 to 15 g/l) in the top half, but always quite smaller than the average sea water salt content which is around 36 g/l.

Artesianism with unsalted water seems to have induced leaching of the clay, as indicated by the low salt content of its pore water (see figure 7). Leached marine deposited clays tend to develop a metastable (sensitive) condition (see, for example, Rosenquist, 1953; Quigley, 1980; Torrance, 1983). Liquidity indexes above unity presented in figure XX seem to confirm this fact. Clays in such conditions are prone to develop high shear induced pore pressures. The high  $A_f$  values obtained in the triaxial tests (Sandroni et al., 1997) are indications that this might have been the case. Therefore, the generation of considerable shear induced excess pore pressures (which could not be registered by the piezometers) may have played an important role on the failure.

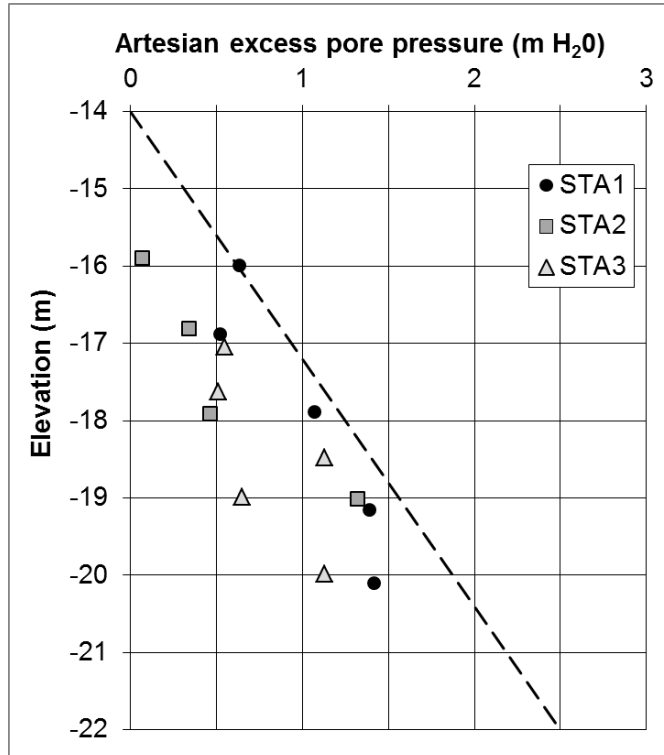
Figure 8. Measured excess pore pressures across the soft clay layer.

Excess pore pressures measured with open tube piezometers indicated an artesian excess pressure between 1,50~2,50 meters at the base of the layer (elevation -21 m) and zero at its top (elevation -14 m), as shown in figure 8.

It is possible that part of this excess pore pressure is remnant of the load of the geotechnical berm, although it is considered that this part would be very small.

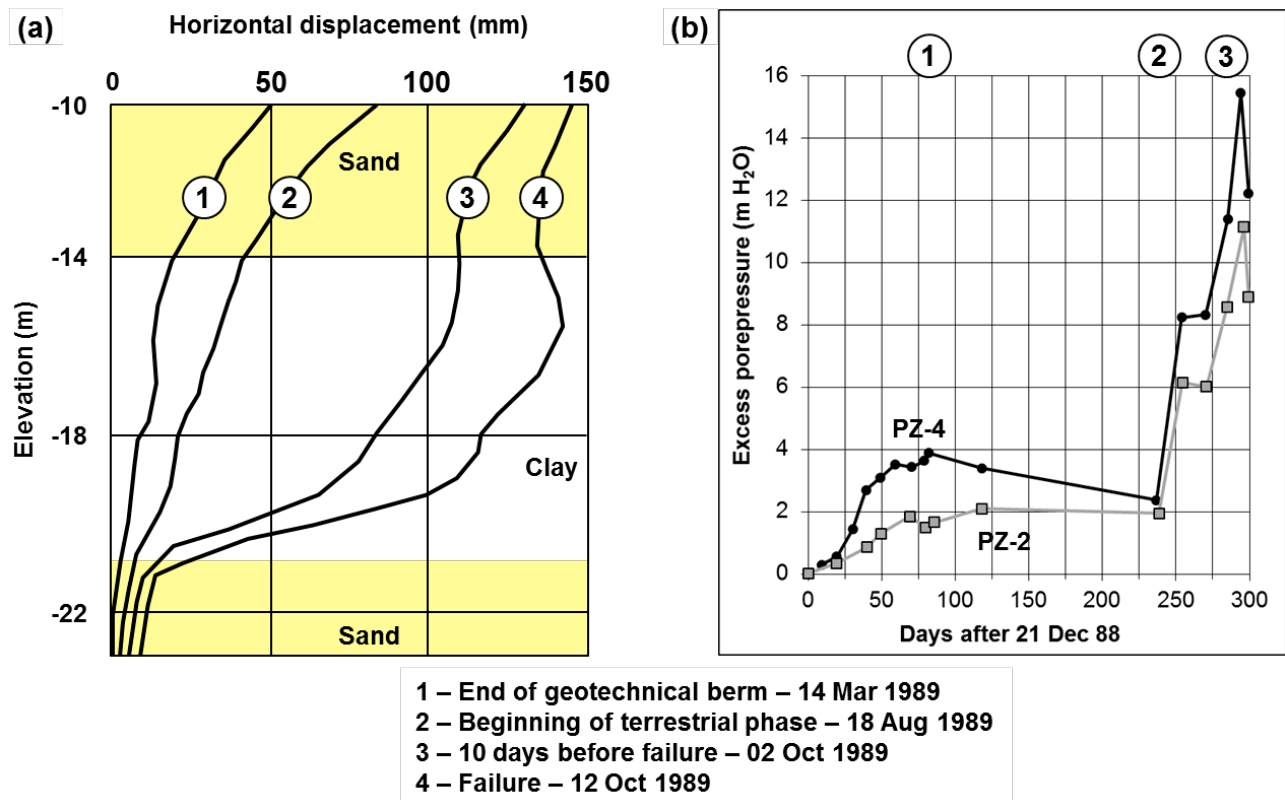
Figure 9. Monitoring before failure at STA1: (a) Horizontal displacements; (b) excess pore pressures.

The horizontal displacement and the pore pressure measured in some piezometers at STA1 in the months prior to the failure are presented in figure 9a.

It is worth mentioning that the tube of the inclinometer at STA1 was spiraled due to manufacturing defect, which was providing incorrect readings. In view of this, the values presented in figure 9 result from a correction and show large horizontal displacements between August 18<sup>th</sup> and October 2<sup>nd</sup>.

The excess pore pressures presented in figure 9b are coherent with the stages of heightening of the breakwater.

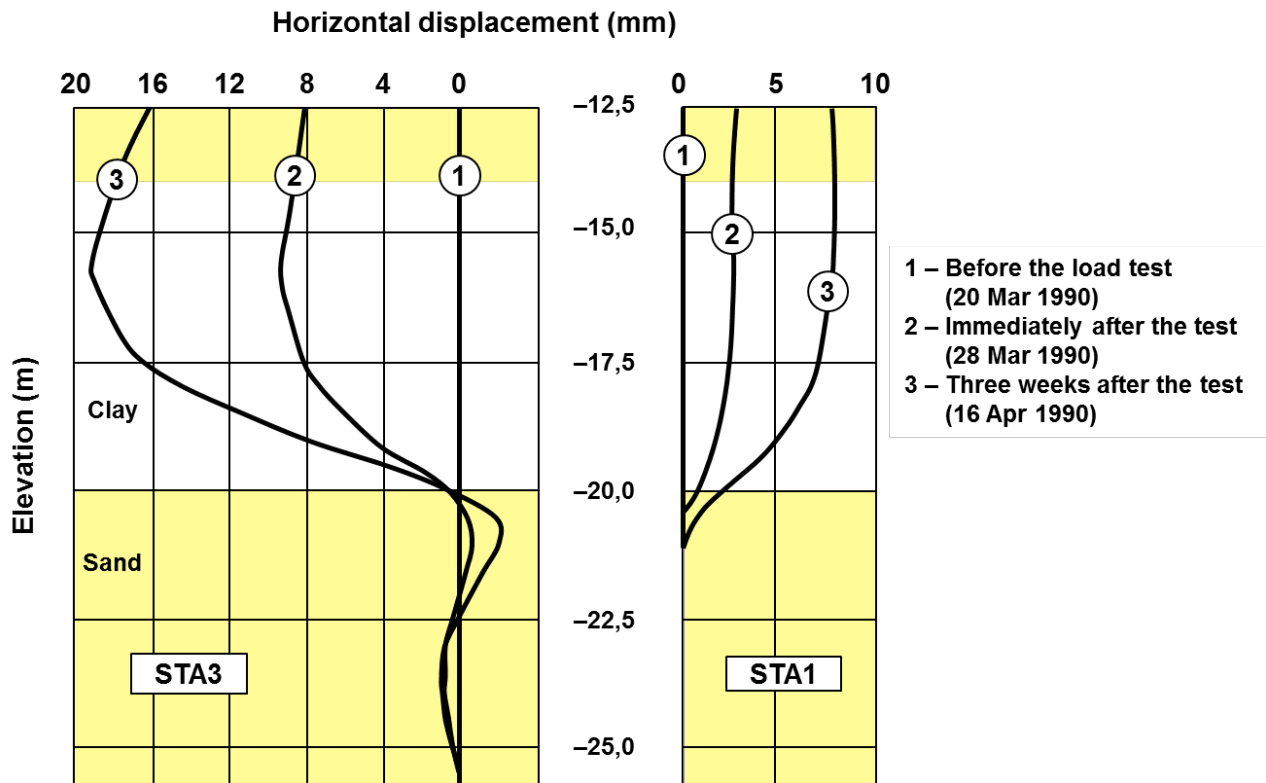
Figure 11. Horizontal displacement before and after the load test.

The observations also showed that displacements would be tolerable for the access bridge (BWAB). In the right hand side of figure 11 the horizontal displacements measured by the inclinometer at STA1 are shown.

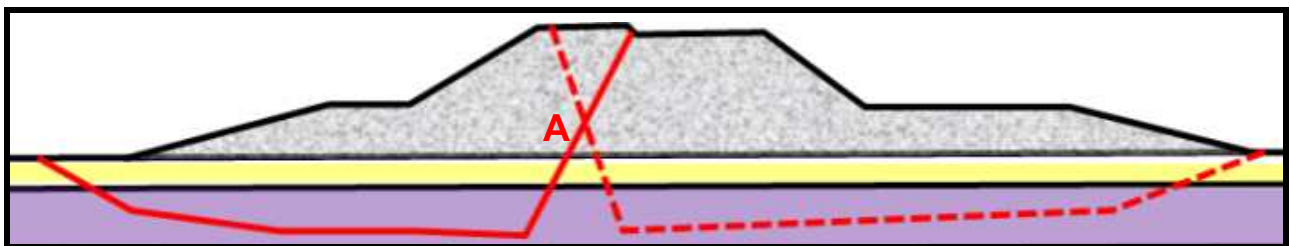
Figure 12. Schematic indication of shared failure.

The third aspect considered to explain why safety factors well above unity correspond to failure can be called “shared failure” as shown schematically in figure 12. The instrumentation (at the landside) showed that up to a certain moment displacements occurred in both directions: towards the sea side and towards the land side. During this period, the rockfill above point A may have acted as a “liquid” in the sense that it did not develop shear strength. With the continuation of the instability process the movements increased in the sea side and failure was completed. Therefore, the strength mobilized in the rockfill up to a certain (unknown) point of the failure process is virtually impossible to ascertain. One can speculate that the strength effectively mobilized in the rockfill is much smaller than its effective friction angle.

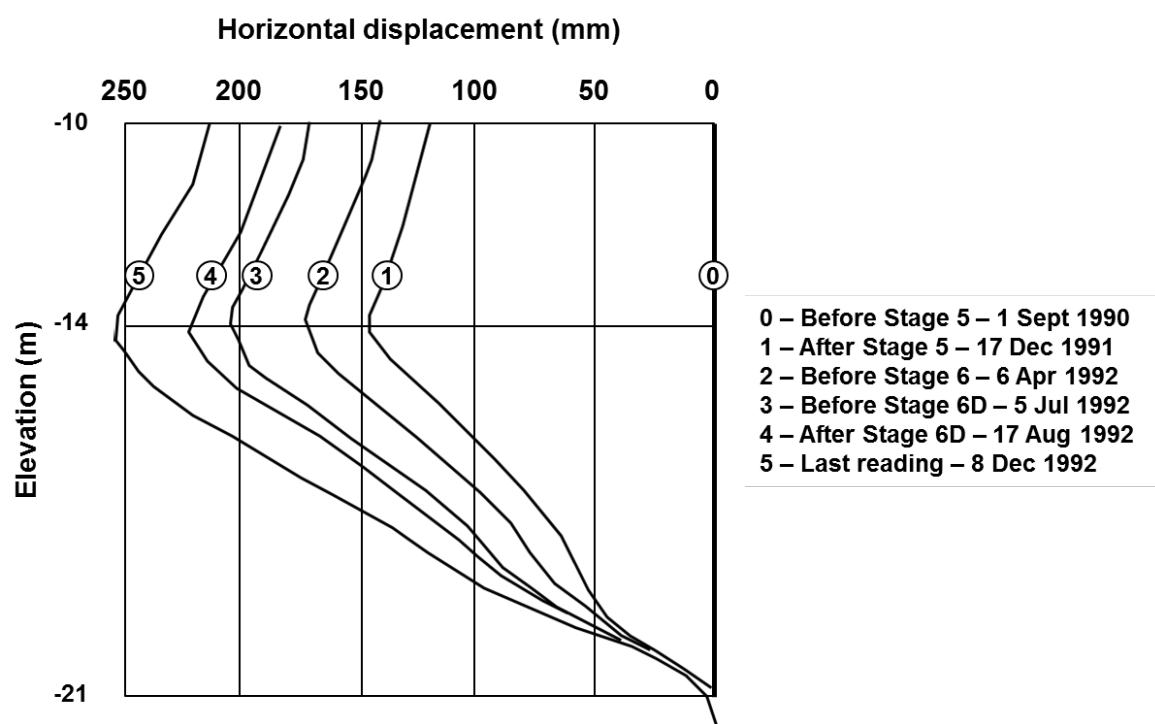
Figure 14. Horizontal displacements measured at STA4 since before Stage 5 until after conclusion of Stage 6.

The readings of the inclinometer installed at STA4, shown in figure 14, indicate that the horizontal displacements kept inside acceptable intervals, even though large values were observed. However, during placement of Stage 6 an increase of waiting period has been recommended due to what was then considered as excessive horizontal displacement.

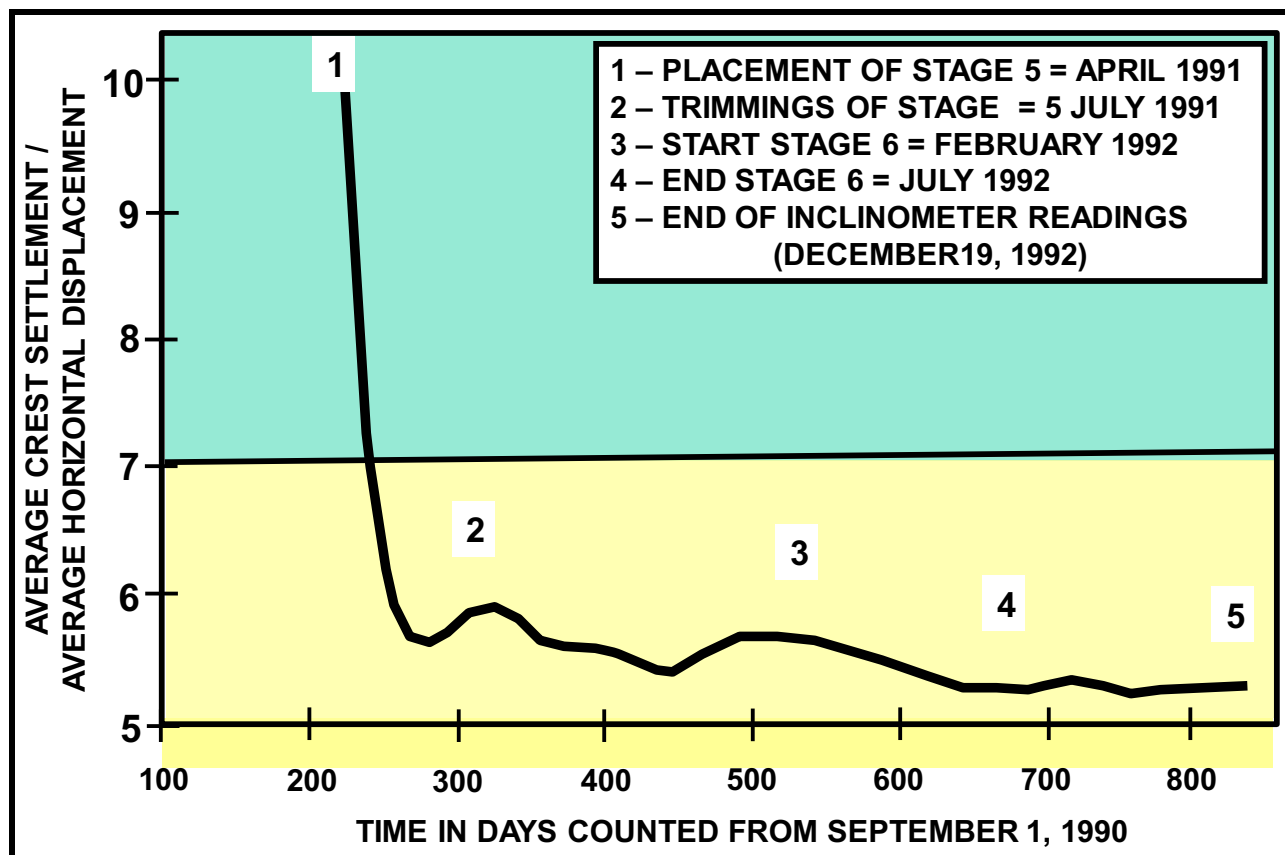
Figure 16. Method of volumes applied to station STA 4.

When applied at the job, criteria d) and e) proved to be adequate. Figure 16 shows the evolution with time of the relation  $\Delta r/\Delta h$ . As can be seen the value fell from values above 10 at the beginning of Stage 5 to values around 5,5 at the end of Stage 5. During Stage 6 the relation fell a bit further to values around 5,25 and kept stable after the end of Stage 6.

The sharp decrease in the relation  $\Delta r/\Delta h$  during placement of Stage 5 caused some concern during construction and resulted in the introduction of a waiting period before Stage 6 and also propitiated Prof. Ladd's consultancy.
