# A Few Lessons from Two Dams and an Excavation Instrumentation Projects

This paper is a contribution to the instrumentation design of geotechnical structures and particularly to tailings dams. It brings the Author's experience with a few case histories including Morro do Ouro and Fundao tailings dams, as well as an unique deep excavation in Rio de Janeiro.

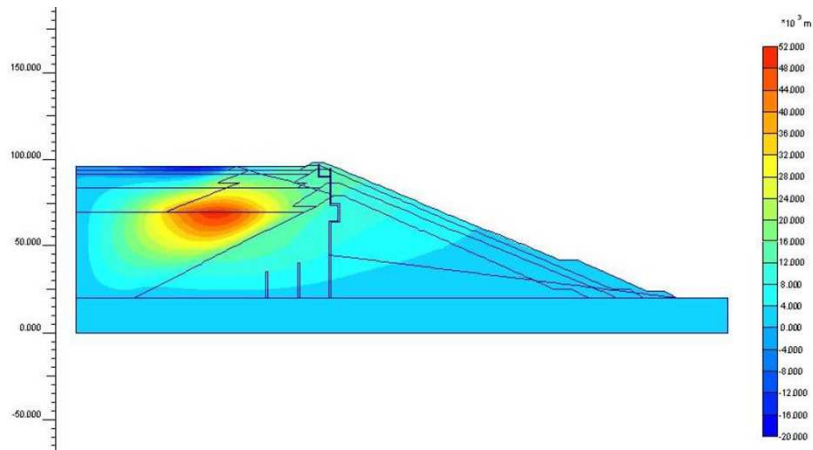
The first case history is a very large gold tailings dam: Morro do Ouro Dam, located in Paracatu, MG, Brazil, nowadays belonging to Kinross Mining. Ortigao et al (2013) described the dam and a trial embankment built on the tailings. The dam was constructed by the centreline method and founded on soft phyllite rocks. The embankment dam height reached 120 m and its length is about 4 km (Figure 1). In 2003-4, the dam height was being raised from 80 m to 100 m. Numerical analyses carried out by the designers at that time considered a rigid foundation (Figure 2).

Figure 2 Plaxis 2D deformation analyses plot wrongly assuming rigid foundation

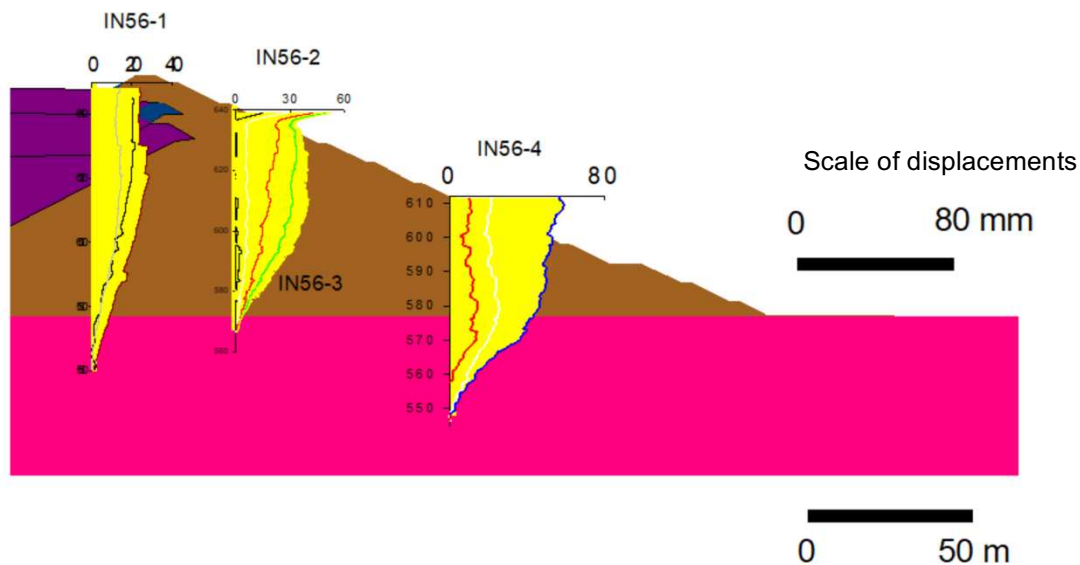
Then, in 2004, a few inclinometers were installed through the downstream slope and some of them were embedded 30 m in the soft rock (Figure 3). Readings (Figure 4) showed that the foundation was, by no means, rigid. Indeed horizontal deformation reached 80 mm. The soft rock under a large embankment loading lead to large deformation measured by the inclinometers. This led to a comprehensive investigation of the dam foundation characteristics and a review of the stability and dam safety.

Figure 4 Summary of inclinometer measurements at Chainage 56

High dams on soft rock foundation needs deformation measurements with inclinometers installed deep in the foundation. Reliable numerical models including the foundation can help to predict deformation behaviour and decide inclinometer depths. Advanced numerical calculations rely on sensitive parameters that must be obtained with correct site investigation. The foundation deformation must be taken into account when dealing with soft rock foundations.

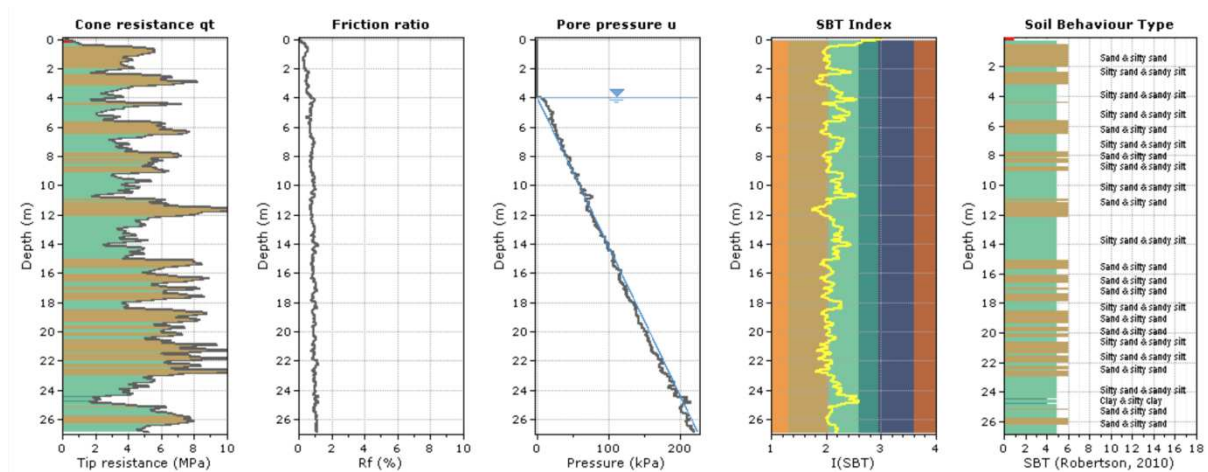
Figure 7 presents a typical CPTU log showing tip resistance, friction ratio, pore-pressures and SBT classification. This test was carried out down to 26 m depth, a small fraction of the tailings depth and shows interlayered loose sands and silts, typical of loose sandy tailings, and the fact that the water level is very high.

Both the preliminary results (Figure 7) and the analyses carried out later (Figure 8) results indicated that two liquefaction precursors: high water level and loose and contractive sandy tailings were clearly present. These were two necessary conditions for static liquefaction to take place at the Fundão Dam failure, which occurred in November 2015.

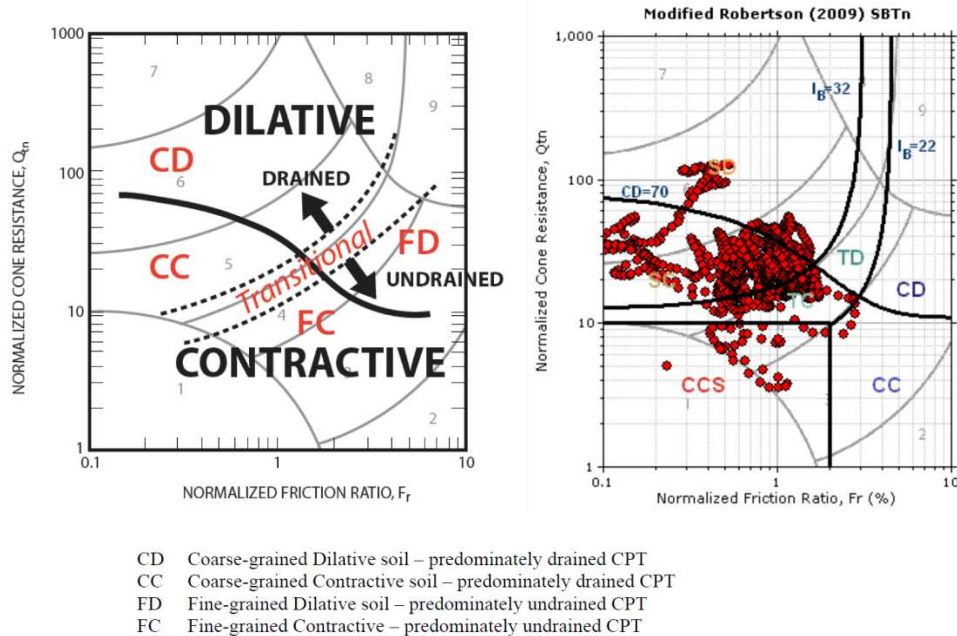
CPT. Indeed, by plotting CPTU 1 in such a graph, most data points plot the lower zone where contractive behaviour takes place.

Figure 8 Analysis of CPTU 01 test data (Robertson, 2016)

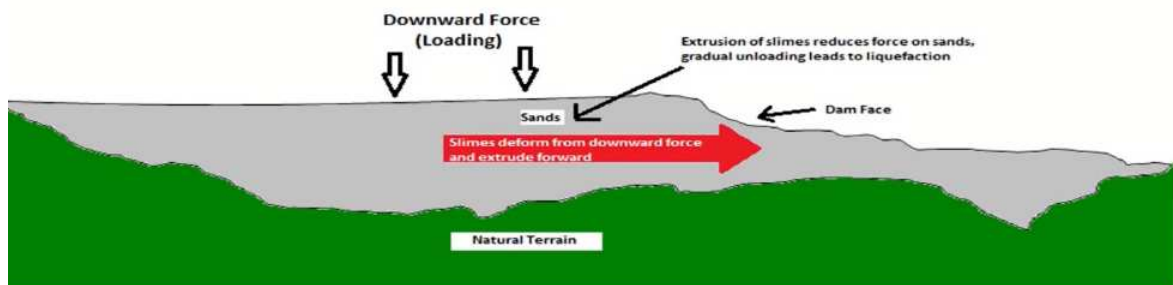
Morgenstern et al's (2016) report on the causes of failure explored extensively the triggering mechanism. One possible cause is dam horizontal displacement caused by disposal of fine tailings close to the starting dyke on the dam's left abutment. Morgenstern's report called it the *toothpaste effect* (Figure 9) in which a soft material is squeezed by vertical stress and force to displace horizontally. This could have triggered failure.

Figure 9 The toothpaste effect (Morgestern et al, 2016) leading to horizontal displacements and failure

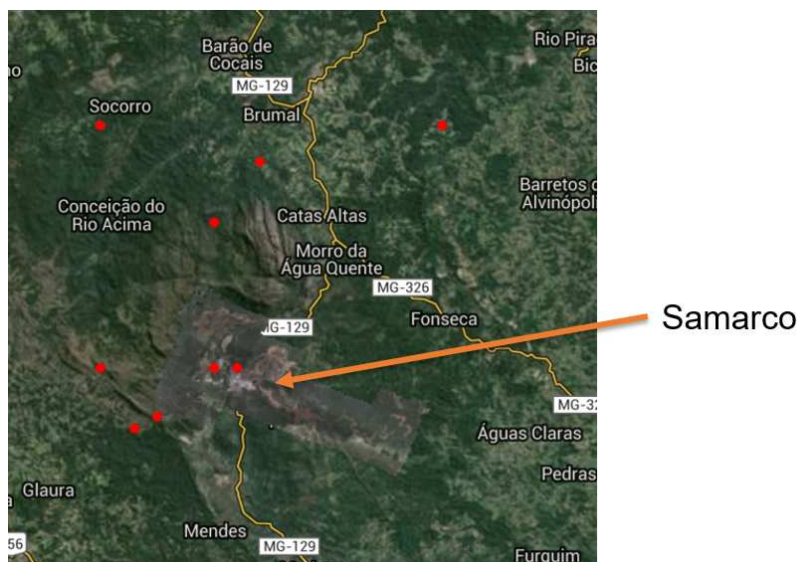
Another possible cause is vibration or low-level seismic events that took place on the eve of failure. Indeed, people working on the dam crest felt these vibrations. Figure 10 shows their epicentres, one of them located under Fundão Dam. This phenomenon may have led to an increase in pore pressures in the tailings, but this information cannot be checked, as there are no quick response piezometers, only open standpipe type and observation wells.

Figure 10 Epicentres of the seismic events taking place the eve of Fundão Dam failure

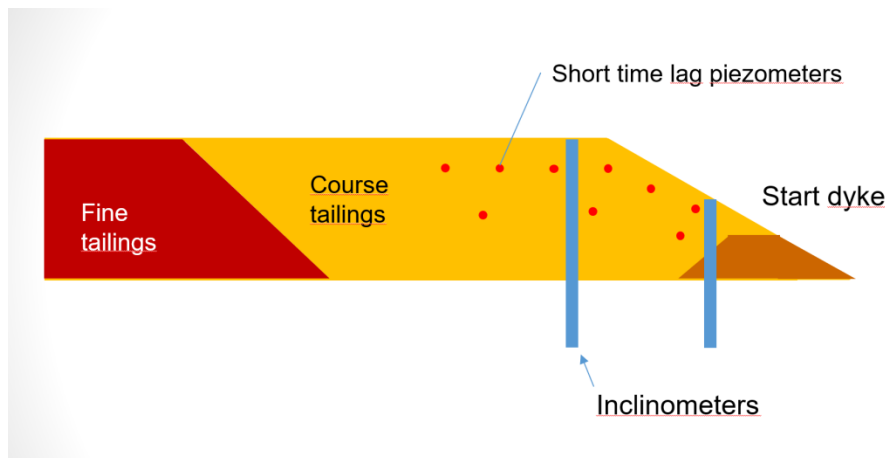
Figure 11 Instrumentation lessons from Fundão Dam failure

1. Need for good high-quality piezometric data, including short time-lag piezometers capable of indicating any quick change in water pressure conditions;
2. Automated instrumentation systems are a must.
3. Vibration measurements
4. Inclinoimeters through the foundation.

Figure 11 shows the layout and type of instrumentation that the Authors would advocate for addressing the issues raised in Fundao Dam.

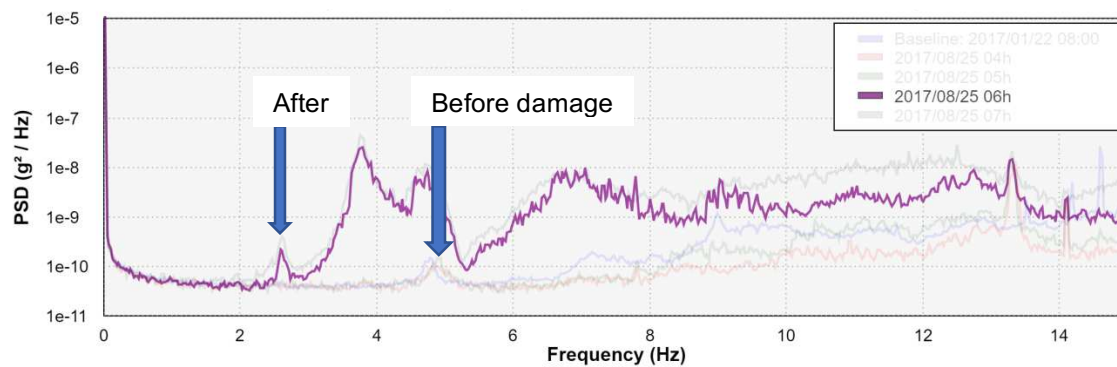
Figure 15 shows the spectrum analysis, or power spectrum density (PSD) as a function of frequency for baseline measurements, i.e., before pile driving started. It shows a fundamental resonance at approximately 5 Hz. However, after pile driving started, the first resonance decreased to half of this value, as low as 2.5 Hz (Figure 16). This is a clear indication that the structure was damaged by excessive vibrations, reduced frequency ( $f_r$ ) leads to a reduction in stiffness, according to equation (1).

Figure 16 Spectrum response during pile driving showing a large reduction in resonance frequency

This kind of instrumentation and analysis is quite cheap and should, in the Author's view, be part of dam instrumentation.

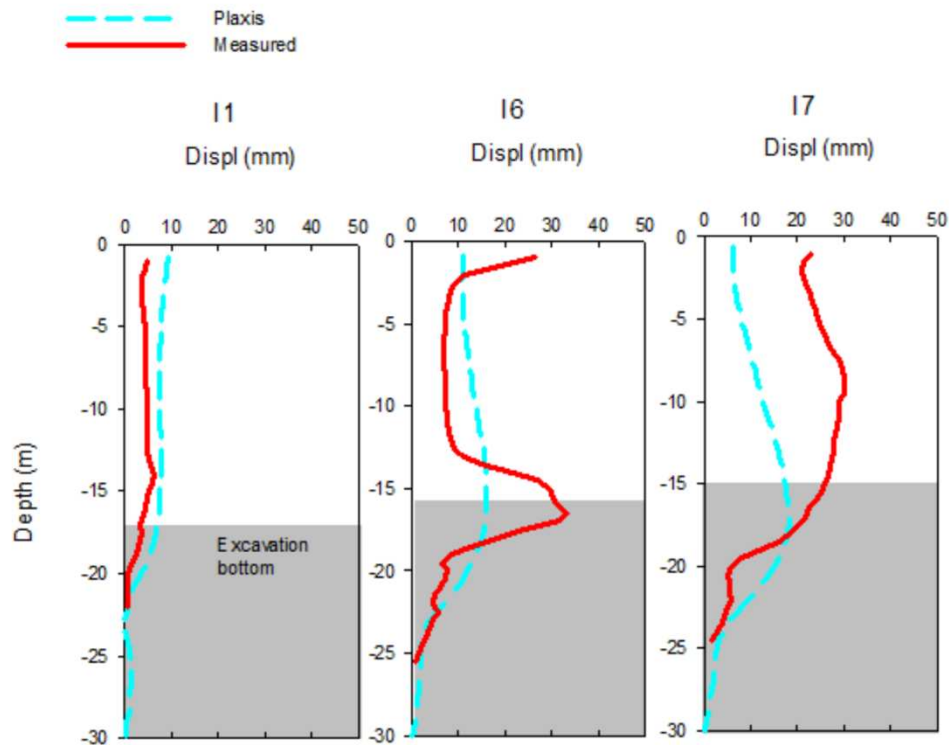
Figure 30 shows a comparison between predicted and measured horizontal displacements in three inclinometers, out of the seven which were monitored. The I-1 instrument is located on the north wall (Figure 29). It shows very small displacements, less than 10 mm and less than predicted. Inclinometers I-6 and I-7, located at the West Y joints, have shown displacements of about 30 mm, larger than predicted, but still less than 0.2% of the excavation depth.

Figure 30 Comparison between predicted and measured horizontal displacements at inclinometer I-1, I-6 and I-7 (I-1 at the north side, I-6 and I-7 close to the west Y joints)
