Collapse of permafrost and failure of bridges in the community of Pangnirtung, Nunavut

Entzu Hsieh, P. Eng.,
AMEC Earth & Environmental, Calgary, Alberta
Alexandre Tchekhovski, Ph. D. P. Eng.,
AMEC Earth & Environmental, Calgary, Alberta
Ron Mongeau, Senior Administrative Officer
Community of Pangnirtung, Nunavut

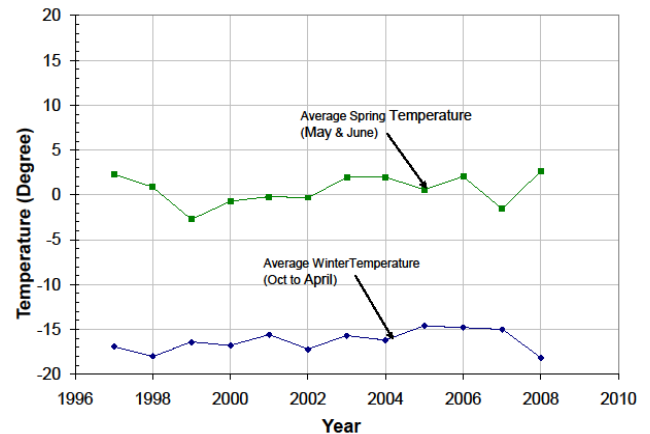
Figure 2: Mean Winter and Spring Air Temperature

The mean winter (October through April) and spring (May and June) air temperatures were also calculated from 1996 to 2008. Figure 2 presents the results of calculations. It can be seen that the 2007/2008 winter and 2008 spring had extremely cold (-18 °C) and extremely warm (2.5 °C) air temperatures, respectively.

The air temperatures in the 2007/2008 winter period and in May/June 2008 spring period formed favourable conditions for accumulating considerable amount of water in the Duval River valley. Figure 2 shows that the mean air temperature for the 2007/2008 winter season was about -18°C , while the average winter temperature between 1996 and 2008 was calculated to be -16.3°C . On the contrary, the mean air temperature for May and June 2008 was about 3°C , which is the warmest temperature between 1996 and 2008. The anomalous winter and spring temperatures would to some extent intensify the impact of the rainstorm and exacerbate the consequence of the surface flooding. It is because the extremely cold 2007/2008 winter might result in freezing to a full depth of the river channel and formation of an ice berm at some distance upstream from the community. In spring time of 2008, ice berm and ponding water were observed at a distance of a few kilometres from the community. Any cracks occurred in the ice berm would cause considerable amount of water flowing through the berm and flooding the river valley.

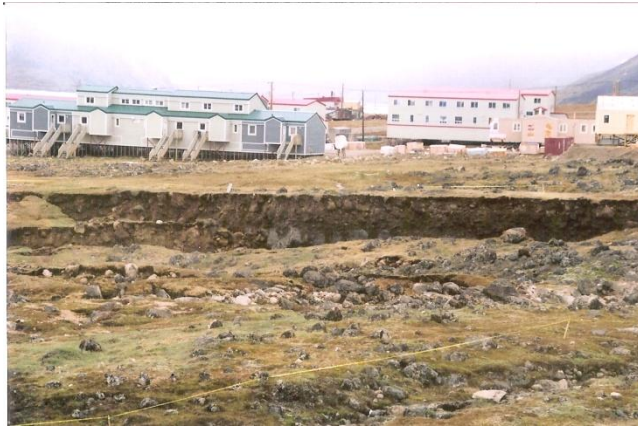
It was observed that large amount of water undermining the river banks and causing severe erosion and landslides along both sides of the river. The depths of landslides could exceed 8 m, and landslide escarpments were in the order of several metres (Photograph 1). Flowing water, greyish to bluish in color, was observed in all of the cracks (Photograph 2). The color of the water suggests that erosion of the marine deposits was occurred. It was also observed that the fines and sand particles in the fluvial deposits were being washed out, leaving a cobble-boulder matrix with large voids between the particles.

Photograph 1: Landslide Escarp

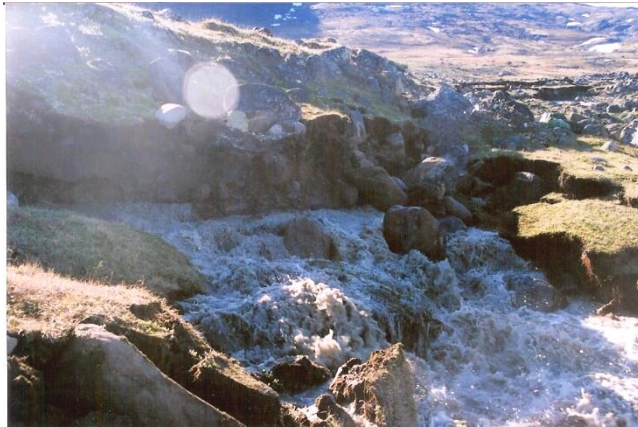
Photograph 2: Water Flowing from River Bank

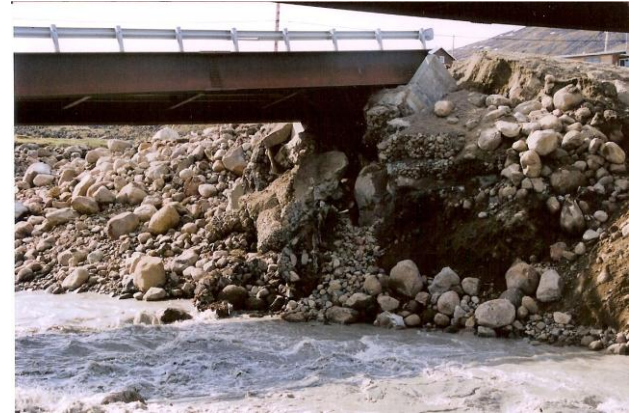
Photograph 3: Failure of South Abutment

The upstream bridge experienced the most severe damage. Photograph 3 shows that failure of the abutment on the south bank of the river resulted in significant tilting of the bridge substructure. Two major cracks and significant displacement developed in the approach embankment behind the north abutment as well as failure of north bank occurred, resulting in considerable settling of the bridge steel structure (Photograph 4 and 5)

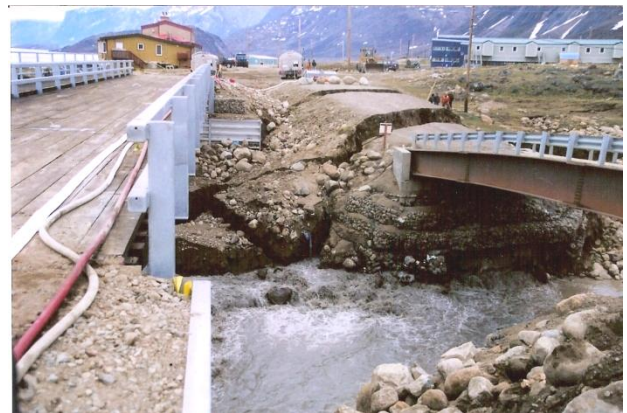
Photograph 4: Failure of North Approach Fill

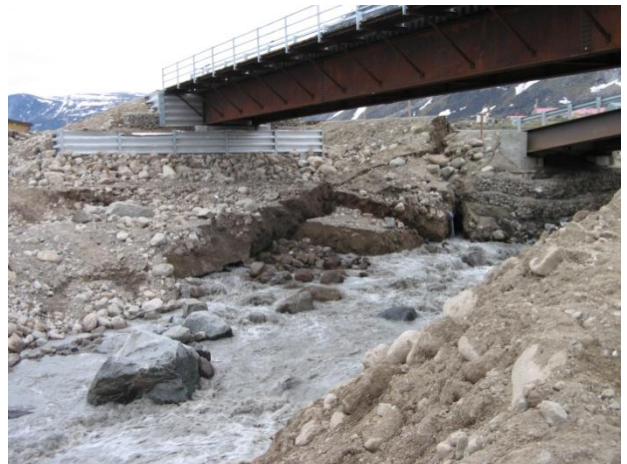
Photograph 5: Failure of North Bank

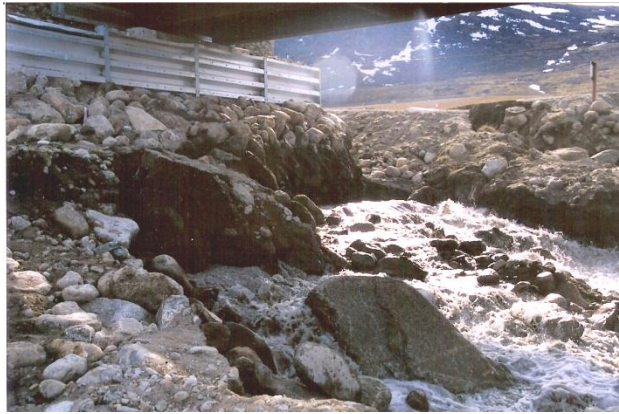
In general, abutment foundation soils were in an unfrozen state during the reconnaissance, and water was flowing out underside of the bridge abutments (Photograph 6), resulting in significant ground loss and lateral/vertical movements of the bridge substructures.

Photograph 6: Water Flowing Underside of Bridge Foundation
