Soil Cracks related to land subsidence. The main geotechnical hazard affecting to constructions in Aguascalientes City, México.

2011 Pan-Am CGS
Geotechnical Conference

J. Pacheco-Martínez, M.E. Zermeño-De-León & J. A. Ortiz-Lozano
CCDC de la UAA, Aguascalientes, México
A. Solís-Pinto
CGeA-Consultores en Geociencias Aplicadas S.C., Aguascalientes, México
Miguel A. Romero-Navarro
MARN-Servicios en Geotecnia, Aguascalientes, México
Francisco Aguilar-Valdez
CITIA-Ciencia de la Tierra Asesores, Aguascalientes, México
Juan A. López-Fuentes
GEO-Geofísica y Geotecnia Aplicada, Aguascalientes, México

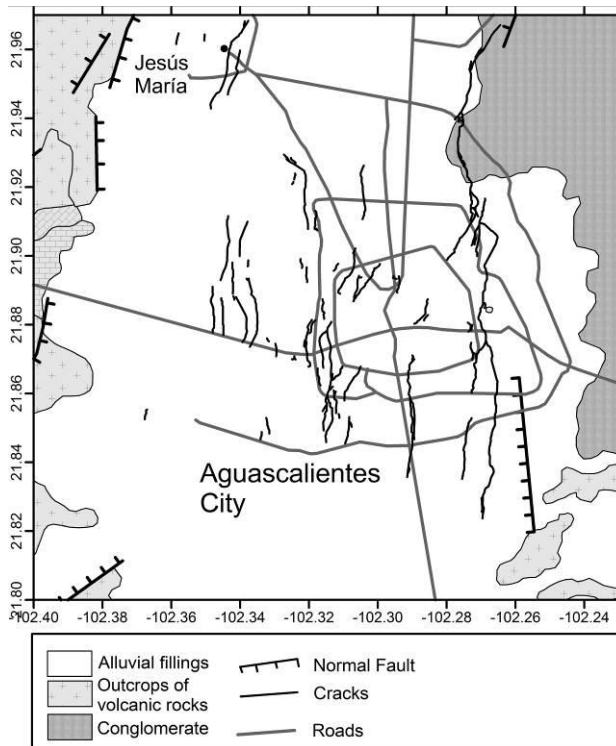
The soil cracks at present are of several kilometres in length. Initially, they start as cracks with only some centimetres in width, but according to observations in the AGSV, their width can enlarge until near to 4 meters by the erosion, which is caused mainly by the rain. There are not measurements about their depth, but It was estimated that they can reach several tens of meters depth (Pacheco et al. 2006).

Figure 2. Soil cracks in the urban zone of Aguascalientes city

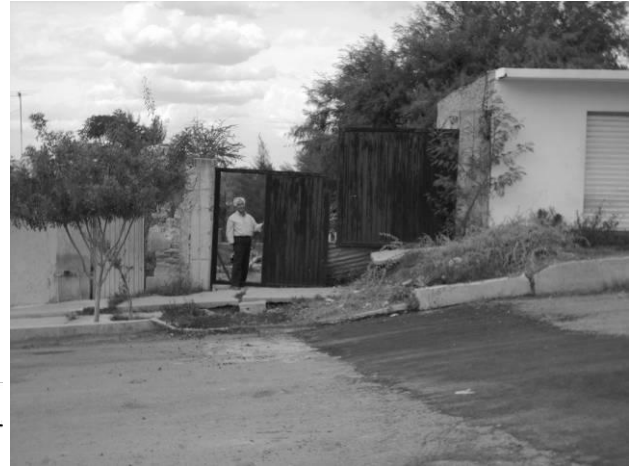
In the figure 3 it is shown an example of soil crack and the differential sinking between the two generated blocks.

Figure 3. Ramp developed by a soil crack at the northwest of the City of Aguascalientes. The vertical displacement of the blocks generated by the rupture is evidenced by the gate.

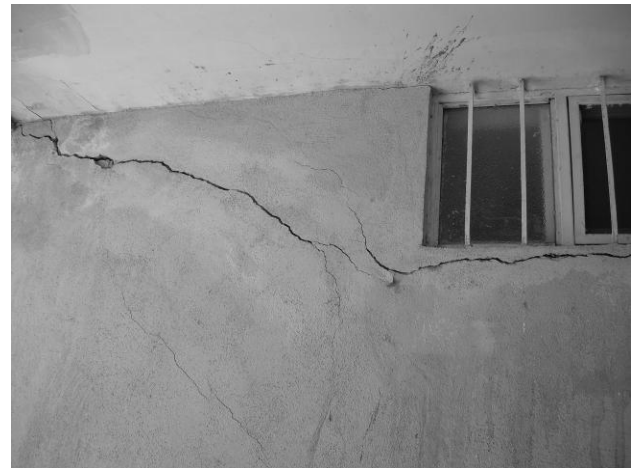
Figure 4. Caused damage to a bearing wall by differential settlement

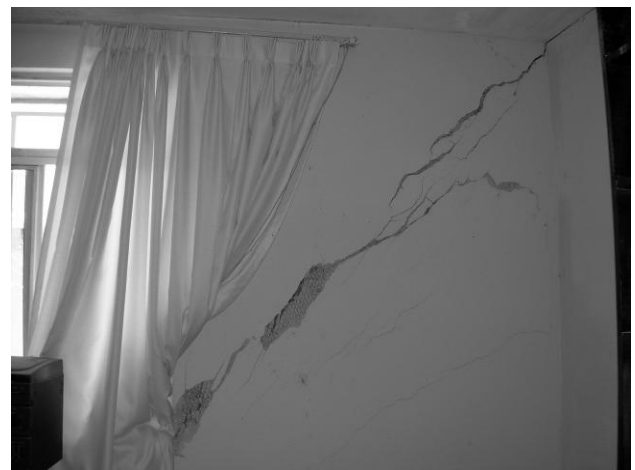
Figure 5. Diagonal cracks in a bearing wall due to diagonal tension.

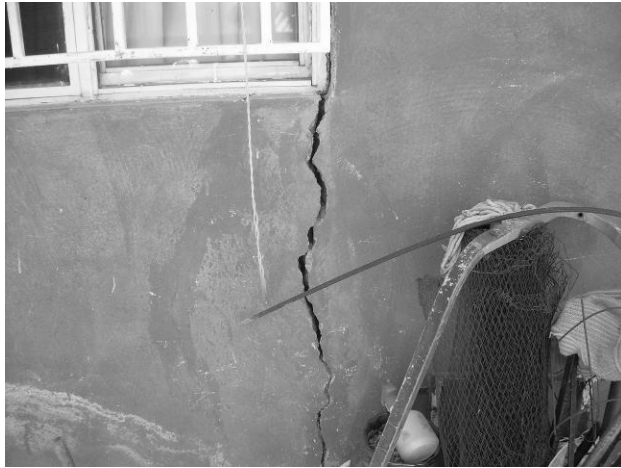
Figure 6. Vertical cracks due to differential settlement in non-reinforced walls

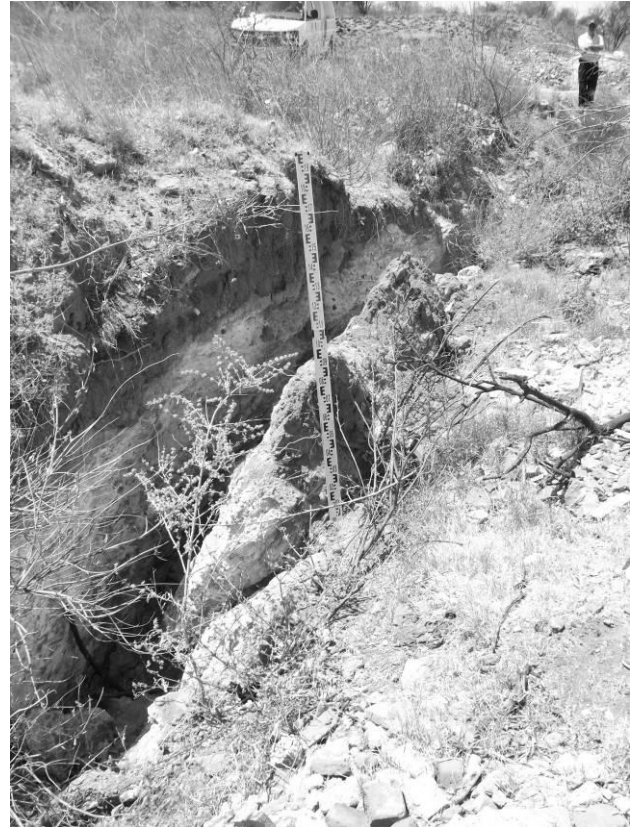
The photograph of the figure 11 shows a crack that is related to an irregularity in the bedrock with shape of stair or normal fault (point number 4 in the figure 10). This kind of crack develops a ramp or scarp in the surface that can reach until 1.1 metres high according to observations on the surrounding area of Aguascalientes City. On the other hand, the figure 12 shows a photograph of a crack related to a paleochannel.

Figure 11.- Surface fault related to differential sinking in the Aguascalientes City.

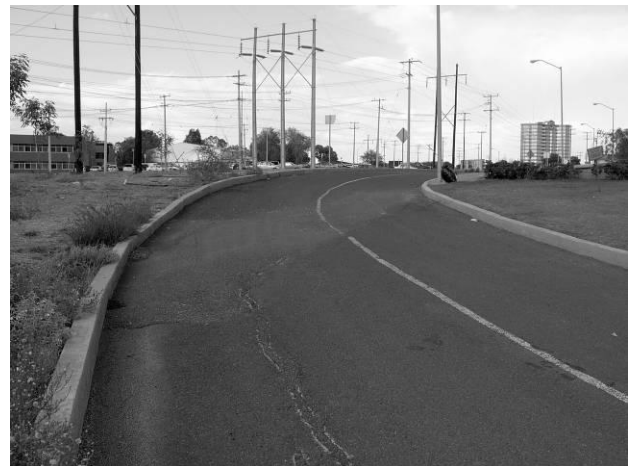
Figure 12. Cracks related to formation of caves by drag of fine material through paleochannels

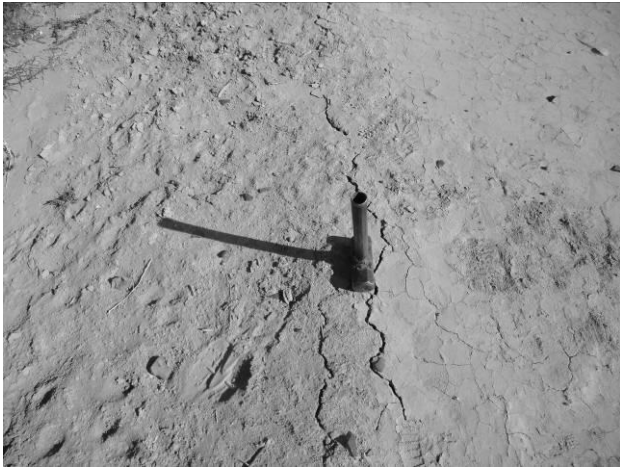
For convenience, two stages in soil cracks detection were differentiated; the first is referred in detecting cracks at their first stage of formation. In this stage, cracks are not visible on the surface because the crack-related damages are negligible (Figure 15), and they can be easily hidden by the erosion or by the activities for prepare the land for the construction.

Figure 15. Soil crack in a first stage of formation
