# Highway cut made in a rock formation with precarious stability

Herrera, S., Schmitter, J.J. & Colonia, J.  
*Free-Lance Consultancy, ICA & CONNET, Mexico City, D.F., Mexico*  
Macedo, V.H. & Reynoso, E.A.  
*CONNET & ICA, Mexico City, D.F., México*

The paper describes the peculiar deformational behavior observed in the vicinity of a 60 m tall highway cut, where the natural slope of the surrounding ground is of about 33% (18°). A description of the observed behavior and comments about its stabilization are included.

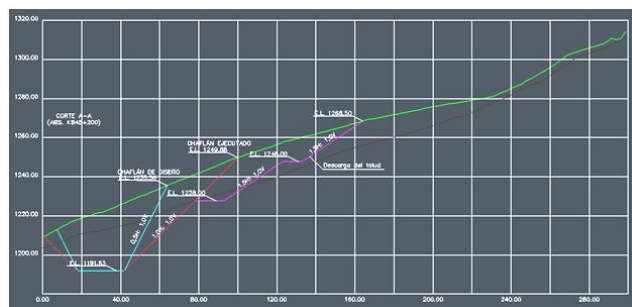
Figure 2. Cross section at Cut XV, at station km 845+200

According to the original project design, the cut should have been excavated with an inclination of 0.5:1, to reach a height of 44 m, measured at its shoulder. However, in reality it was excavated with an inclination of 1:1, and its height at the shoulder (chamfer) became equal to 57 m (Figure 2).

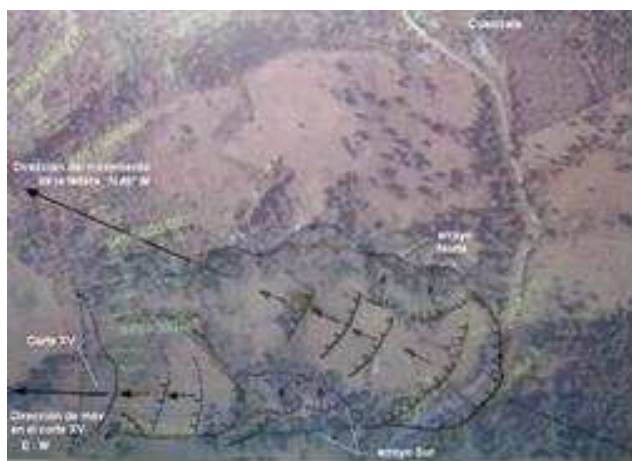
Figure 3. Aerial photograph of the site where Cut XV is located

Morphologically, the hillside is characterized for presenting undulations and stepping representative typical of quite accentuated crawling movements of the residual soil that covers the area and it is quite possible that part of the weathered rock is also involved in the flowage. At the northern hillside, adjacent to Cut XV, there exists another topographic feature that evidences important recent movements, prior to the excavations for the freeway, as shown in Figure 3.

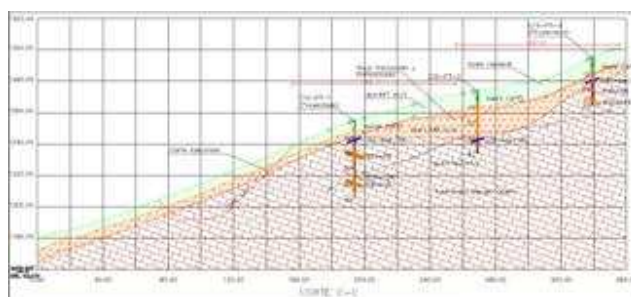
Figure 4. Stratigraphic profile of Cut XV

Figure 4 depicts the stratigraphic profile of the highway cut referred to that, according to INGETEC (2009) report, in its deepest part there is fractured clay-type marl and limestone of the Méndez formation (Ksm), whose stratification follows a slightly descending inclination towards the mountain itself and it is therefore favorable for the stability of the cut.

Overlying the Méndez formation, a deposit of fractured and weathered rock is found, having variable thickness, covered in turn by a layer of residual soil with thickness ranging from 7 to 10 m and constituted by reddish brown clay and silt, with low plasticity.

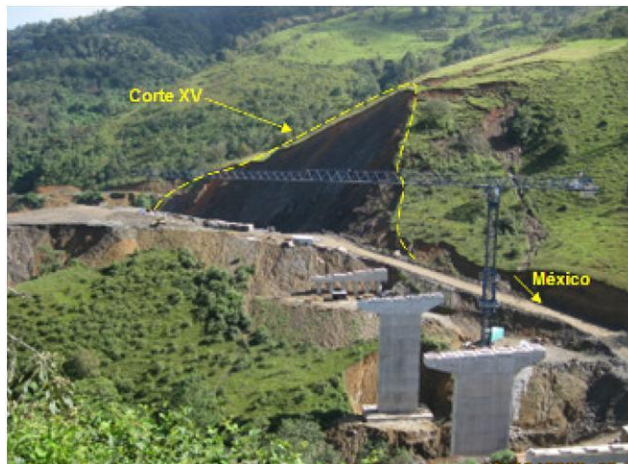
Figure 5. Cut XV

The shear failure occurred when the elevation of the excavation to accommodate the freeway had already reached the fractured, but not weathered limestone of the Méndez formation. The first or initial failure took place in the southern side of the cut between stations km 845+160 and km 845+200, covering a height of approximately 50 m, and creating tensile slope cracks at a distance of 25 m from the shoulder of the slope.

The second failure encompassed a larger volume and it occurred 40 days after the first one, appearing a series of tensile cracks at the upper part of the hillside running to about 120 m behind the shoulder of the cut, between stations km 845+200 and km 845+260.

To prevent problems of local stability, the surface of Cut XV shall be reinforced with conventional anchors, protecting the surface with triple torsion wire mesh so as to prevent small blocks from affecting the pavement wearing surface and also leaving a wide sidewalk at the toe of the slope and a retrieving wall (collection box) to catch large rock falls.

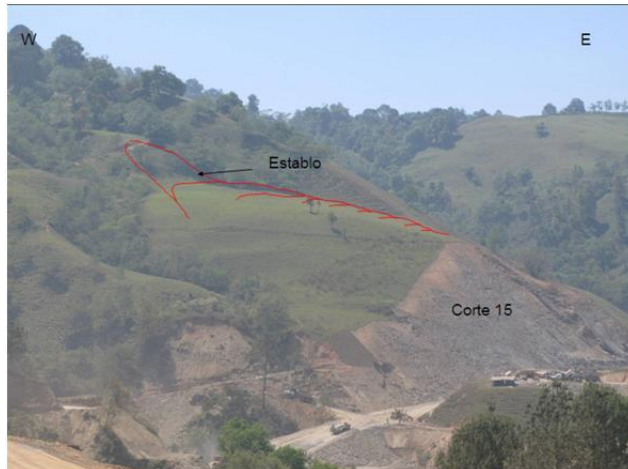
Figure 6. Cracks on the hill adjacent to Cut XV

Under present conditions found at the hillside of Cut XV, with a large number of tensile cracks due to the displacement produced, the potential effect of water infiltrating into the subsoil is going to be a major factor in the long-term stability and therefore the most important actions to be implemented will imply preventing seepage, the superficial channeling of rain water and the under drainage of the ground through drilling of long drains.

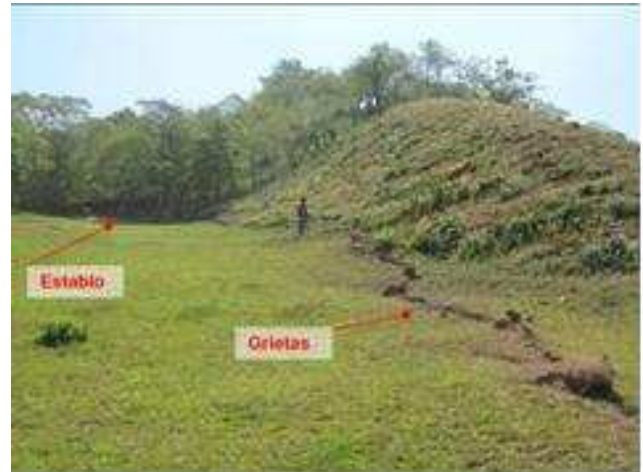
Figure 7. Detail of cracks on the hill adjacent to Cut XV. INGETEC (2009)

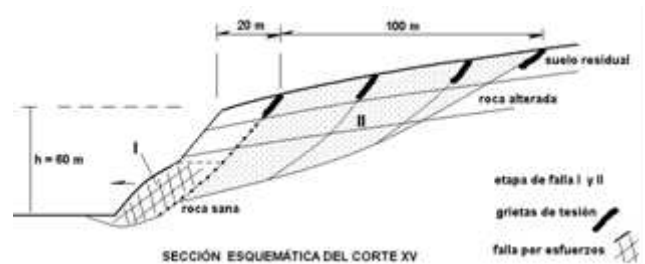
Figure 8. Schematics of the failures occurred in Cut XV

Figure 8 shows schematically the failures occurred.

The initial shear failure developed at the toe of the slope with repercussion toward the upper part along a relatively very short distance (20 m) with presence of tensile cracks.

The second shear failure encompassed the whole hillside with the tensile cracks extending to a distance of about 120 m behind the cut (Figure 8). It is considered that this second failure was due to the fact that the upper part of the hillside is characterized by the presence of materials with smaller shear strength and it is constituted by layers of disturbed rock and residual soil.

The second failure mechanism corresponds to the classic circular approach that is generally developed in soils.

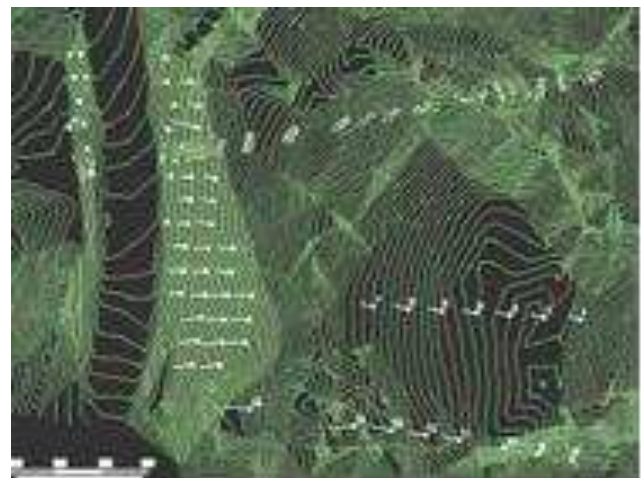
Figure 9. Vectors of the displacements observed at Cut XV

The rate of displacement recorded at the instrumentation bench marks placed at the top and alongside the hill, at the beginning of the movement varied between 2 and 15 cm/day, depending on the location of each bench mark. It subsequently dropped to less than 0.04 cm/day, with a trend to become stabilized.

Recently, at the beginning of the month of July 2010, as a result of the occurrence of heavy rains the trend to movement of the cut reappeared at rates of about 1 to 2 cm/day, dropping again after 2<sup>nd</sup> August to values of 0.3 cm/day and once more with the trend to become stabilized.

Figure 9 shows schematically the displacement vectors observed in the instrumentation installed at the surface of the cut and at the adjacent hillside.

To allow the displacement of the hillside until the movements become stabilized. Monitoring is carried out by means of instrumentation placed at the cut including topographical measurements and inclinometers installed at the toe of the cut. Currently, the displacements measured are quite small.
