Stability slopes study of dams of Necaxa Hydroelectric System

Nicolás Melchor-García & Roberto Ruedas-Medina
Instituto de Investigaciones Eléctricas, Cuernavaca Morelos, México
Oliver Nava-Tristán
Comisión Federal de Electricidad, México.

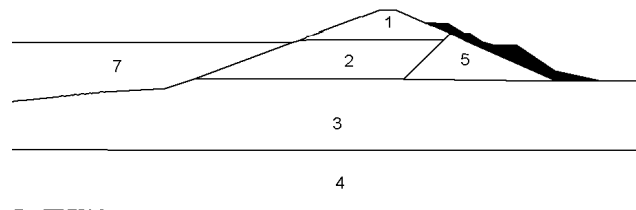
Figure 7. Critical cross section 1, Tenango dam (between landmarks 2 and 3)

thickness of rockfill that covers the finest soil materials. During the drilling of boreholes, drilling mud was lost at different depths. The most outstanding is the borehole on the landmark 2 located on the crest, where the mud was lost to 2.4 m depth, probably due to cracks in the clay or piping.

In the boreholes close to 25-26 y 35 landmarks drilling mud was also lost. The extracted materials were identified as CH and CL. The percentage of fines that passed the No. 200 mesh was generally greater than 90% in almost all samples taken from the hydraulic fill. As for the rockfill, a friction angle of 36° was considered (Marsal, 1975), taking into account that the material was placed to turn and has compacted during its operation period getting more stability. The critical sections of the dam were defined based on the stratigraphy results of the exploratory drilling. Table 1 and Figure 7 present the mechanical properties and permeability of critical sections.

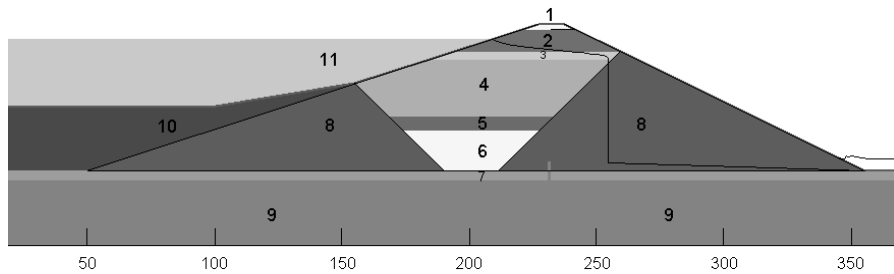
Figure 8. Critical section 3, Necaxa dam

In the curtain of Necaxa dam were drilled 6 geotechnical boreholes, four on the crest (66, 68 and two 45 m deep) and two on the downstream slope. The slopes borings were aligned with crest borings, to obtain cross sections. In two boreholes the basement rock was reached and deepened further 4 and 5 m, respectively. In some parts of the curtain, during the standard penetration test, the bars were driven into the material by its own weight, which indicates a very low resistance. The minor strengths were between 5 and 25 m of depth and represent a potential area of failure by sliding surfaces, which was considered in the stability analysis. It was observed that materials that include boulders and gravel do not form well defined layers. Rather they were erratically deposited forming regions or areas with resistance due to friction and cohesion and higher permeability, where significant seepages may occur. On the downstream face, deformations were observed altering the flat geometry of the slope. It was not possible to measure the age or the speed of these deformations to determine whether they

are growing or stable. The installation of inclinometers is recommended. Table 2 and Figure 8 present a summary of the properties of the Necaxa dam.

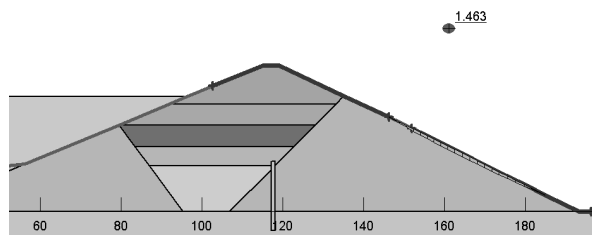
Safety factors of the three sections analyzed for Tenango dam are greater than the minimum recommended ones (USACE, 2003). Only in the downstream slope safety factors were slightly lower than those recommended, however, these granular materials are stable if the angle of inclination of the slope is greater than the angle of resistance. In addition, the slip surfaces associated with these SF occur on the surface of the slope, containing a small amount of material and do not represent a condition of instability of the slope. The slip surfaces that penetrated deeper and other critical sections had SF greater than 1.5 for the same condition. Using the criteria Hynes-Griffin and Franklin, the 3 sections have pseudostatic safety factor greater than one, therefore, they will not suffer large deformations that could threaten the safety of the dam. However, the loss of drilling mud during the geotechnical exploration indicated the existence of cavities and they could facilitate the development of slip surfaces.

Figure 13. Critical section 3, Tenango dam. Steady flow condition, downstream failure. F.S = 1.463 (Spencer's method)

The Tenango dam does not have stability problems due to the strength characteristics of materials. However, during the drilling of some boreholes, large quantities of drilling mud were completely lost through pipings of unknown dimensions and trajectories, which suggests that slip surfaces could be developed to continue the path of the pipings and the safety factors could be considered as intolerable. Moreover, the results of chemical analysis of water from the reservoir and spring revealed that the into the curtain of Tenango dam reactions may occur between clay and sodium ions and generate a dispersive behavior, so there probably is a piping phenomenon under way as might be confirmed by the loss of drilling mud described above. Based on the results here reported LyFC carried out the construction of plastic walls of bentonite-cement to reinforce those areas.

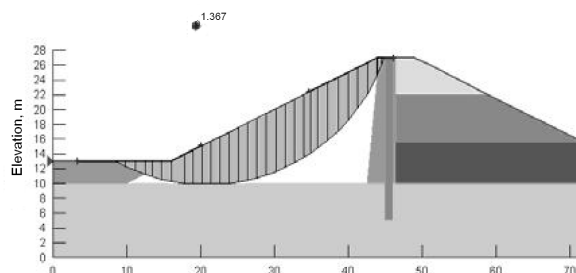
Figure 15. Critical section 3, La Laguna dam. Slip surface on upstream slope., rapid drawdown condition. F.S = 1.367 (Spencer method)

The stability analysis of La Laguna dam showed safety factors above the minimum acceptable in the three conditions of analysis. The chemical analysis of water from La Laguna dam showed no conditions for the development of piping but, because this phenomenon already occurred long ago, it is advisable to install instrumentation in the dam to observe changes in behavior that could indicate in time the possible development of a fault.

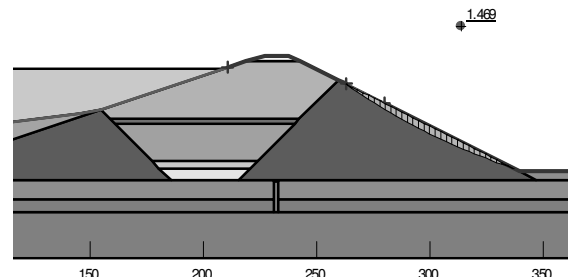
For Necaxa dam, the SF for steady flow condition is greater than the minimum recommended by Reséndiz (1975) and is considered satisfactory for the stability of the dam. The seismic coefficient $c = 0.065$, equal to half the peak ground acceleration produces a $SF = 1.26$, according to the Newmark method, so the dam is not expected to become permanently deformed.

Figure 14. Critical section, Necaxa dam. Steady flow condition F.S = 1.69 (Spencer's method)

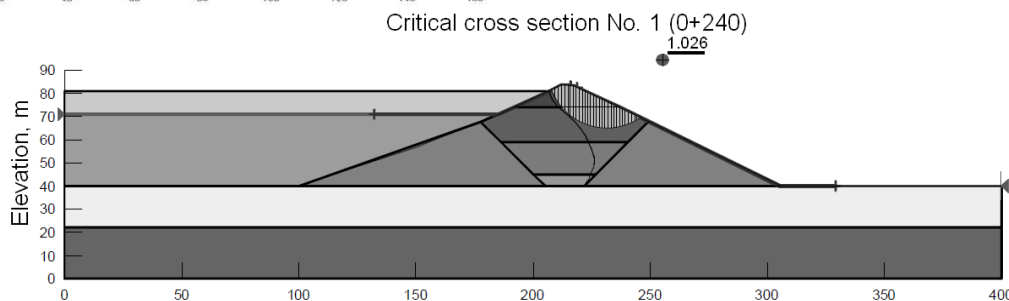
Figure 17. Critical section 1, Nexapa dam. Dynamic conditions. F.S = 1.026 (Spencer's method)

However, in Nexapa Dam, one of the critical sections has values somewhat lower than recommended. In this section the failures for steady-state flow, rapid drawdown and seismic excitation occur at the base of materials of brown silty clay with undrained strength of 21.5 and 35.75 kPa. It was mentioned above, that the resistance obtained with SPT tests corresponds to a material with hard consistency. So it is recommended to obtain

undisturbed samples in these materials, to assess the stability of this dam in a more reliably way.
