# Retrofit of a pile-supported bridge in soft clay damaged by failure of adjacent soil stockpile

Sy, A., Thavaraj, T. & Hamersley, B.  
*Klohn Crippen Berger Ltd., Vancouver, BC, Canada*  
Gillespie, D.  
*Ministry of Transportation and Infrastructure, Victoria, BC, Canada*

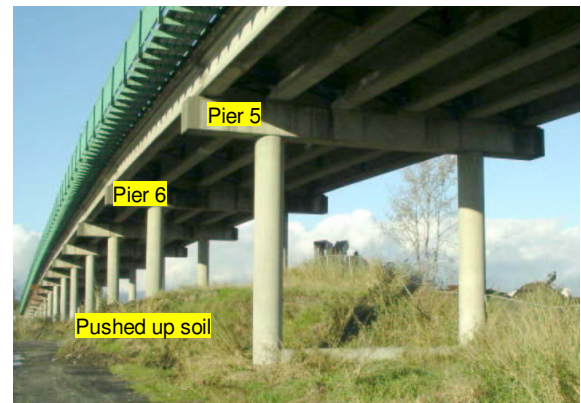
full-length of the south approach of the bridge, failed. The soil failure pushed up the ground level between Bents 5 and 6 to a height of 3 to 4 m, and to a lesser height between Bents 6 and 7 (see Figs. 2 and 3). The bridge centerline moved horizontally by more than 150 mm between Bents 4 and 7, with up to 428 mm at Bent 6, resulting in a noticeable kink in the structure at this location. Fig. 4 shows the surveyed permanent horizontal displacements of the pier centreline after the event.

Figure 2. Soil pushed up between Piers 5 and 6 (looking north)

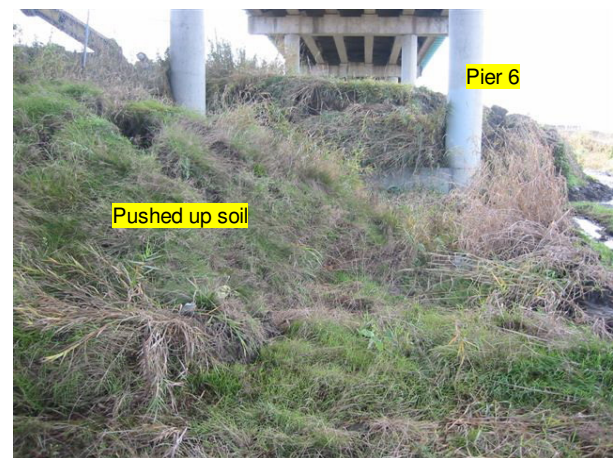
Figure 3. Soil pushed up near Pier 6 (looking south)

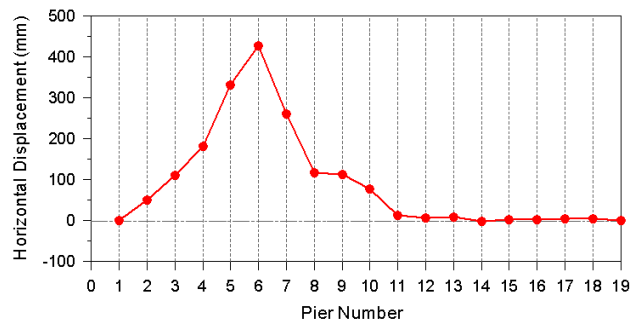
Figure 4. Horizontal displacement profile of pier centreline (Note pier numbering starts from south end of overpass)

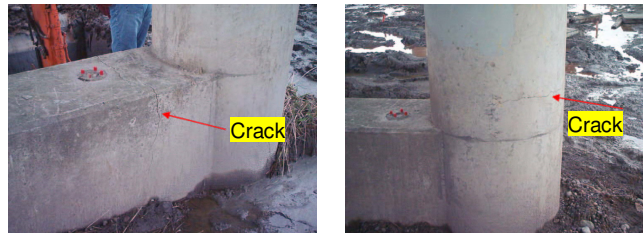
In addition to the transverse pier movements, significant tilting or rotation of pier columns was observed at Piers 5 to 7. Top to bottom relative displacements of up to 45 mm transversely and up to 84 mm longitudinally, were measured. Substantial cracks on pier columns and pile cap beams were observed (see Fig. 5). Several girders at Pier 6 also shifted over the bearing pads, reducing the available bearing seat lengths (see Fig. 6).

Figure 5. Cracks in pile cap beam and column at Pier 6

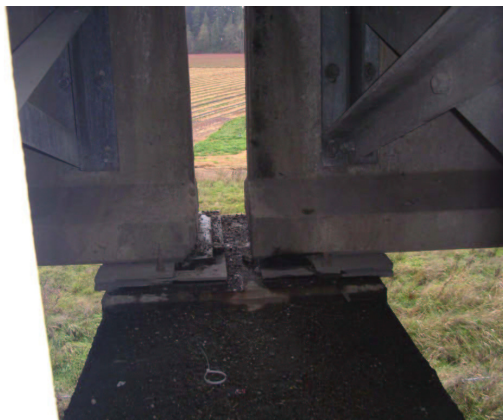
Figure 6. Displaced girder at Pier 6 (looking west)

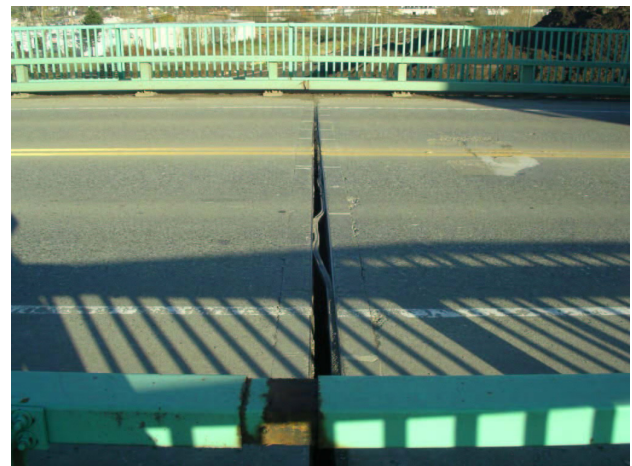
The deck expansion joint at Pier 6 had opened to 147 mm on the west side compared to 14 mm on the east (see Fig. 7). On the other hand, the joint at Pier 8 opened

Figure 7. Uneven displacement of expansion joint at Pier 6, and traffic rail pulled apart at the west side (foreground)

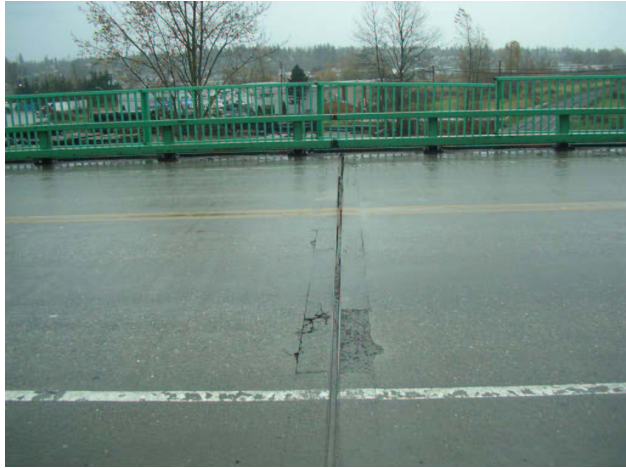
the opposite way, and was measured at 72 mm on the east side and 14 mm on the west (see Fig. 8).

Figure 8. Uneven displacement of expansion joint at Pier 8, and handrail pulled apart at the east side (far side)

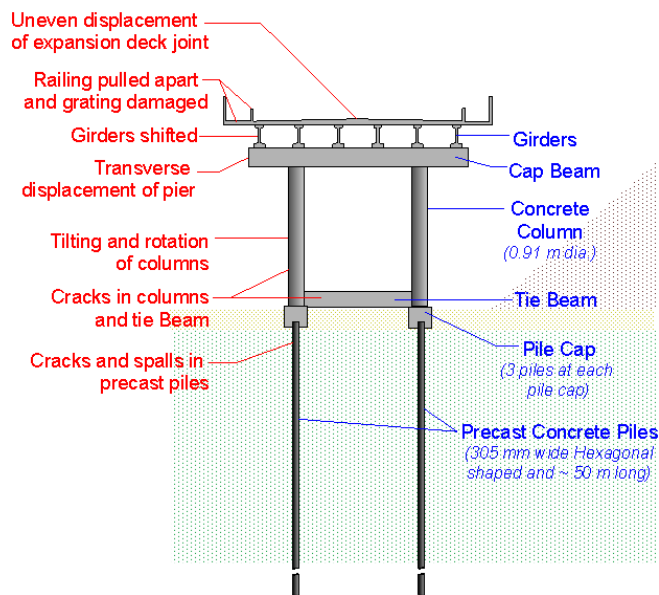
Figure 9 summarizes in schematic the damages observed on the south approach of the bridge due to the November 2004 soil failure. Shortly after the event, cracks in the columns, tie beams and exposed piles (described in Section 4) were epoxy injected, the soil stockpile in the adjacent property was re-profiled to a much flatter overall slope, and the heaved soil between Piers 5 to 7 was removed. Despite the displacement and damage, structural assessment showed the bridge to be safe for traffic, but all repair and construction activities were carefully controlled with constant monitoring of the bridge and foundation.

Figure 9. Observed damages on bridge after soil failure

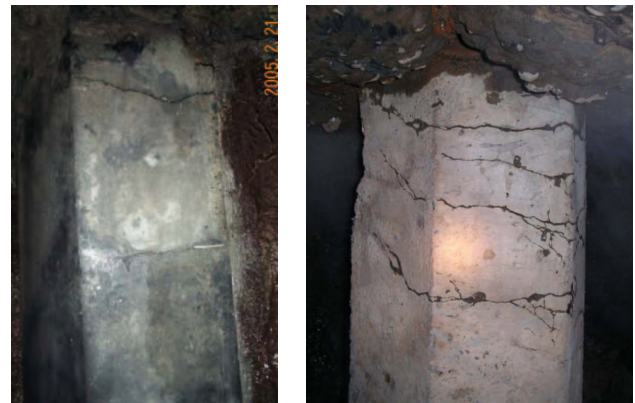
1. The visual inspections indicated cracks and spalls in the upper part of many piles on the west side of Piers 4, 5 and 6. Note in particular, that cracking was observed on the west side of the individual piles and spalling on the east side of the piles. The piles on the east side of the pier (adjacent to the soil stockpile), however, did not show any apparent damage in the upper 1 m of the pile length. Figure 10 shows photos of cracks in the top part of concrete piles observed upon excavation.
2. The low strain integrity testing indicated impedance reductions of piles on both the east and west sides of Piers 4 to 8. These impedance reductions suggest presence of partially opened joints and/or concrete cracks, but no evidence of complete pile separation.

Figure 10. Cracks in precast piles at Pier 5 and Pier 6 on the west side

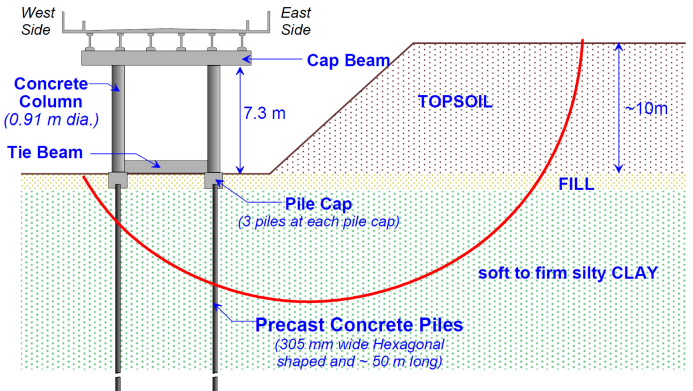
- The topsoil stockpile failure resulted in ground displacements likely along a circular-type slip surface 6 m to 10 m deep beneath the east side of the bridge, and exiting near the west side of the bridge, as illustrated in Fig. 15. This conclusion is supported by the observed soil heave between Piers 5 and 7 following the failure event, comparison of cone penetration test data inside and outside the affected area, high excess pore pressures in the ground as observed in the piezometers, and the observed pile damage.

- The ground failure mechanism would have resulted in soil displacement and loading against the upper portion of the piles and pile caps on the east side, and mostly structural loading from the cross beams to the piles on the west side. This is confirmed by the difference in damage patterns observed on the piles in the east and west sides of the bridge.

Figure 15. Failure mode of topsoil and bridge pier

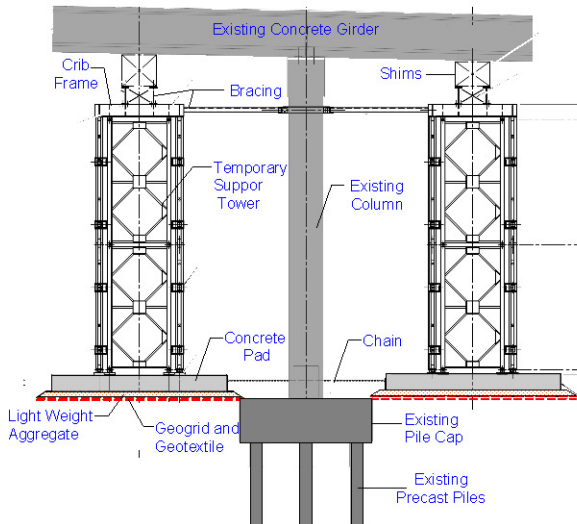
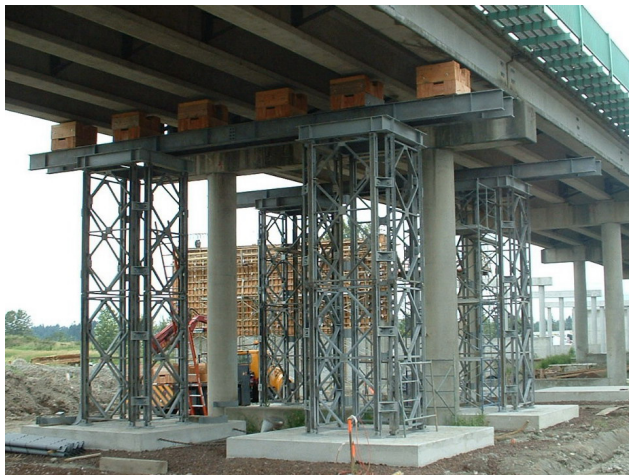
Figure 16. Temporary support towers around pier (longitudinal view)

Figure 17. Temporary support towers as constructed

- Temporary shoring towers (using Acrow temporary bridge panels) were erected to support the girders between Piers 4 to 8, as shown in Figs. 16 and 17. The towers were founded on concrete pads on a layer of lightweight pumice fill. The footings were sized to limit bearing pressure to 50 kPa and to minimize settlement. The tower height was adjustable by shims to accommodate expected settlement.
- Longitudinal restrainers were installed between the girder ends at Piers 4, 6 and 8 to prevent loss-of-span failure. The restrainers consisted of Dywidag bars with steel brackets bolted onto the web of the girders.

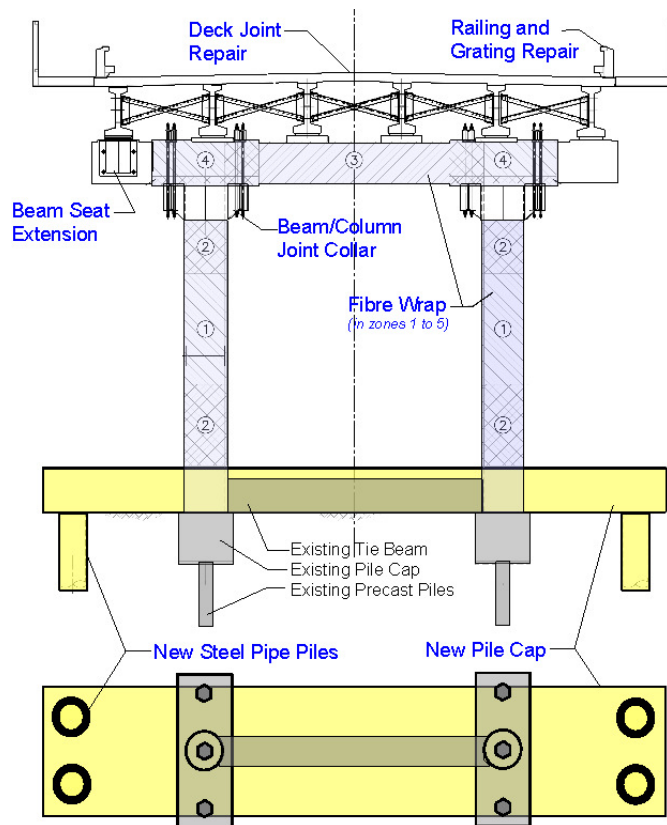
Figure 19 Permanent bridge retrofit including new pile caps and steel pipe piles

- New piles, pile cap extensions and tie-beams at Piers 3 to 8 to replace damaged piles;
- Fibre wrapping of damaged columns to limit concrete spalling and increase column strength;
- Beam-column joint retrofit using steel collars and fibre wrap;
- Transverse shear keys between girders at the top of capbeams;
- Deck joint repair;
- Beam seat extension at Pier 6; and
- Sidewalk grating, fence and roadway railing repair.

Figure 19 shows details of the permanent retrofit at a typical bent. The permanent retrofit was carried out during shutdown of the existing bridge between October 2006 and May 2007, while traffic was diverted to the new bridge to the west.

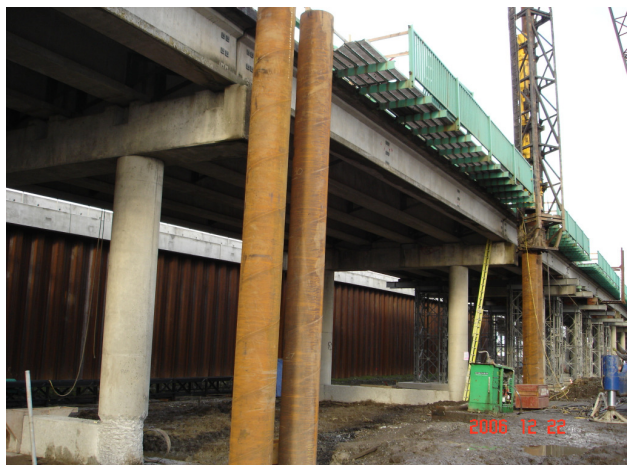
Figure 20. Installation of replacement steel pipe piles at east side of bridge

Open-toe steel pipe piles, 610 mm outside diameter by 12.7 mm wall thickness, driven to toe bearing in the dense till-like soils underlying the soft marine clay were used to replace the existing damaged concrete piles. Two new piles were installed at each existing column or pile cap at Piers 3 to 8. The pipe piles were driven to practical refusal (15 blows for last 25 m of penetration) using a Berminghammer B64 diesel hammer (see Fig. 20). Pile

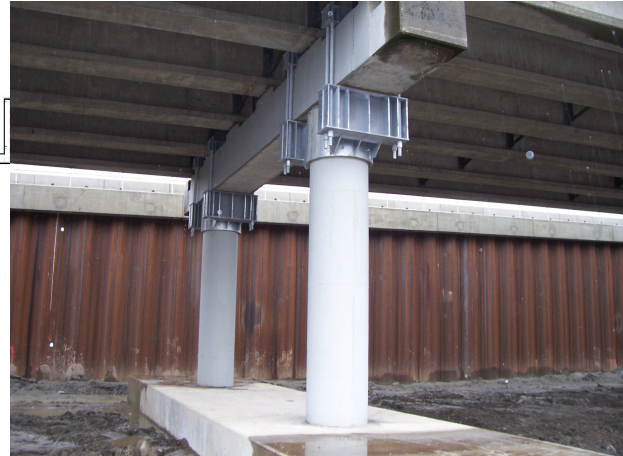
Figure 21. Bent after permanent retrofit (looking west)

Figure 21 shows a typical bent after permanent retrofit. Note the new parallel overpass in the background.
