Geotechnical Forensic Engineering: Settlement of Structures in Industrial Facilities Located in Puerto La Cruz, Venezuela

Alvaro BOIERO^{a,1}, José L. OLIVER^b and José I. AMUNDARAY^c

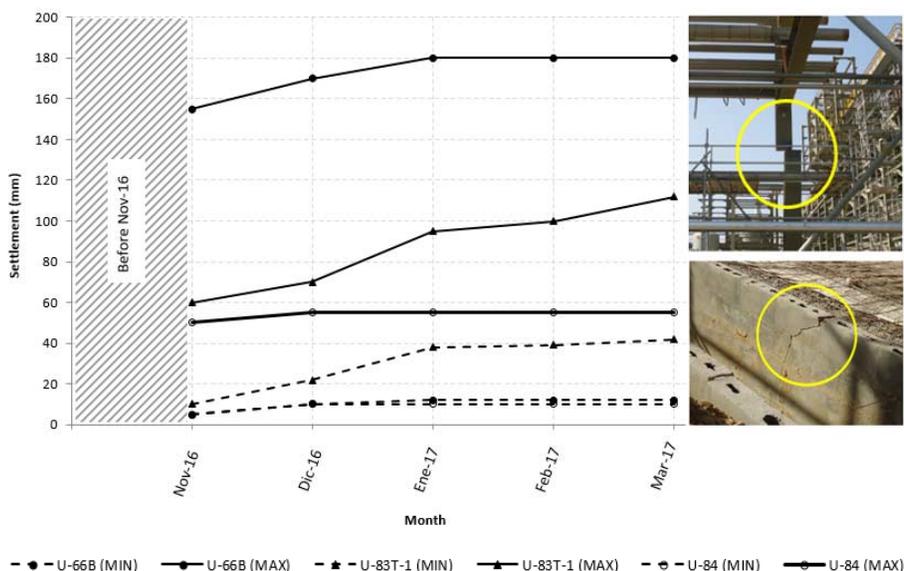
In Figure 1, measurements corresponding to the topographic control of the project are observed. These measurements correspond to the extreme settlements (minimum and maximum) in the most affected units. Also, photographs illustrating the effects of registered settlements are shown.

Figure 1. Settlement measurements and field deformations evidences.

Topographic deformation measurements before November 2016 (when the settlements of the structures reached, in some cases, more than 40 mm) were not reported, which suggests that a progressive topographical control of the foundations' coordinates was not carried out during the construction stage. Also, based on the values shown in Figure 1, it is evident the occurrence of variable differential settlements between 45 mm and 168 mm, inadmissible for the structures installed in the project.

The proposed foundation solution, basically consists of installing a number of micropiles, which will cross the existing foundation, and build a cap head that serves as a connection between these deep elements and the existing foundation. In this way, the loads transmitted by the superstructure will be completely absorbed by the micropiles.

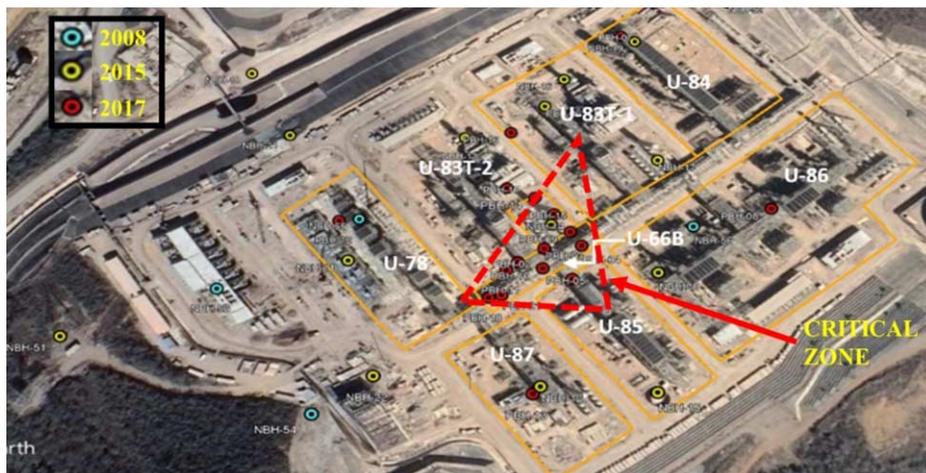
Figure 2 shows the location of the low soil rigidity are in the studied parcel, considering the explorations made in 2008, 2015 and 2017.

Figure 2. Critical zone of the parcel, considering explorations performed on 2008, 2015 and 2017.

According to the above, the presence of a layer of low rigidity materials between the surface and 11.5 m depth is evident, in which a critical sector of very low soil rigidity between 3 m and 8.5 m of depth is observed.

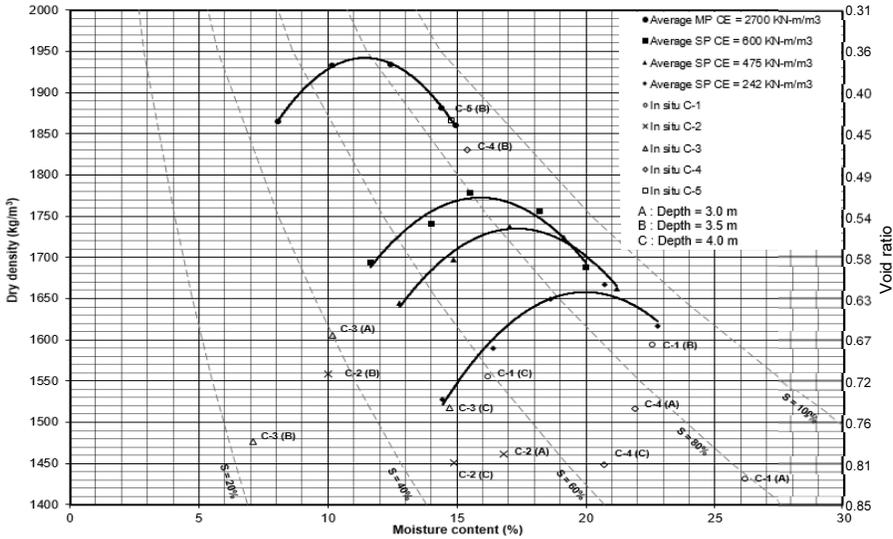
In Figure 3 it can be seen that, in general, *in situ* dry density values are lower than $1,600 \text{ kg/m}^3$, which is equivalent to compaction energy levels below 275 kN-m/m^3 . The *in situ* moisture content values present a great dispersion, with a minimum of 7% and a maximum of 26%. The degree of saturation of the backfill presents a variable range between 40% and 80%, without reaching the degree of total saturation. Also, it can be observed that the void ratios determined for *in situ* conditions are considerably higher than the void ratios corresponding to compacted materials.

Figure 3. Compaction lab tests and *in situ* compaction measurements in trial pits C-1 to C-5.

Considering the previous analyzes, it is evident the existence of around 5 m of an uncontrolled backfill (even conformed without any type of compaction, or simply compacted by the passage of trucks) below the foundation levels (between 3 m 8.5 m deep), in those sectors of the parcel where significant settlements were observed in the installed structures. Likewise, it is clear that the degree of compaction of backfill conformed in the critical zone of the parcel, does not comply with the conditions stipulated in section 3.7 of the PDVSA AK-11 standard.

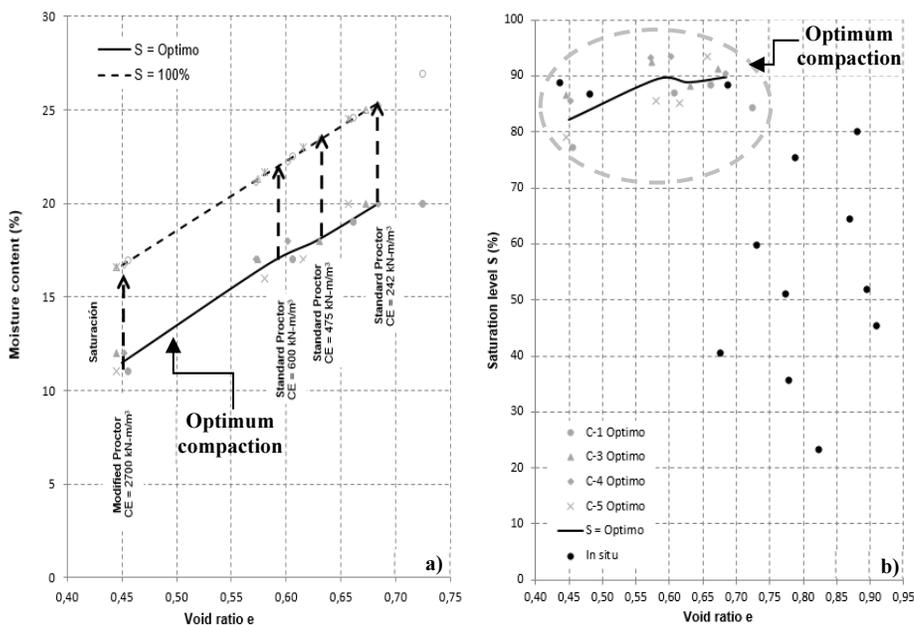
Figure 4. Moisture content vs. void ratio for different compaction energy levels (CE) and saturation (S), and *in situ* conditions according to measurements in trial pits C-1 to C-5.

According to the information shown in Figure 4, the materials compacted according to the pattern derived from a modified Proctor test, and subsequently saturated due to some external reason, would not reach moisture content values higher than 18%. For uncontrolled backfills conformed with the same material, in which the void ratio could be greater (and therefore have greater capacity to store water), moisture content values higher than 30% would be reached in case of saturation of the material.

Considering the analyzes carried out, it is clear that, in general, the effect of softening by saturation of the backfill is less significant than the low resistance of the material due to the low compaction energy. This can be explained because the *in situ* saturation levels present a great variability (between 20% and 90%), and also due to the fact that the greater settlements recorded, do not necessarily correspond to the sectors with higher saturation levels.
