# **‘Stuff happens’ - A case history of a safety incident while assessing slopes in Waioeka Gorge**

D. L. Stewart<sup>1</sup> and B. O’Loughlin<sup>2</sup>

Field inspection of steep slopes adjacent to transport corridors can pose serious safety hazards. An accident that occurred on one such project highlights the risks and safety considerations posed for geotechnical fieldwork. Geomorphic evaluation of slopes was undertaken in the Waioeka Gorge to assess the risk to the highway from large landslide events. The gorge is a hazardous environment for field work, characterised by very steep bush covered slopes up to 500m high, no cellphone coverage and numerous small rock fall events affecting the road on a daily basis. The investigation methodology used sought to minimise risk exposure to staff by utilising remote techniques such as assessment of GoogleEarth and LiDAR data, helicopter inspections, followed by field mapping to ‘ground truth’ selected slope features. Due to the hazardous nature of the site a rigorous health and safety plan was developed for the off-road slope inspections. The safety plan was severely tested by a serious incident during field inspection of a steep remot

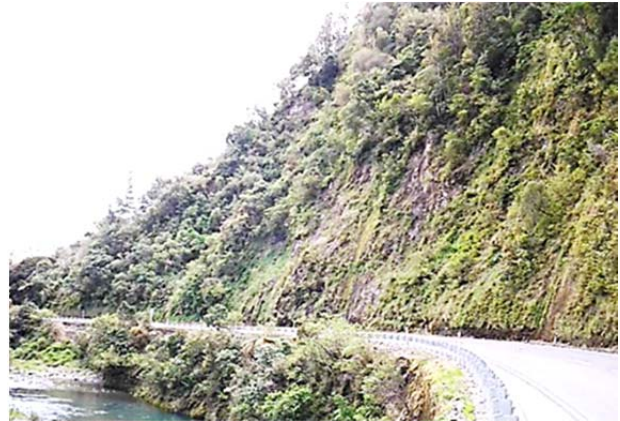
Figure 2. Typical steep slope in Waioeka Gorge

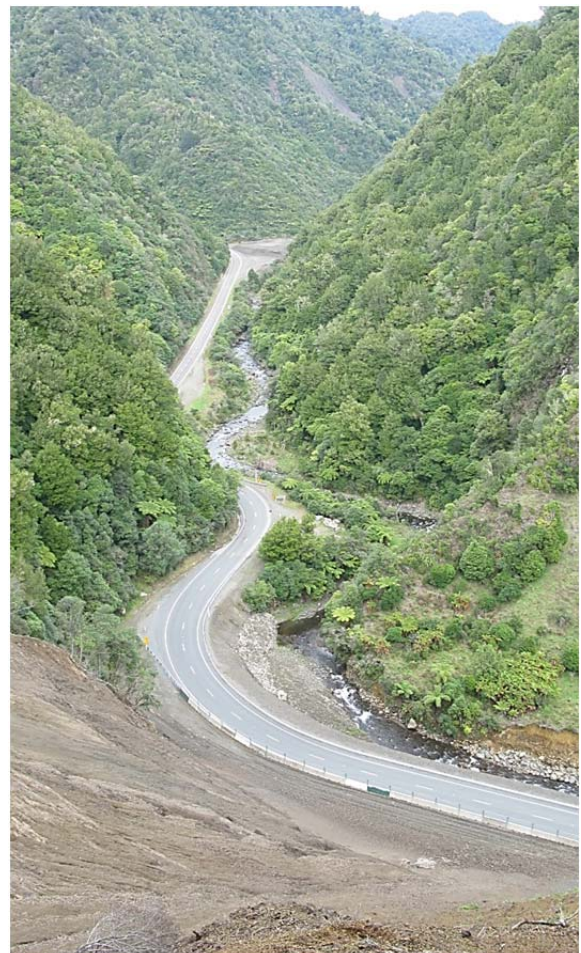
The field work for Stage 2 of the project proposed visits to four potential landslide sites including the 150m high slopes adjacent to the 2012 Sandy Slip site (Figure 3) and three others slopes of 200 to 500 m height (including Figure 2).

Figure 3. Waioeka Gorge looking down the March 2012 landslide scar. May 2013 photo.

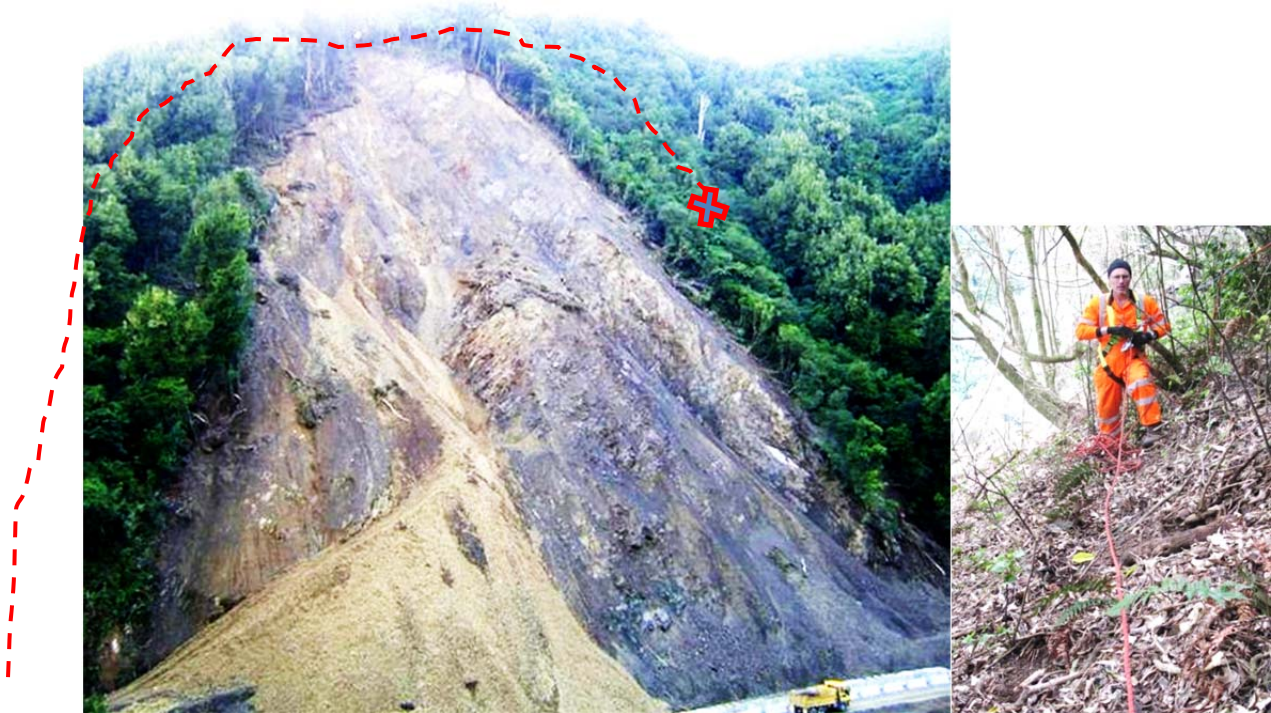
The inspection started mapping along the base of the slope from the road and then climbing up bushed slope to the west of the 2012 slip (Figure 4) inspecting features of interest identified from the LiDAR assessment. Inspections of the top of the slip were made at the slip crest while roped to the abseil support person (Figure 5). The inspection continued down the eastern flank of the slip in the bush toward road level. Approximately 1/3 of the way down (100m above road level), the guide (the abseil contractor) slipped on a tree root and fell heavily on his shoulder. It became clear that he wasn't able to continue as he was in severe pain and had dislocated his shoulder. We concluded that he was unable to continue and that help was needed.

*Figure 4. Sandy Slip site in April 2012 partway through debris clearing, showing route of 25 May 2013 inspection and incident site (x). GDC photo. Figure 5. Set-up for short roped inspection of landslide head scarp prior to descending toward road.*
