The paper was published in the proceedings of the 12th Australia New Zealand Conference on Geomechanics and was edited by Graham Ramsey. The conference was held in Wellington, New Zealand, 22-25 February 2015.

Population explosion onto unstable ground in the Auckland region

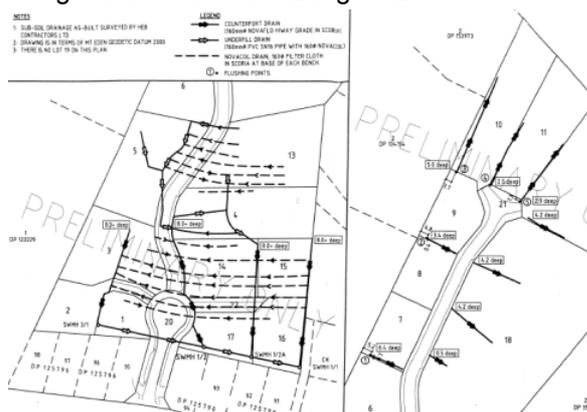
Figure 2. Shear Key / Subsoil Drainage (4E)

Site features included both shallow seated rotational slumps in the overburden soils and remnants of historic transitional zone land movement in the form of head scarps, debris mounds, mid-slope benches and soil creep. Investigation encountered / defined two main failure types:

The machine boreholes and the trial pits revealed that these features are probably controlled by fine sand or silty fine sand layers (rock soil interface). Above this zone the overburden consists of predominantly clayey silts and silty clays.

- Eastern and Western Shear Key's with underfill drainage (see Figures 2 and 3);
- 20+ Counterfort Drains (6m deep); and,
- In ground Timber Retaining Walls.

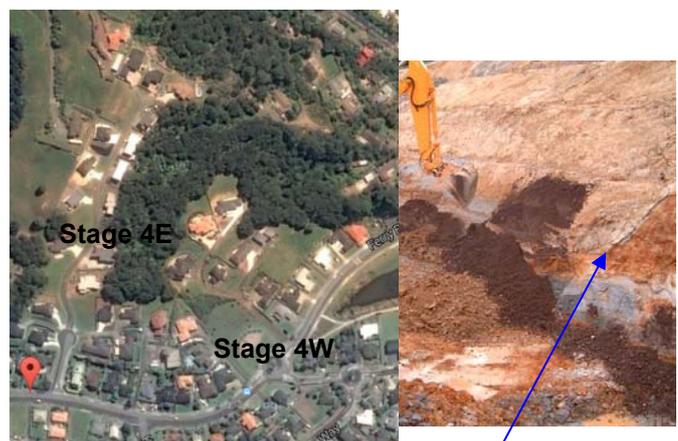
Figure 3. Aerial Photograph and Shear Plane 4W

Following the deep seated slope movement, recent residual shallow seated circular failures in the form of soil slumping / creep have occurred along the southern and eastern slopes of the site.

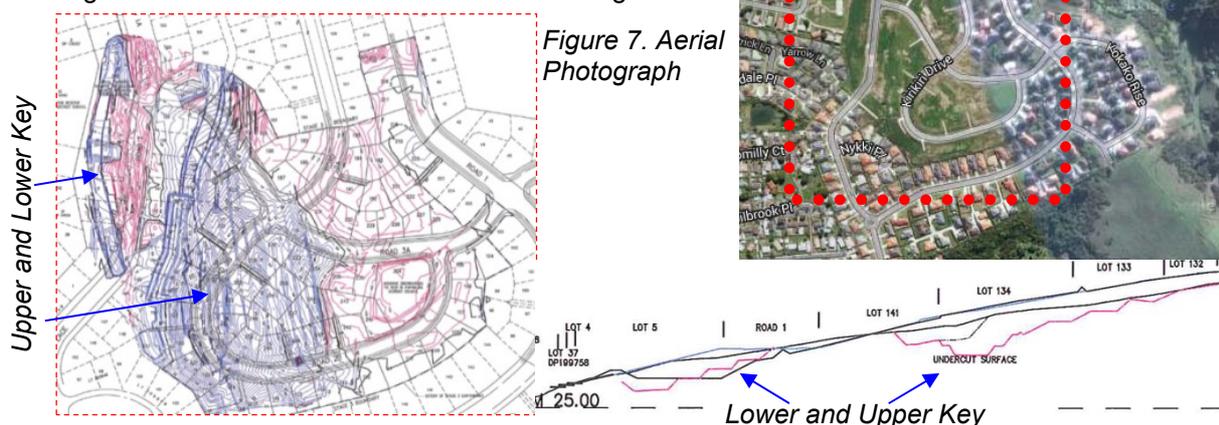
Figure 6. Shear Key As-built and Section

A significant landslide was identified within the western side of the subdivision (within area labelled Upper/Lower Key on Figure 6). Dual shear keys (upper and lower) were required to be constructed to provide code compliant land for development. Investigation encountered / defined two main failure types:

Shear key excavations revealed that these features are controlled by fine sand or silty fine sand layers (rock soil interface) and to bedding plane.

- Upper and Lower Shear Key's (6-10m deep,
- 150+m long and 10 to 20m wide at base);
- 30+ Counterfort Drains (6m deep); and,
- In ground Timber and Steel Tied-Back Retaining Walls.

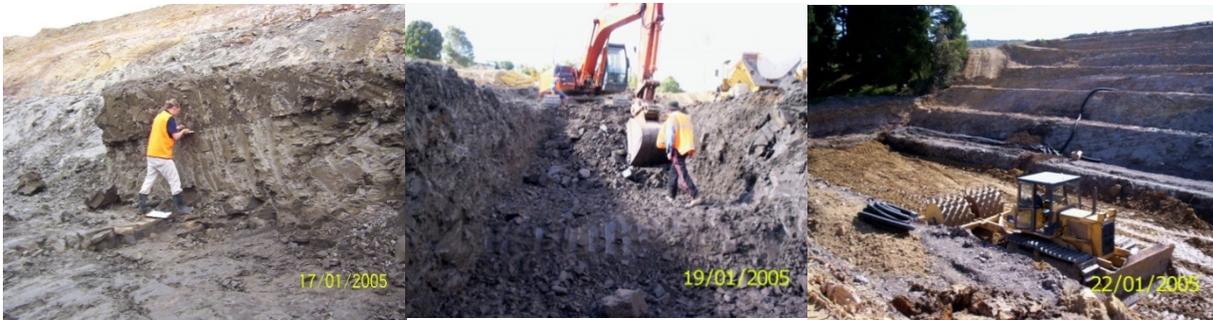
Figure 8. Photographs 1, 2 and 3: Shear Key Excavation and Compaction of Engineer Certified Filling

With all such excavation work (see Figure 8) there is a risk of batter collapse or instability. Careful consideration was given to the stability of all temporary batters during shear key construction and benching and drainage works.

Shear keys constructed range between 10 and 20 metre's wide (base of excavation) and extend at least 2 metres into rock. The base of the shear keys should extend well below any pre-existing failure surfaces with side slopes formed no steeper than 1(v):1(h).

Full height drainage blankets comprising SAP 50 (i.e. self-filtering) drainage material and 160mm diameter Hiway grade Novaflo draincoils were placed against the rear face of each shear key to intercept and collect all groundwater. This material was also wrapped in suitable filter cloth (eg Bidim A14 or Terram 1000). Depending upon ground conditions exposed in the shear key excavations, rear face drainage may be constructed in "hit and miss" sections.

Upslope of the shear keys, additional drainage was required at the toe of all cut benches prior to filling. Backfilling of the shear keys should comprise compacted Engineer certified filling placed in accordance with the earthworks specification outlined in the sites Geotechnical Investigation Report.

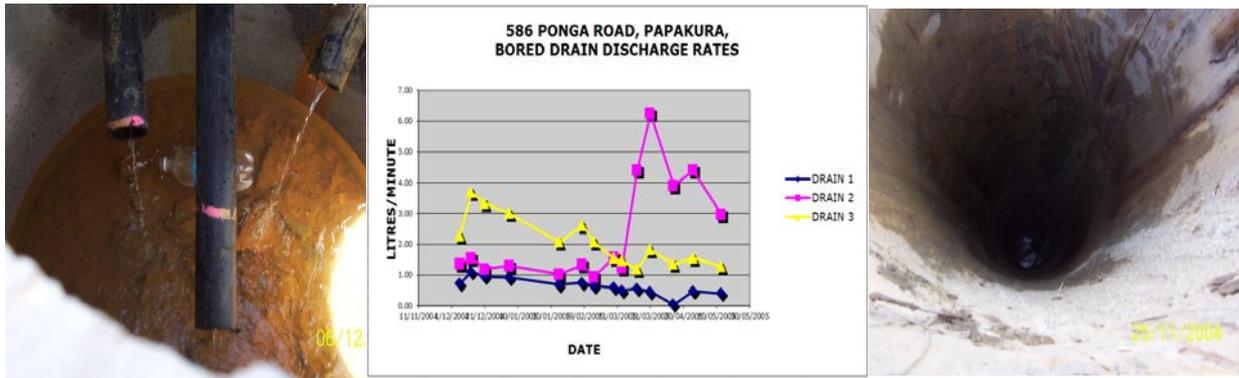
Figure 9: Bored Subsoil Drainage Discharge Manhole, Discharge Data and Example Drainage Well.

In addition to the above, pressure relief wells were required to further relieve pore water pressures within the Waikato Coal Measures (Ponga Rd development – see Figure 9). The locations of the wells were surveyed and recorded within the as-built plans and Geotechnical Completion Reports.

A series of bored drains in a fan configuration were installed under the shear key within the Ponga Road development to intercept artesian groundwater at approximately 11m bgl to reduce pore water pressure and to help maintain adequate factors of safety.

The 100mm diameter drains were slightly inclined above the horizontal and were up to approximately 200 metres long. They extended beneath the shear key and daylight at upslope with a flushing point.

These wells were 600mm diameter bored chambers backfilled with approved scoria, eg. SAP50. Collected groundwater seepage will be discharged via one of the proposed bored drains recommended above.
