Fox Glacier – Geological and geotechnical issues for access

J. P Riding, BSc, MSc

This paper describes the work undertaken on assessment of subsidence of the Terminal Car Park and causeway at Fox Glacier Valley.

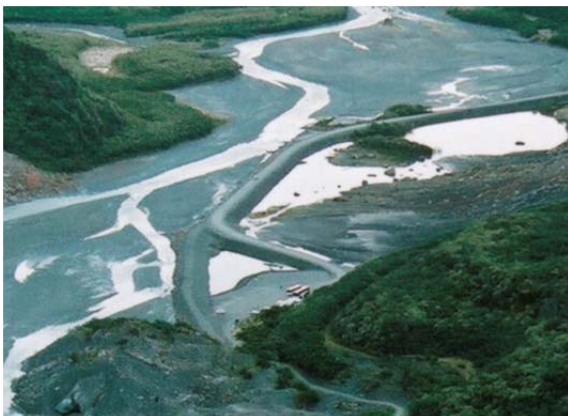
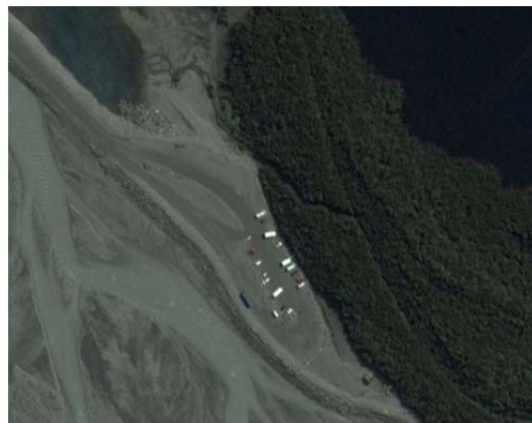
The various car park profiles are characterised by a strong reflector at about 3 m depth. Aerial photographs taken in 1965, 1981 and 1985 show the river flowing around the west of the then present 1960's ice-cored moraine and across what is now the car park area. Figure 3 below compares aerial photographs of the car park as it was in 2004 and 2011. As it can be seen in 2004 the area was a pond and not filled in. The photograph from 2011 shows the car park much as it is today.

Figure 3. Comparison of Terminal Car Park in 2004 and 2011

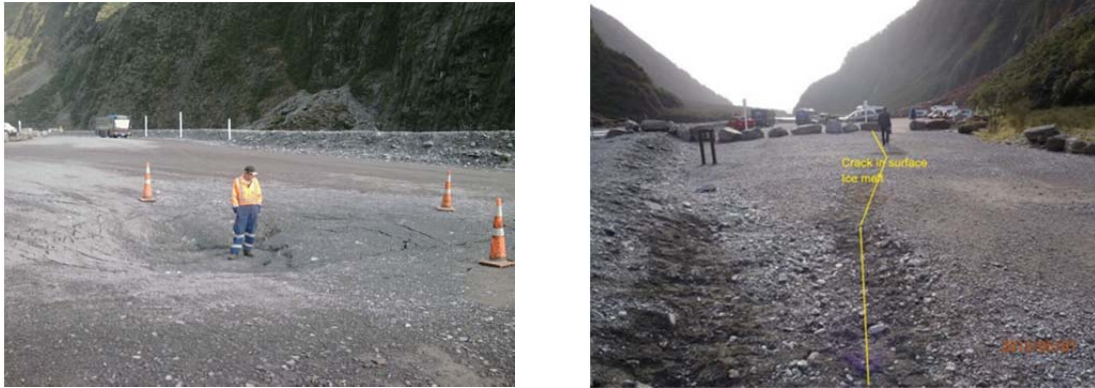
During ongoing site visits and maintenance observed settlement and subsidence of the car park has been noted. This has occurred on a regular basis over the last few years with a couple of incidents between April 2012 and May 2013 that have seen more substantial changes, illustrated by photographs in Figures 4 below.

Figure 4. Photographs of subsidence

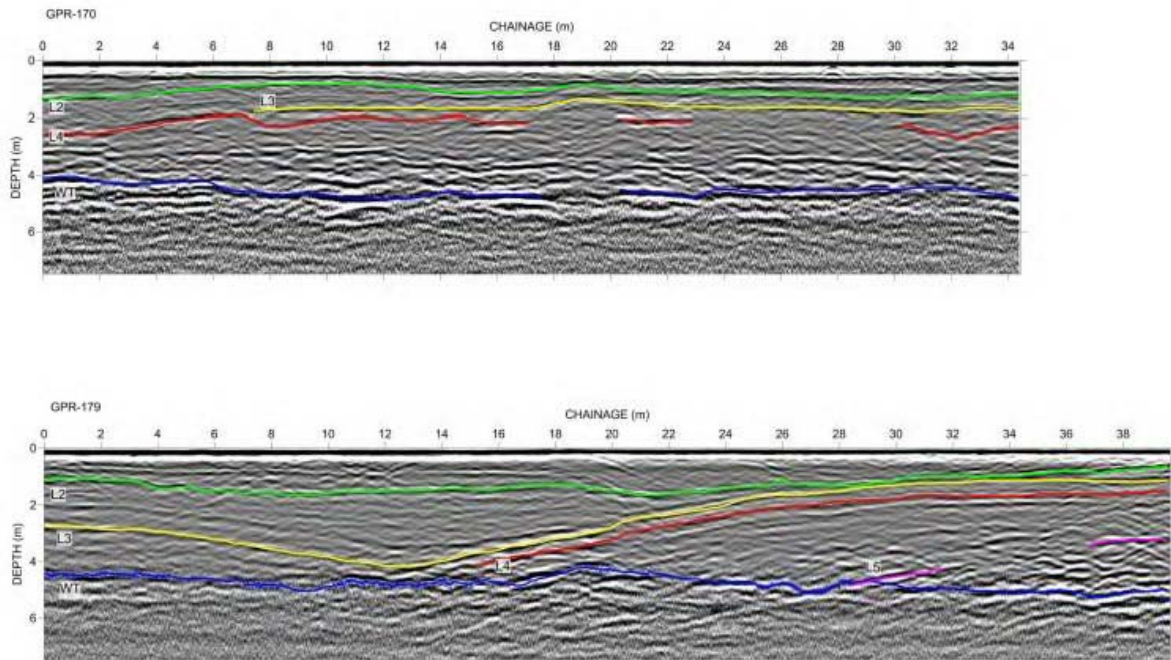
- Subgrade layers across the car park were found to have good lateral continuity across the site and have been shown to dip or subside to the north-west corner of the car park. Subsidence of layers to 4 m depth are shown to have occurred in the north-western area, see Figure 5 and 6, older deposits have been shown to have subsided down to 15 m bgl in the south-eastern area of the car park near the toilet block, Figure 7.

Figure 5. Settlement of car park layers demonstrated by GPR survey.

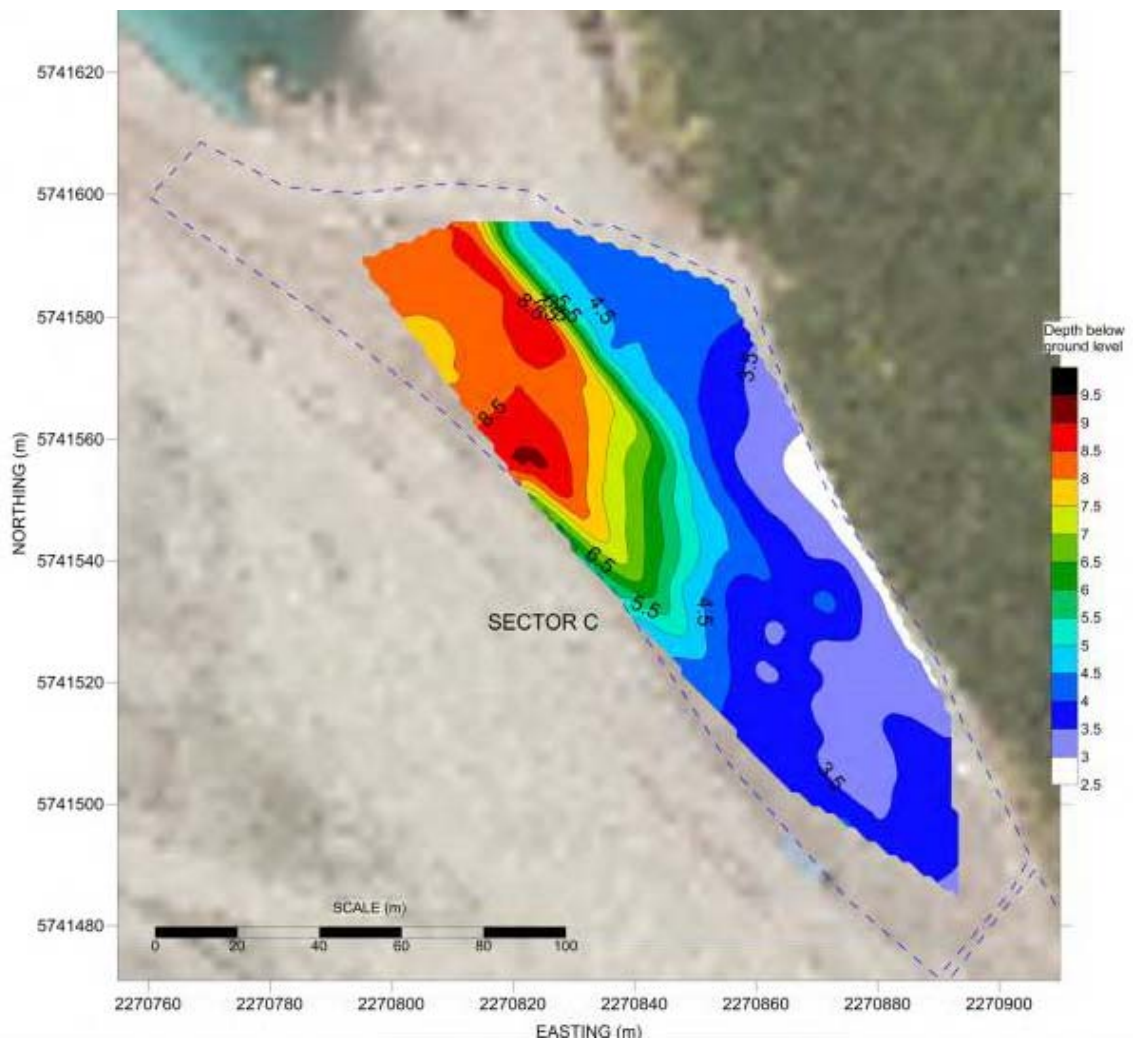
Figure 6. Fill layers showing subsidence depths.

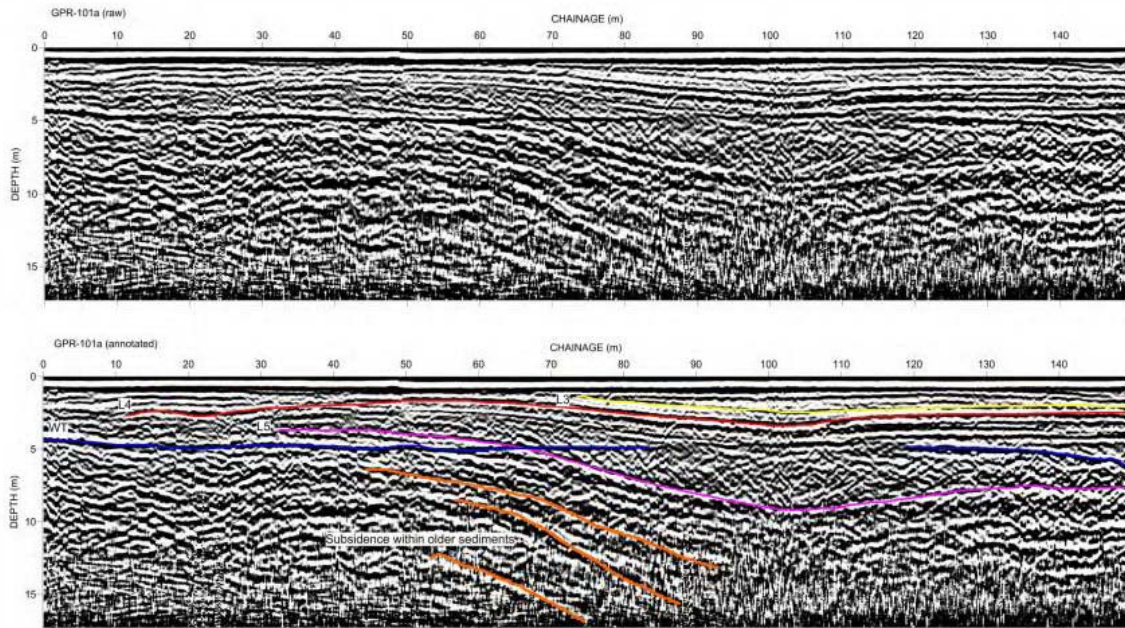
Figure 7. Deep subsidence layers within the Terminal Car Park

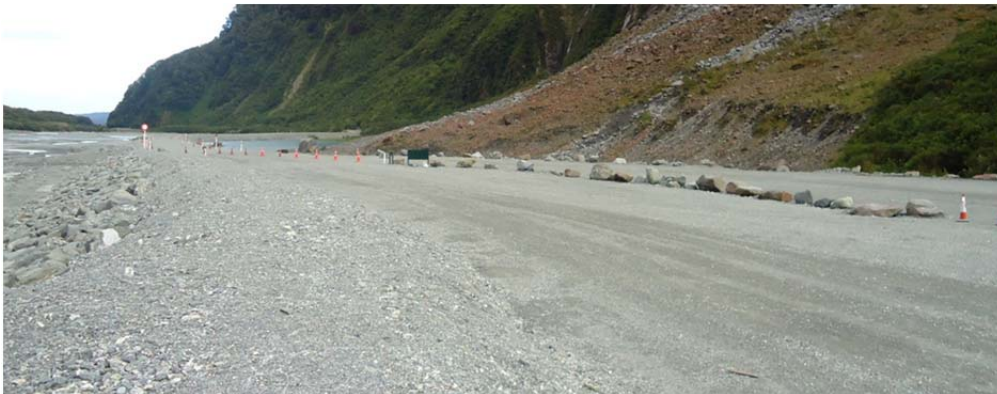
Figure 9. Terminal Car Park 2014 after maintenance works.
