# Performance and stability of Terramesh® reinforced retaining walls during the 2010/2011 Canterbury Earthquakes

Marcus Frank Santo Lazzaro<sup>1</sup>, CPEng MIPENZ

<sup>1</sup> Senior Geotechnical Engineer, Aurecon, Christchurch, New Zealand [marcus.lazzaro@aurecongroup.com](mailto:marcus.lazzaro@aurecongroup.com)

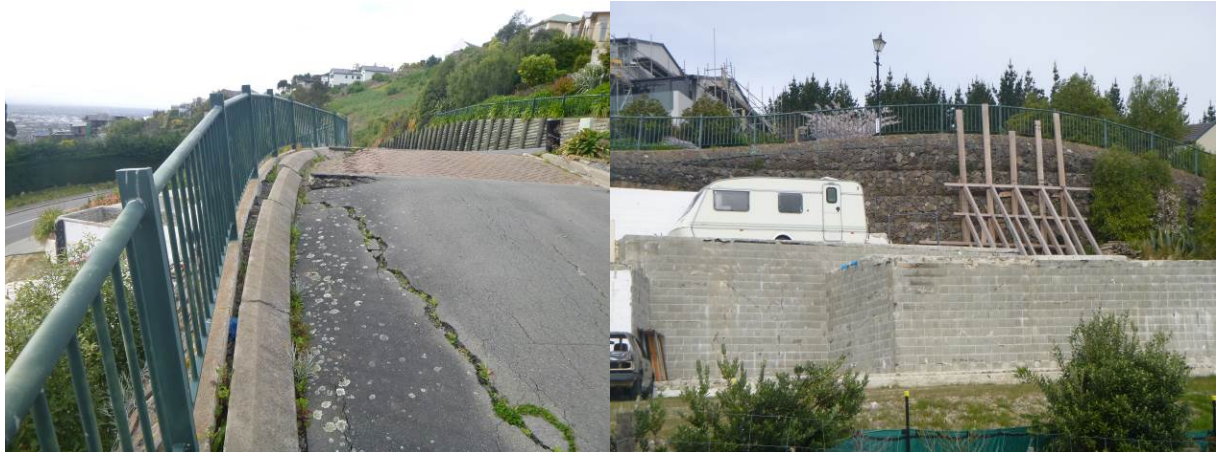
- All observations are of the external damage to the wall. The internal damage was not investigated.
- The damage commonly observed was translation and rotation of the upper row or rows of baskets. The amount of translation or rotation was generally proportional to the overall height of the wall, with up to about 500mm of translation observed in some cases. The bottom row or rows of baskets did not translate forward but often showed signs of bulging.
- The gabion facing baskets often displayed signs of distress including bulging and vertical compression of the baskets.
- The pavement, kerbing and landscaping above the wall was commonly damaged with the formation of tension cracks and separation of kerbing from the pavement.
- The horizontal offset between baskets was reduced and often the walls become vertical.
- Complete failure and rupturing of the gabion baskets was rare.

Figure 5. Damage of mesh gabion wall – Yelverton Place, Huntsbury

The majority of walls assessed were not upgraded with only the pavement, footpath and handrails repaired. In cases where repair of the wall was proposed one of the more cost effective methods for repair was to install ground anchors in the upper portion of the wall to provide resistance to future deformation.

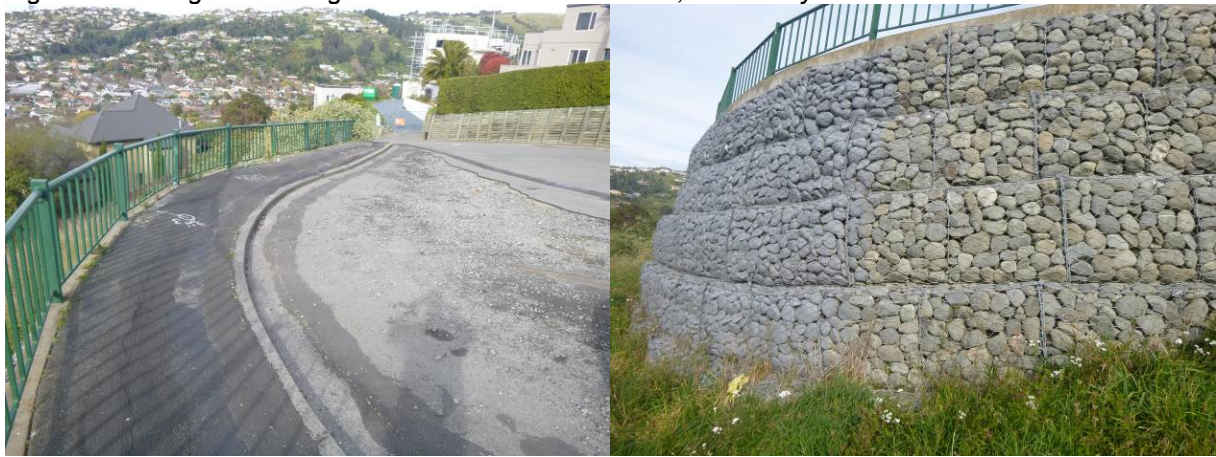
Figure 6. Damage of mesh gabion wall
