The paper was published in the proceedings of the 12th Australia New Zealand Conference on Geomechanics and was edited by Graham Ramsey. The conference was held in Wellington, New Zealand, 22-25 February 2015.

Seismic performance of retaining walls on the Christchurch Port Hills during the 2010/2011 Canterbury Earthquakes

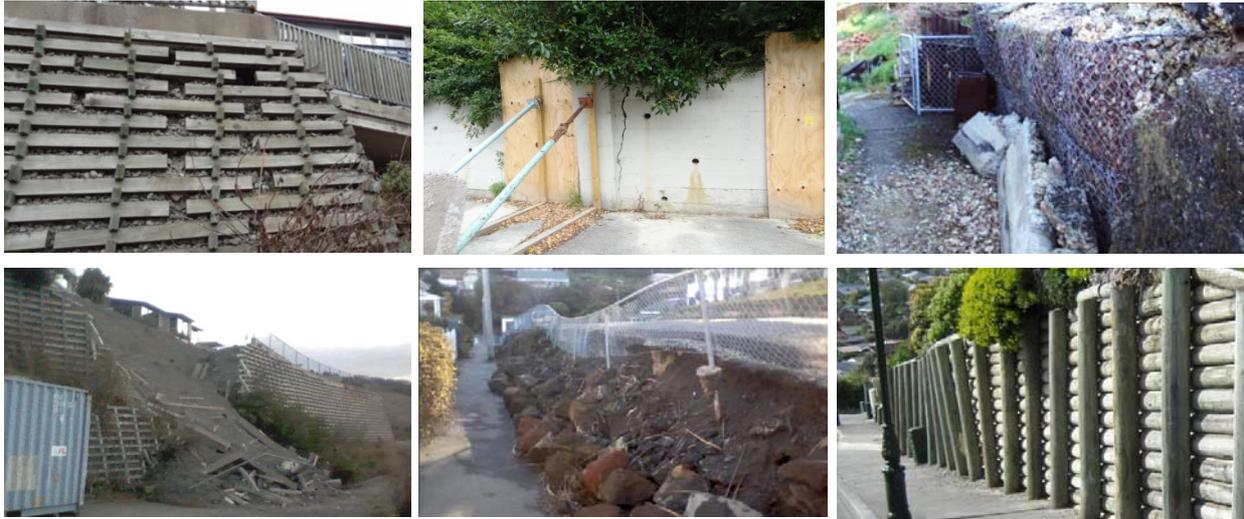
Following the Christchurch earthquake and 13 June earthquakes, CCC retaining walls sustained a wide range of damage and a higher severity was recorded. Table 3 provides a summary of the proportion of wall damage for the severity categories and wall type. Analysis considers a 967 wall data subset of CCC owned walls on the Port Hills. Visual examples of the nature of Major wall damage are provided in Figure 1.

Figure 1. Examples of Major retaining wall earthquake damage
