The paper was published in the proceedings of the 12th Australia New Zealand Conference on Geomechanics and was edited by Graham Ramsey. The conference was held in Wellington, New Zealand, 22-25 February 2015.

Engineering geology and stabilisation of the 2011 landslide which closed SH3 in the Manawatu Gorge, New Zealand

G. T. Hancox¹ and C. D. Robson²

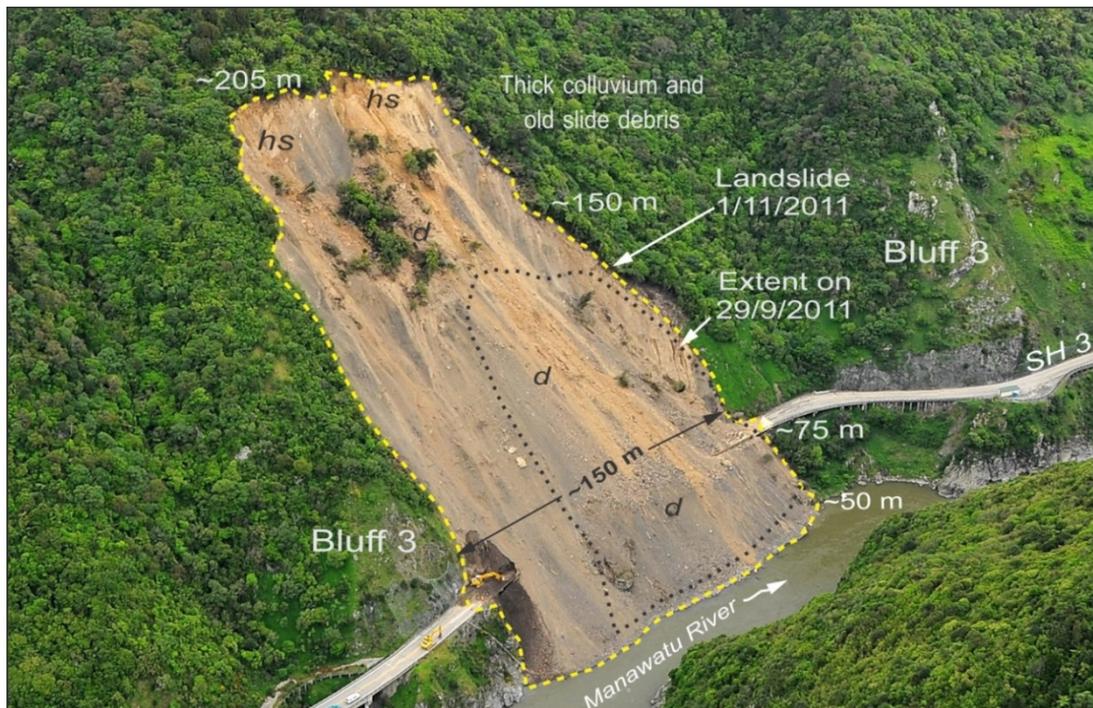
Figure 2. Aerial photo of the 2011 landslide (a rock and debris slide) in the Manawatu Gorge on 1 November 2011 compared to the size of the failure on 29/9/11 (hs – headscarp; d – debris).

The 2011 landslide is the largest slope failure in the Manawatu Gorge in the last 100 years and is possibly the biggest landslide to affect a highway in New Zealand. It mainly involved surficial soils, colluvium, and weathered bedrock, and is most likely to have been initiated by the cutting back and subsequent poor support of the toe of the steep slope above SH3. Continuation of similar methods during efforts to reopen the road after the initial collapse in August 2011 led to the oversteepening and enlargement of the slip face, culminating in the major collapse on 18 October 2011 (Figure 2). The effects of this process on the development of the landslide are discussed below.

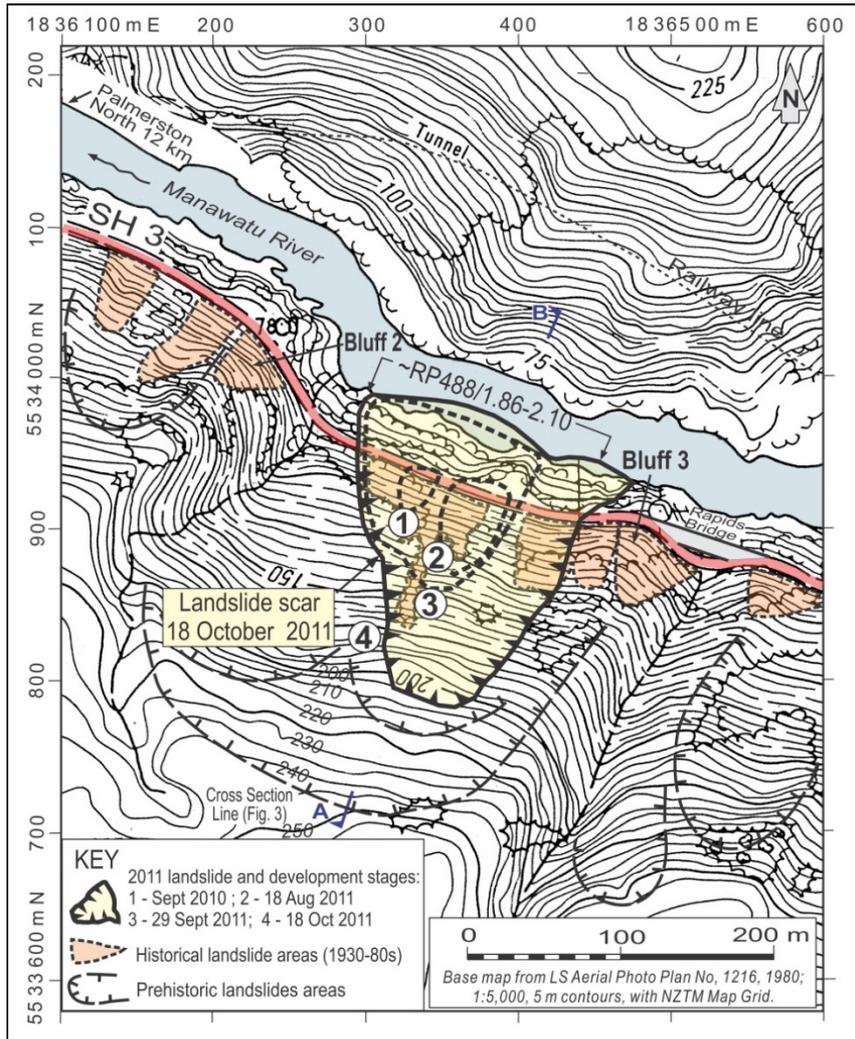
Figure 3. Geomorphic map of the 2011 landslide in the Manawatu Gorge.

- (a) *Location:* The landslide occurred between Bluffs 2 and 3 from RP488/1.86–2.10.
- (b) *History:* Shallow failures at or near the site from 1930 to ~1950 and 1968-1969 (Figure 3).
- (c) *Dimensions:* Height: 130 m; area: 15,000 m²; average thickness: ~10 m; volume: ~150,000 m³; average slope angle: 45–60° (headscarp), 45–35° (above scarp, see Figure 4).
- (d) *Geology:* The bedrock is greywacke sandstone/siltstone and minor red argillite, overlain by 1-10 m of older slide debris, colluvium, and at the top of the slope ancient alluvium capped by surficial loess and top soil.
- (e) *Failure type:* Based on the Varnes Landslide Classification (Hungr et al. 2014) the landslide is classed as a typical rock and debris slide (see Figure 2).

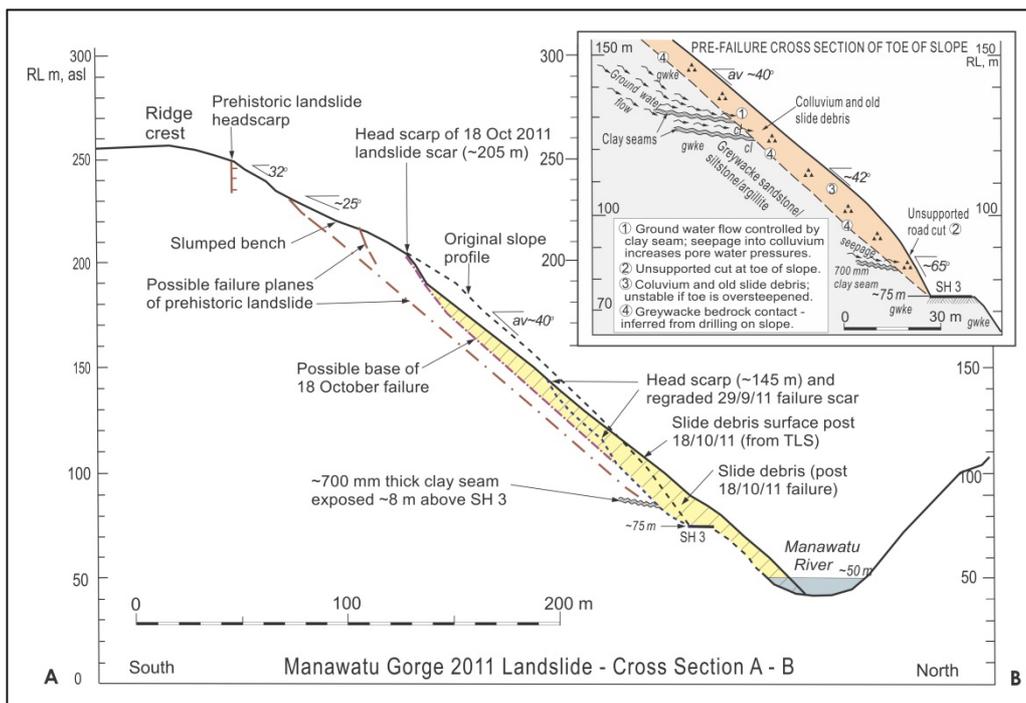
Figure 4. Geological cross section of the 2011 landslide and the slope above.

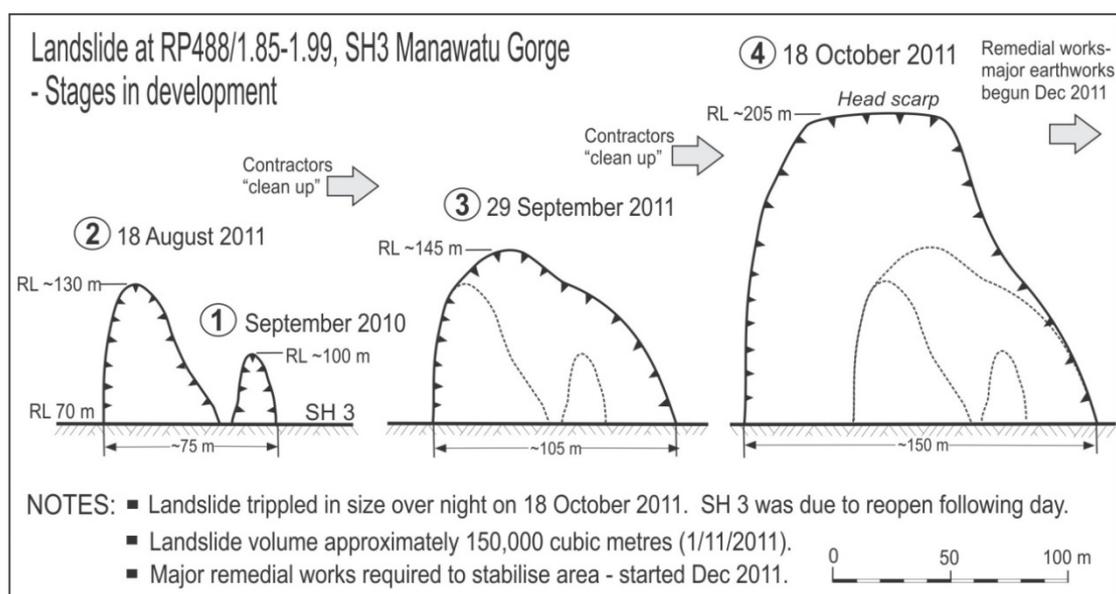
Figure 5. Graphic illustration of stages in the development of the 2011 landslide.

As shown in Figure 5 and 6 the initial failure at the landslide site between Bluffs 2 and 3 was a small rock and debris fall that closed the west-bound lane of SH3 in September 2010 (Stage 1). Debris from this failure was quickly cleared away and the road was reopened. Following a period of higher than usual rainfall on 18 August 2011 a debris fall of $\sim 1000 \text{ m}^3$ occurred about 20 m east of the 2010 collapse (Stage 2). This second failure extended upslope to $\sim 60 \text{ m}$ above road level and increased in size to about 5000 m^3 , at which point it completely blocked both lanes of SH3 (Figure 6).

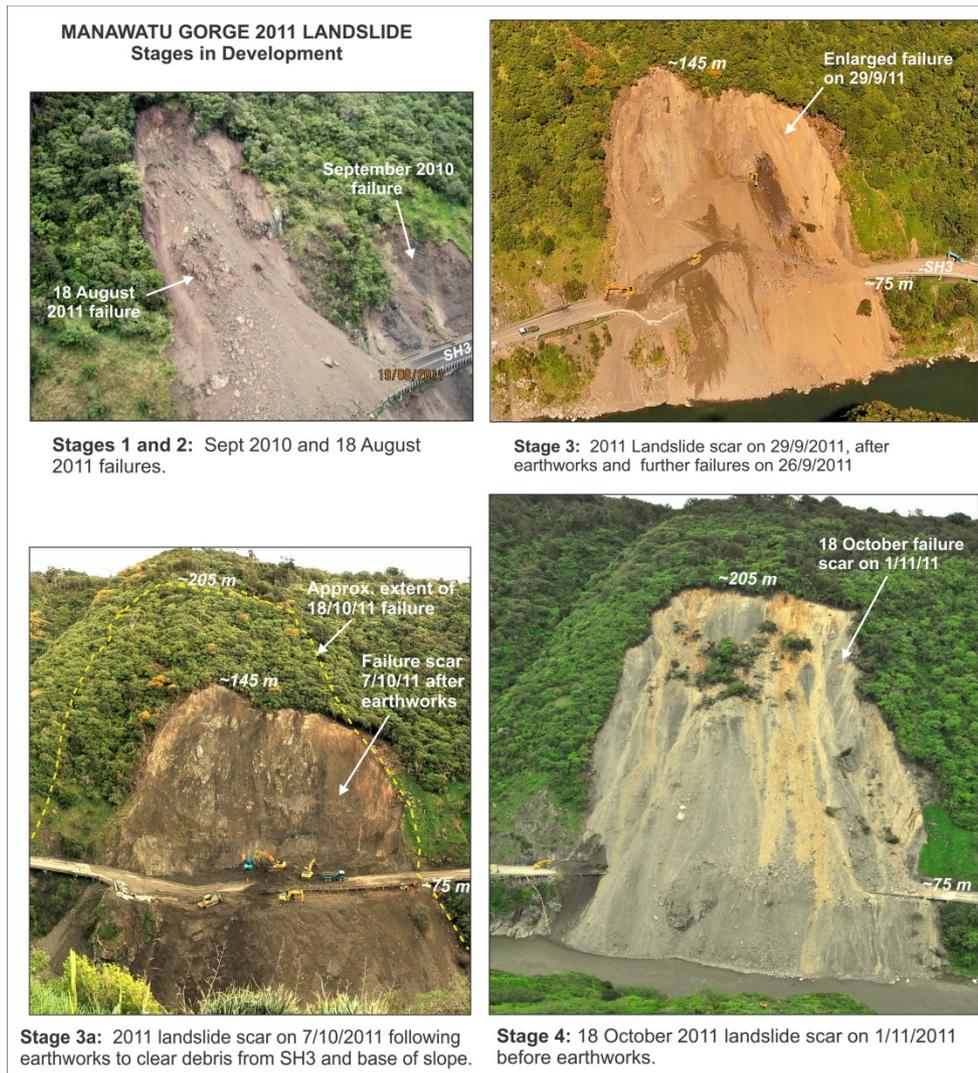
Figure 6. Photos sequence showing the main stages in the development of the 2011 landslide.

The gorge highway road was due to be reopened to traffic when a major collapse occurred early on 18 October 2011, engulfing SH3 over a width of 150 m and sending about 150,000 m³ of rock and soil tumbling down the slope into the river (Stage 4, Figure 6). The area of the landslide tripled overnight and the headscarp regressed to about 130 m above road level (RL205 m). Fortunately nobody was harmed as the road was closed. A hill-shaded aerial and terrestrial (TLS) LiDAR image shows the extent of the failure and other geomorphic features on the slope on 1 November 2011 (Figure 7).

- (e) The methods used by roading contractors to clear slide debris from SH3 involved cutting back the toe of the failure site to form a debris 'catch area' alongside the highway. As shown in Figure 6 this process undercut and is likely to have further destabilised the head of the landslide and the slope above, making it more vulnerable to collapse. Since the slope was already close to the point of failure this is believed to be the main cause of the large collapse on 18 October. As similar 'clean-up' measures were used to clear debris from the road after the failures in August and September 2011, this is also believed to be a reason for the considerable enlargement of the landslide between Stages 2 and 3.

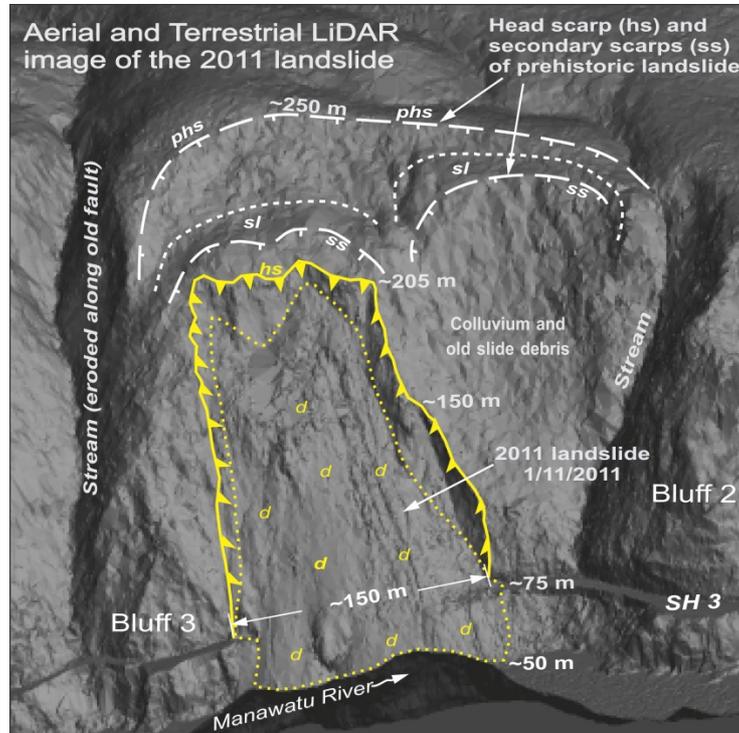
Figure 7. LiDAR and TLS image of the 2011 landslide and prehistoric landslide scarps (hs, ss), and potentially unstable slumped areas (sl), colluvium and old slide debris at the top of the slope.

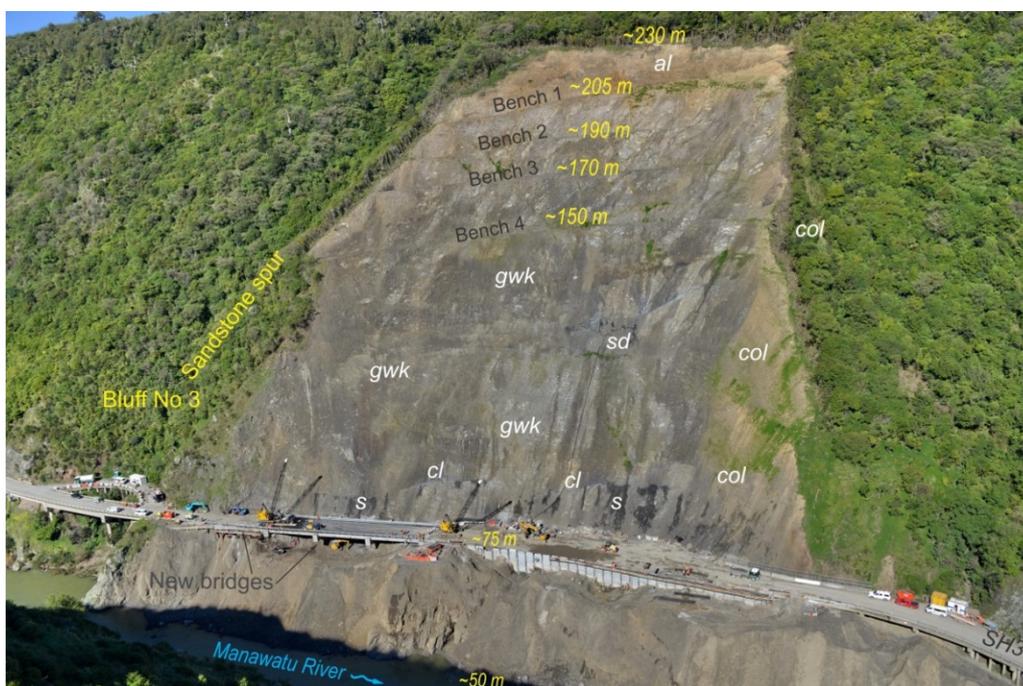
Figure 8. Completed earthworks and benching (1-4) of the 2011 landslide on 24 August 2012 (gwk – greywacke, col – colluvium, cl – clay seam, s – seepage, sd – seepage drainage, al – alluvium).

The remediation earthworks began in December 2011 and were completed down to road level in May 2012. Approximately 370,000 m³ of material was removed from the landslide area. The extent and shape of the earthworks was determined using a digital terrain model based on aerial and terrestrial LiDAR images. The earthworks excavation began near the ridge crest above the landslide and progressed down the slope to road level. All of the excavated soil and rock was pushed over the edge of the benches and removed from the base of the slope. Figure 8 shows the landslide area on 24 August 2012 after the main earthworks and benching had been completed, while the overall shape of the earthworks benches and material removed from the slope is shown in Figure 9.

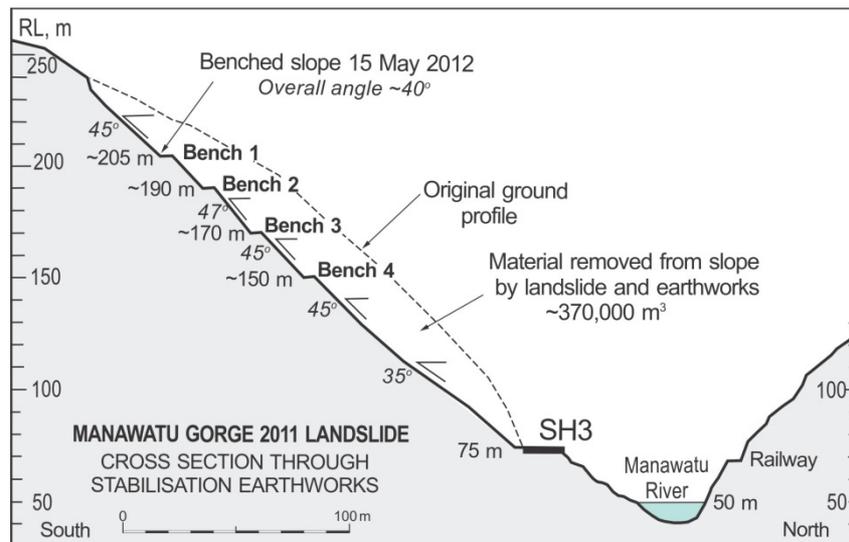
Figure 8. Section showing the shape of the completed earthworks in May 2012.

Once the earthworks and four benches were completed (Figure 9) the highway bridges damaged by the landslide were rebuilt, ground water seepages controlled, and rock fall control measures were installed on the slip face. Geovert were commissioned directly by NZTA for the installation of slope drainage holes, Geobrugg Deltax mesh drape over the eastern part of the slip face, a 500kJ Geobrugg rock fall attenuator fence, and grouted rock anchors with steel waling beams to stabilise the western colluvial slope. These measures are described in detail elsewhere by Avery and Bourke (2012).
