The paper was published in the proceedings of the 12th Australia New Zealand Conference on Geomechanics and was edited by Graham Ramsey. The conference was held in Wellington, New Zealand, 22-25 February 2015.

Rock, rumble and roll: DoC high country hut hazard assessment procedures

P.J. Wopereis¹ BSc, K.M. O'Rourke² CPEng and K. Forbes³

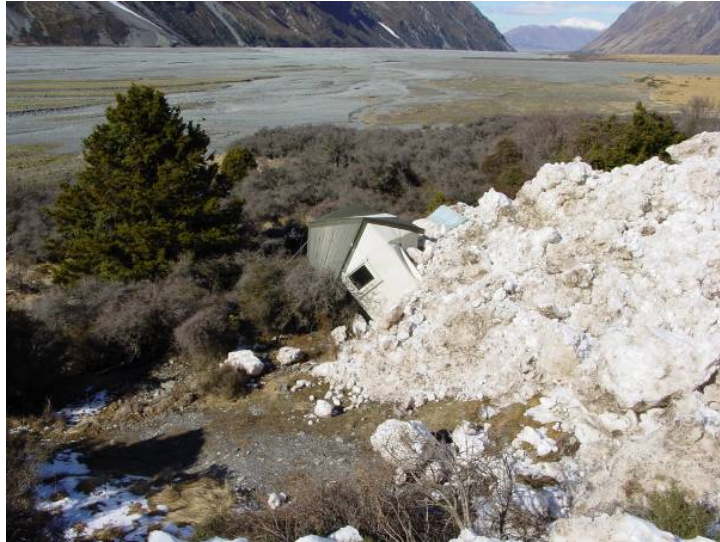
Hut destroyed by avalanche. Figure 1 captures the extent of avalanche and the impact on the hut.

Figure 1. Finlay Face Hut, Havelock River – Photo DOC Raukapuka

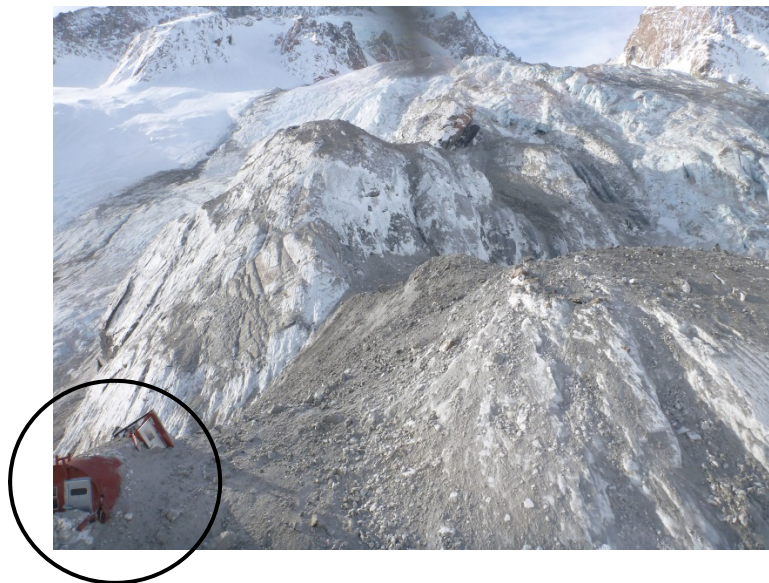
A large rockfall from the South Ridge of Mt Cook enveloped Gardiner Hut with debris, destroyed the toilet on the upslope side of the hut and pushed the hut off its foundations. Figure 2 presents the view eastwards up the Noeline Glacier of the rockfall debris enveloping the hut in the lower left corner of the photograph.

Figure 2. Gardiner Hut rockfall landslide 2014

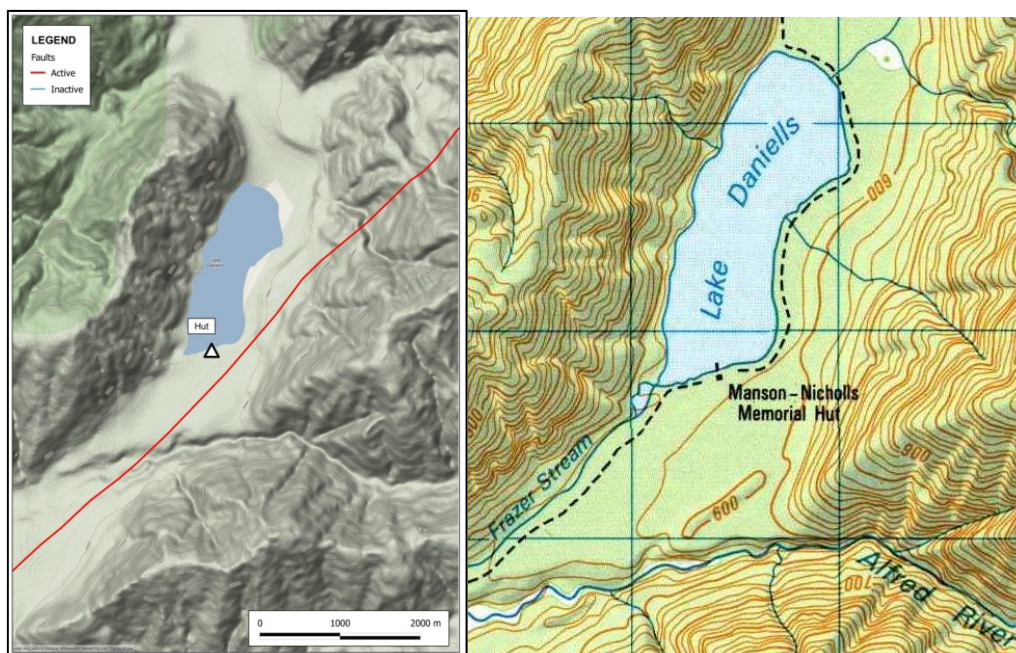
The Alpine Fault has been mapped by GNS Science as being located some 300m southeast of the hut site. The fault is active and severe ground shaking would occur when it next ruptures. The Alpine Fault last ruptured in the year 1717 and GNS have calculated that there is a 50% probability that the fault will rupture within the next 100 years with a likely earthquake magnitude of 7.5 – 8.

Figure 3 shows the approximate position of the hut site relative to the Alpine Fault, while the NZ Topo Map M31 gives a general indication of surface topographical contours at the site.

Figure 3. Manson-Nicholls Hut GNS Active Fault Database (left) showing proximity of Alpine Fault to Hut site. NZ Topo Map M31 (right)
