Foundation Drainage Performance at Gordon Dam

S. GIUDICI

Section Engineer, Structures Section, Hydro-Electric Commission, Tasmania

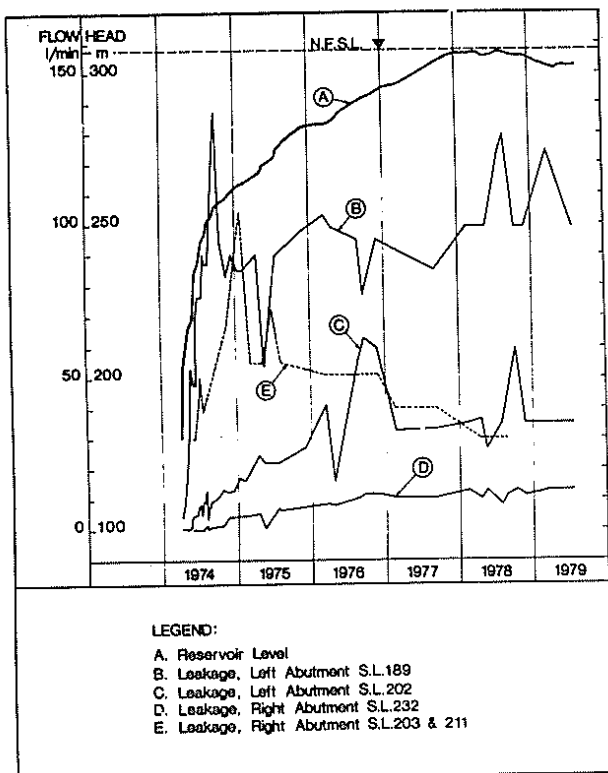
Figure 4 Typical leakage histories

Fig. 4 gives a chronological picture of the leakage in various parts of the dam since filling of the reservoir began.

It can be seen that leakages have generally increased with lake level and stabilised at the attainment of Full Supply Level. It is also evident that the relative watertightness of each major section of the foundation can be assessed from information such as that presented in Fig. 4 and Fig. 7.

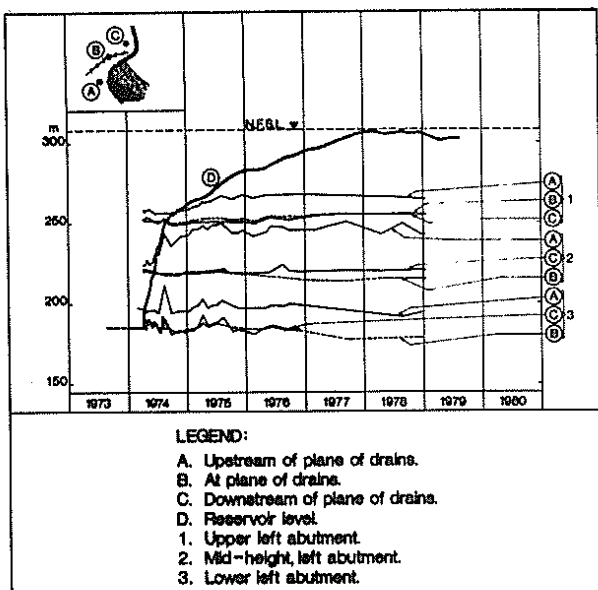
Figure 5 Typical L.A. piezometer records

Fig. 5 shows, for the left abutment, the pressures measured by three groups of piezometers as functions of time. One group is chosen near the bottom of the reservoir, one about a third from the bottom, and one about a third from the top. The labels A, B and C for each group refer to piezometer locations upstream of the drain curtain, at the drain curtain and downstream of the drain curtain respectively. Instruments at locations B and C show an essentially constant and low piezometric head, indicating that the drainage curtain is working and that high pressure water is not present downstream of it. Instruments A initially show a rise of pressure with the lake rise and then a generally constant pressure as the rate of rise of the lake has decreased. This accords with their

position between the source of head and the drainage curtain. The pattern is similar to that of data presented by Casagrande (1961).

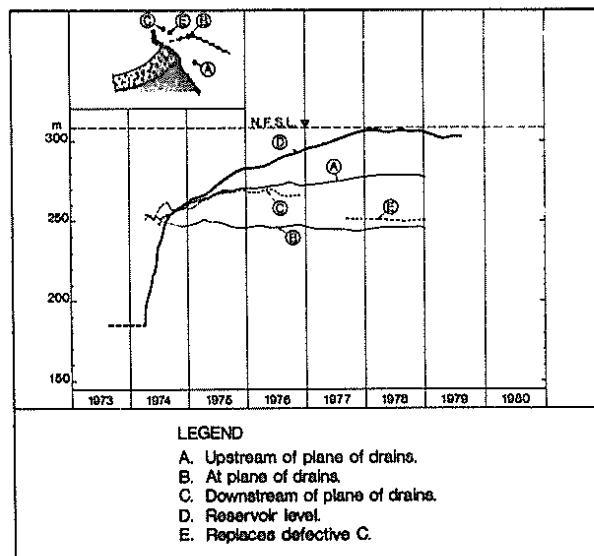
Figure 6 Right abutment piezometer data

For the right abutment, Fig. 6 shows a similar plot using the one set of piezometers initially installed, together with a replacement for a defective instrument.

At the drainage curtain, the piezometric head remained constant and low as the lake was rising, but at the instrument downstream of the curtain a pressure indication almost equal to that of the upstream instrument was consistently presented. Since there was no firm reason to disregard the instrument, and because the lack of instruments above and below it did not allow us corroborative evidence for or against the existence of a downstream pressure zone, we decided to drill some more holes into the zone in question. We could not be sure that a discrete joint was not carrying water past the drain curtain, or that water from above was not being trapped to the height implied.

Only two of the five drainage holes intercepted water sources. One of the three into the drain curtain leaked about 0.5 litre/minute, while one of the downstream holes had a "dripping" leakage too small to measure. Water from the first hole is consistent with supply to the area where high pressure was recorded.

The original piezometer registering the high downstream pressure became defective during drilling operations and this casts some doubt on the validity of its earlier record. Three piezometers were successfully installed and their readings (e.g. E on Fig. 6, which specifically replaces C) show that no high pressures have been recorded since.

During December 1976 and January 1977 eight diamond drill holes were placed in the right abutment, collared at the entrance to the drainage gallery at S.L. 231.70 m, where sufficient room for siting the drilling rig existed. Five of the holes were meant to augment the drainage, three being in the drain curtain plane and two approximately 10 m downstream of the drain curtain. Their orientation was chosen to intersect possible water bearing joints. The three remaining holes were positioned for installing piezometers to give a vertical coverage of about 35 m (between S.L. 225 m and 260 m) at a position 15 m downstream of the drain curtain.

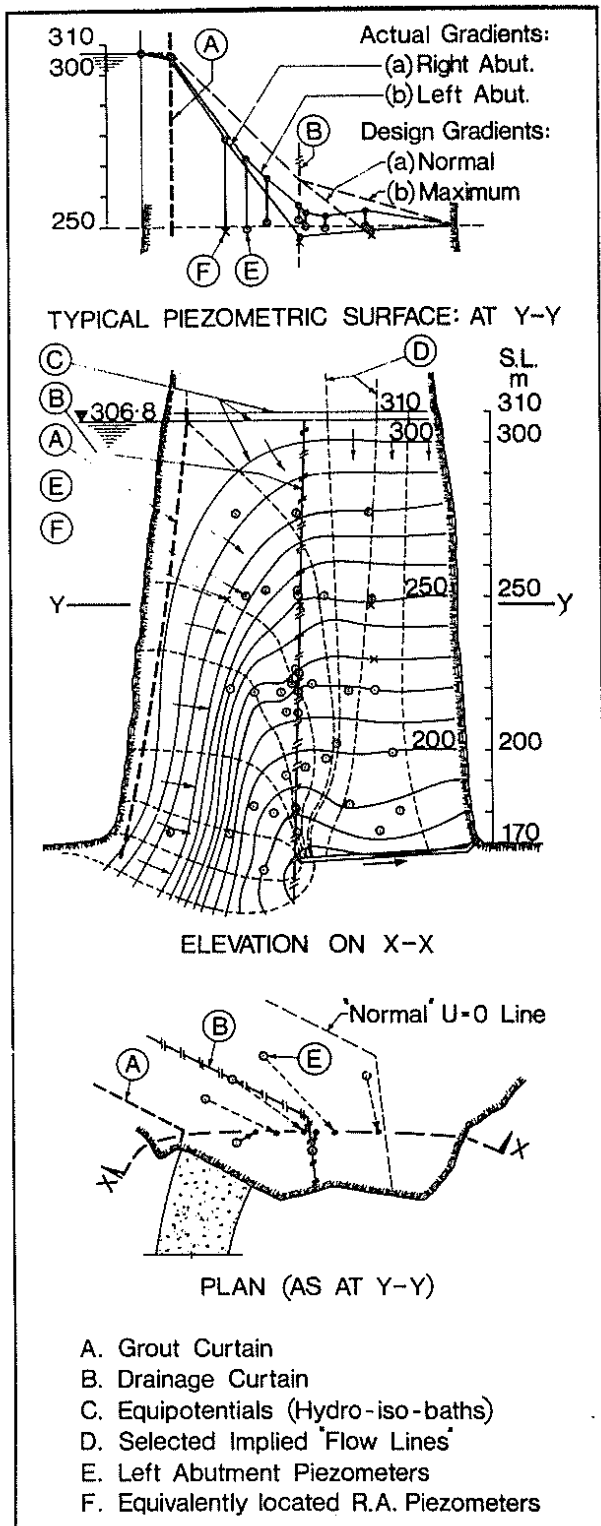
Figure 7 Record of all 40 piezometers, 29-8-78

Of the 34 piezometers initially installed, 32 are still operational and 8 additional instruments (see 4.4.2 and 4.4.3) have been installed. Generally speaking, the pore pressure picture they indicate for the abutments and base is quite clear and confirms that the pore pressure assumptions made in design are on the safe side both in magnitude of pressure and in extent of foundation under such pressure (Fig. 7).

The elevation in Fig. 7 is a projection on to a vertical plane of a curved and sloping section through either abutment and the base just behind the arch contact.

The piezometers are projected, in accordance with their positions in the flow path, on to contours of the surface at their respective installation levels (see plan view in Fig. 7). It can be seen that the drainage curtain is holding the piezometric head below the maximum limits assumed in design for abutment stability analyses. These limits are indicated in Fig. 1 and Fig. 7. Since there is no firm measure of the negative head near a negative reading piezometer, the equipotentials have been located as if such piezometers were reading zero excess pressure.

The pattern of the dotted lines drawn at right angles to the equipotentials gives a general impression of the effect of the drainage curtain on abutment ground water movement.

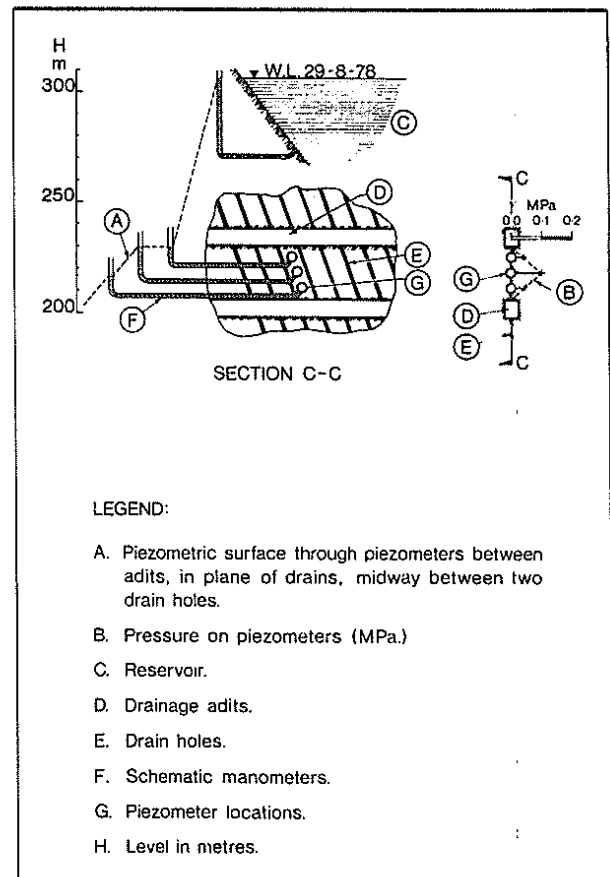
Figure 8 Pore pressures between drains

There was some discussion at the design stage of an appropriate drain spacing. The observed values of pore pressure plotted in Fig. 8 as curve B (i.e. 0.041, 0.105, 0.043 MPa) are well below their "0.3 h" design equivalents (0.24, 0.26, 0.28 MPa). This indicates that the inter-drain pressures are adequately controlled with the chosen 4 m spacing for the left abutment, giving a fair margin for the effects of occasional blockages. The influence of the proximity to the adits is clearly shown.
