Copeton Dam Spillway -- Geological Investigations and Performance

SUMMARY The geological investigations undertaken in connection with the design and construction of Copeton Dam spillway are described, together with the factors influencing the spillway location and type of structure finally constructed. Following two minor discharges through the spillway extensive scour occurred in the discharge area, which necessitated additional geological and engineering investigations including stress measurements and resulted in remedial and additional construction work being performed at a total cost of \$1.3M. The fundamental cause of the problem was found to be the occurrence of high horizontal stresses of up to 20 MPa in the rock over this area. The mechanism of spillway scour here encountered is thought to be unique.

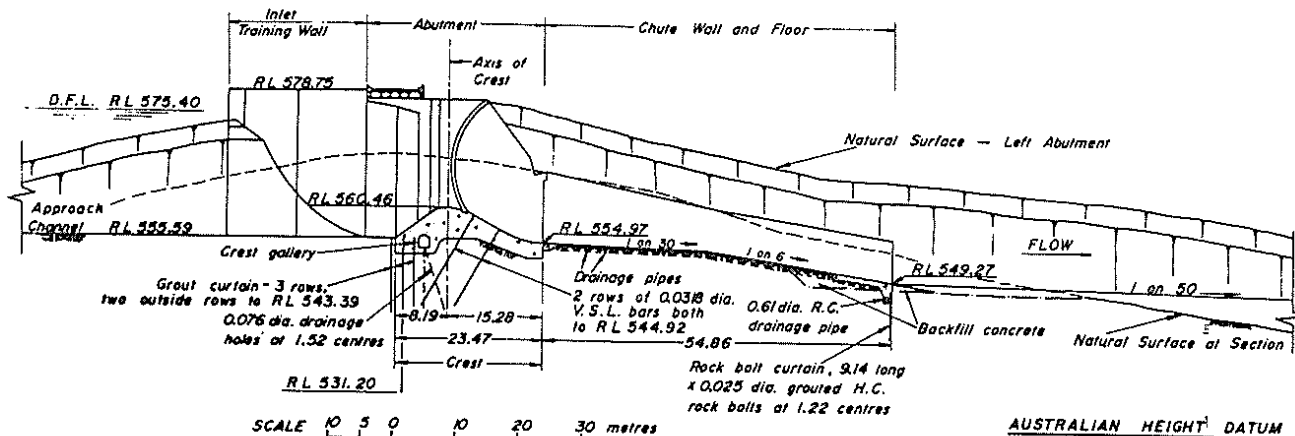
Figure 2 Adopted Spillway Design

with moderately spaced joints and were not inspected using the borehole TV apparatus. The spillway design finally adopted is shown in Fig. 2, the concrete units and the gates being constructed under two separate contracts.

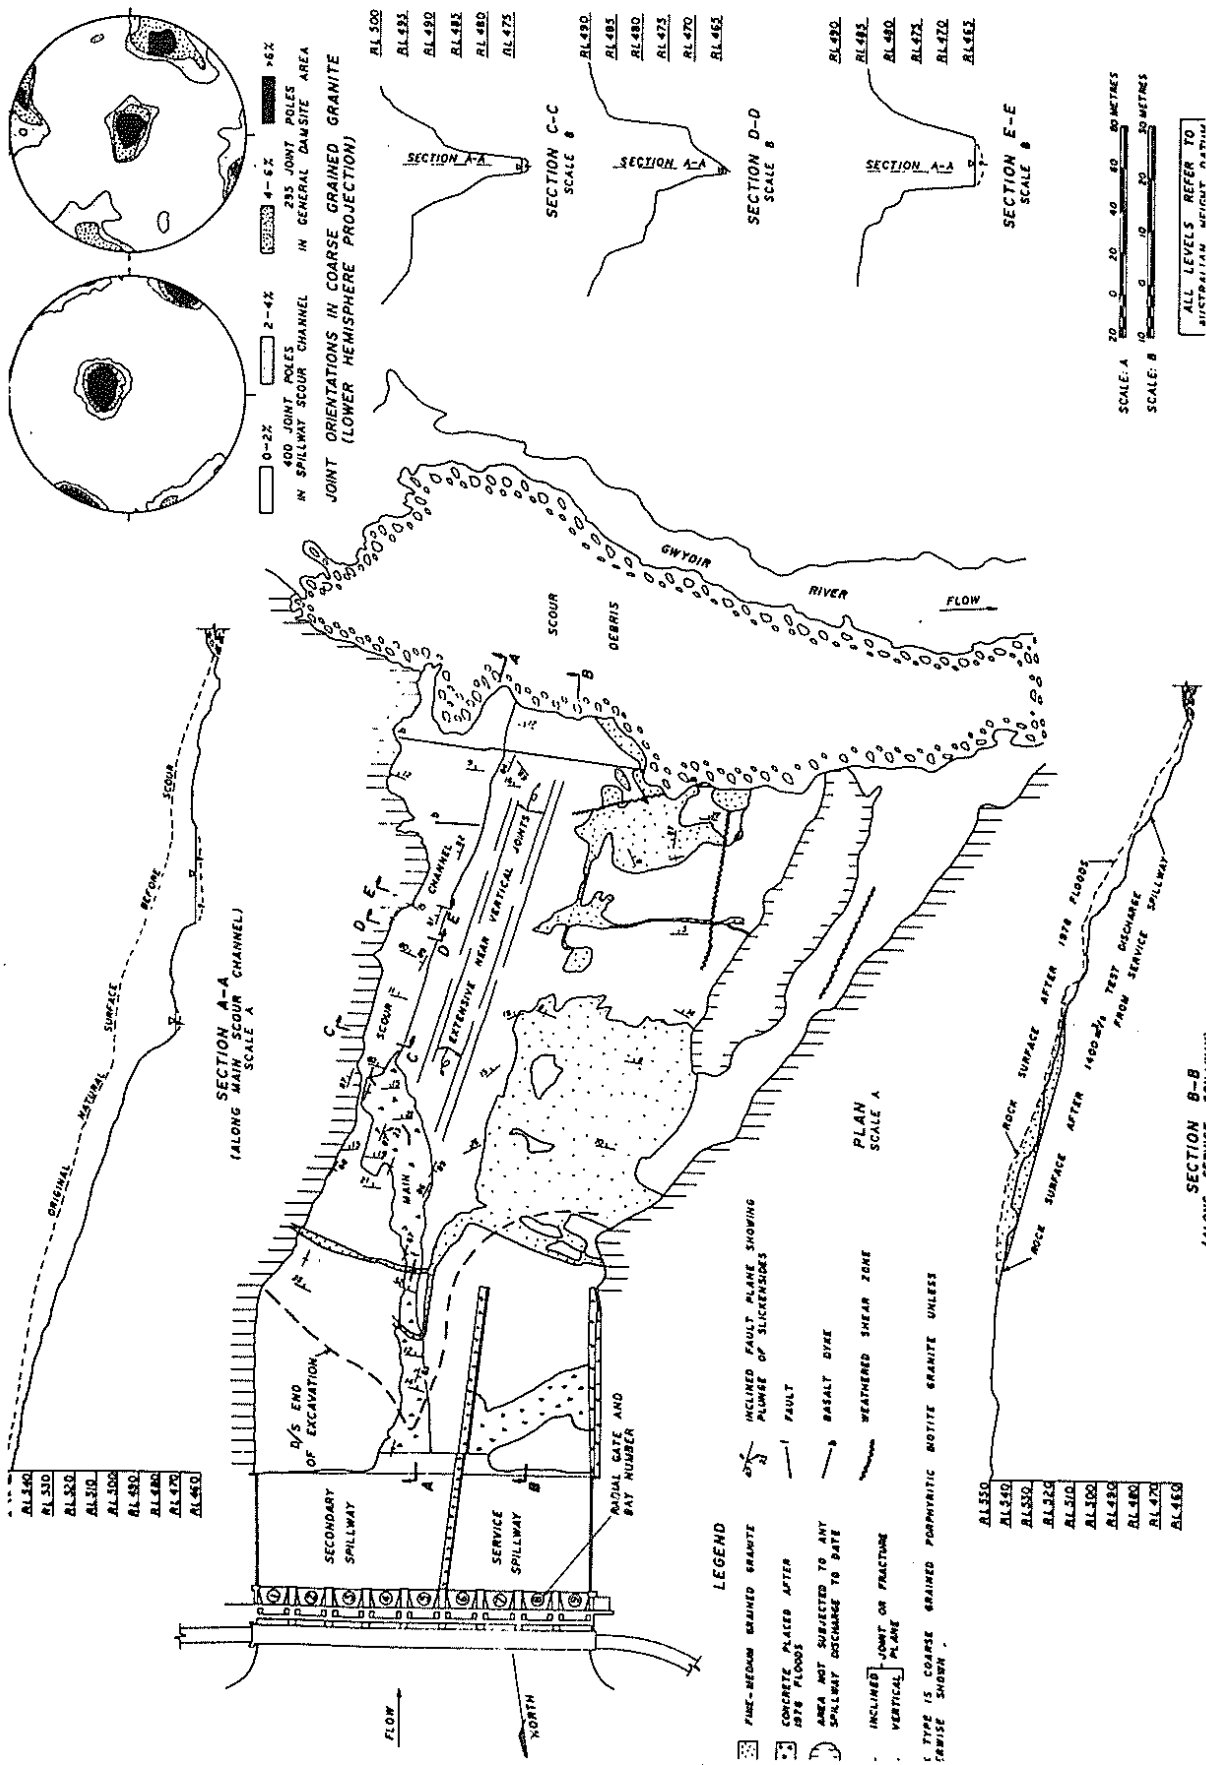
Figure 3 Copeton Spillway - Geological Plan and Sections.

The main scour channel appeared to owe its formation to a previously unrecorded mechanism of stress related scour (the removal of slabs of rock which had failed by upward buckling under high, horizontal in-situ stress). This scour mechanism had two unusual characteristics which indicated the need for some form of remedial works to ensure the future safe operation of the spillway.

The main scour channel commenced at the centre of the spillway near the end of the concrete chute and progressed downstream, becoming deeper as it did so, along an "en echelon" series of laumontite coated joints and faults. These joints strike slightly oblique to the channel and form its near-vertical side walls. The floor of the scour channel was located almost entirely in unweathered granite and consisted of stress relief fractures dipping downstream at 10° - 30° which were either pre-existing joints or fractures newly formed during the flood. The downstream half of the scour channel followed one major zone of laumontite coated joints and it was here that it attained its greatest depth with two

scour holes up to 30 m deep below the original natural surface. There was every indication that future floods would cause these deep scour holes to migrate upstream towards the spillway chute.

The right hand half of the spillway cut floor had suffered a certain amount of relatively minor scour controlled by weathered, erodible joints (not related to failure under stress). Generally however the granite on this side of the spillway cut was only sparsely jointed and appeared to have a high scour resistance. In particular the laumontite coated joints and faults so common in the main scour channel were almost entirely absent from this side of the spillway cut. Immediately downstream of the right hand half of the spillway cut a flat-lying sill-like body of fine grained granite outcropped. Diamond core drilling showed this fine grained granite to have a maximum thickness of about 10 m and to contain weathered, erodible joints as well as being generally more intensely jointed than the coarse grained granite within the cut immediately upstream.

The scheme of remedial works adopted consisted of constructing a training wall from the pier separating gates 5 and 6 so that the four right hand gates could be operated as a service spillway discharging up to 2800 m³/s and the five left hand gates (including gates 4 and 5 which discharge directly into the scour channel) would then be operated only as an emergency secondary spillway (Fig. 3). The service spillway concept was feasible because of the very massive, sparsely jointed rock present on the right hand side of the spillway excavation. There was thus no possibility of a second scour channel developing which could migrate upstream into the service spillway area and undermine the right hand side of the spillway chute.
