Stabilisation of a Mudstone Derived Colluvium Slope

G. RAMSAY

Design Engineer, Ministry of Works and Development, Wellington, N.Z.

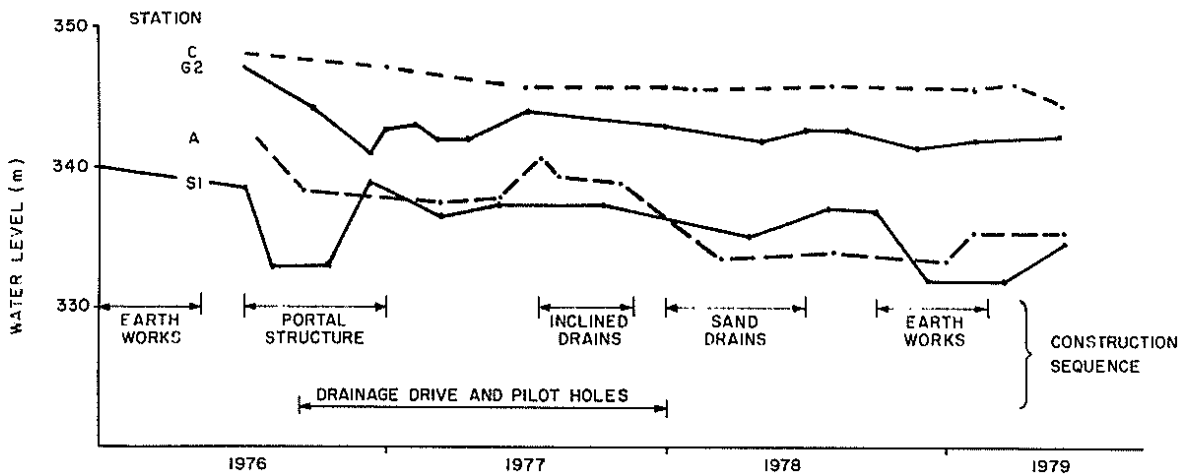
FIG. 2 SELECTED WATER LEVEL RECORDS

Standpipe C which is located outside the area excavated has shown a steady but significant decrease in water pressure since installation. This reduction may result from the effects of surface drainage measures reducing rainfall infiltration.

Stations S1 and G2 located in an area where the interface forms a gully have shown apparent seasonal variations and major reductions related to construction activities and in particular slope excavation. The temporary drop of 6 metres in water level at station S1 in 1976 is associated with successful dewatering of the shafts for the portal structure by the use of adjacent pump shafts.

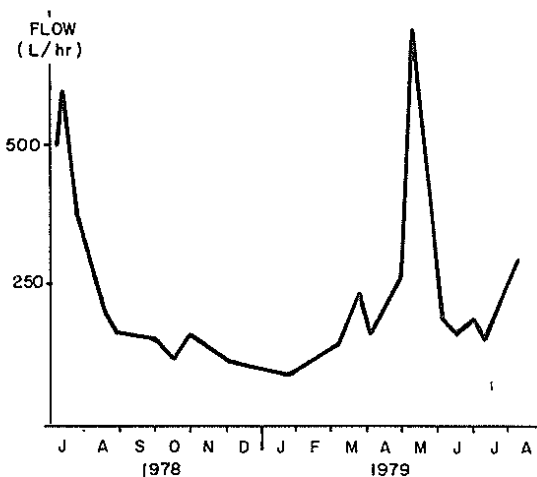
FIG. 3 TOTAL DISCHARGE FROM SAND DRAINS

Observations suggest that the sand drains exhibiting the high flows providing the peaks in Figure 3 have very variable discharge. It is possible that these drains intersect blocky zones and are intercepting recharge water entering the slope through the high permeability blocky zones.

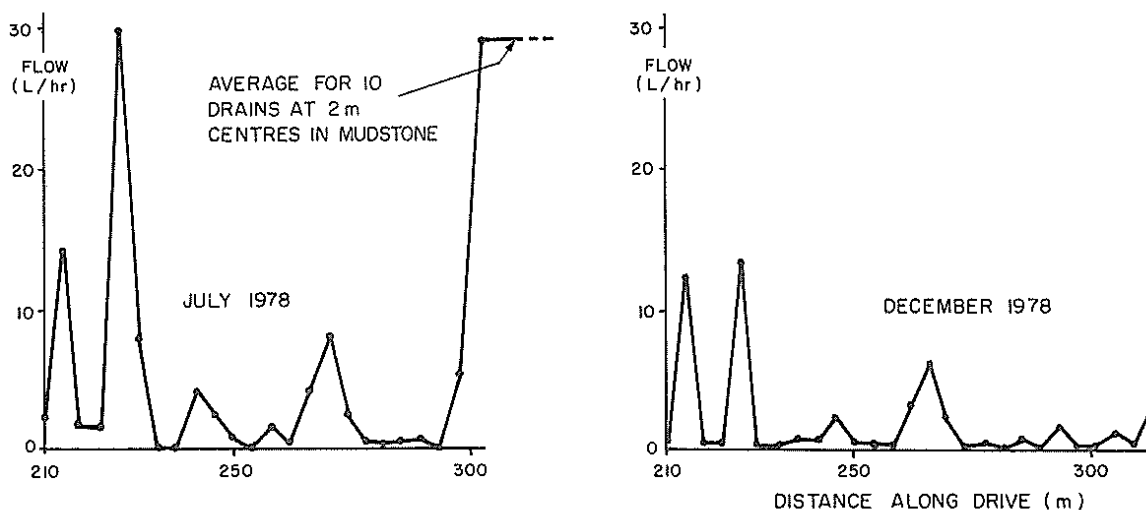
FIG. 4 INDIVIDUAL SAND DRAIN DISCHARGES

The variation in the sand drain discharges suggests that the blocky zones may be localised and that in most of the drains a considerably lower coefficient of permeability would be appropriate.

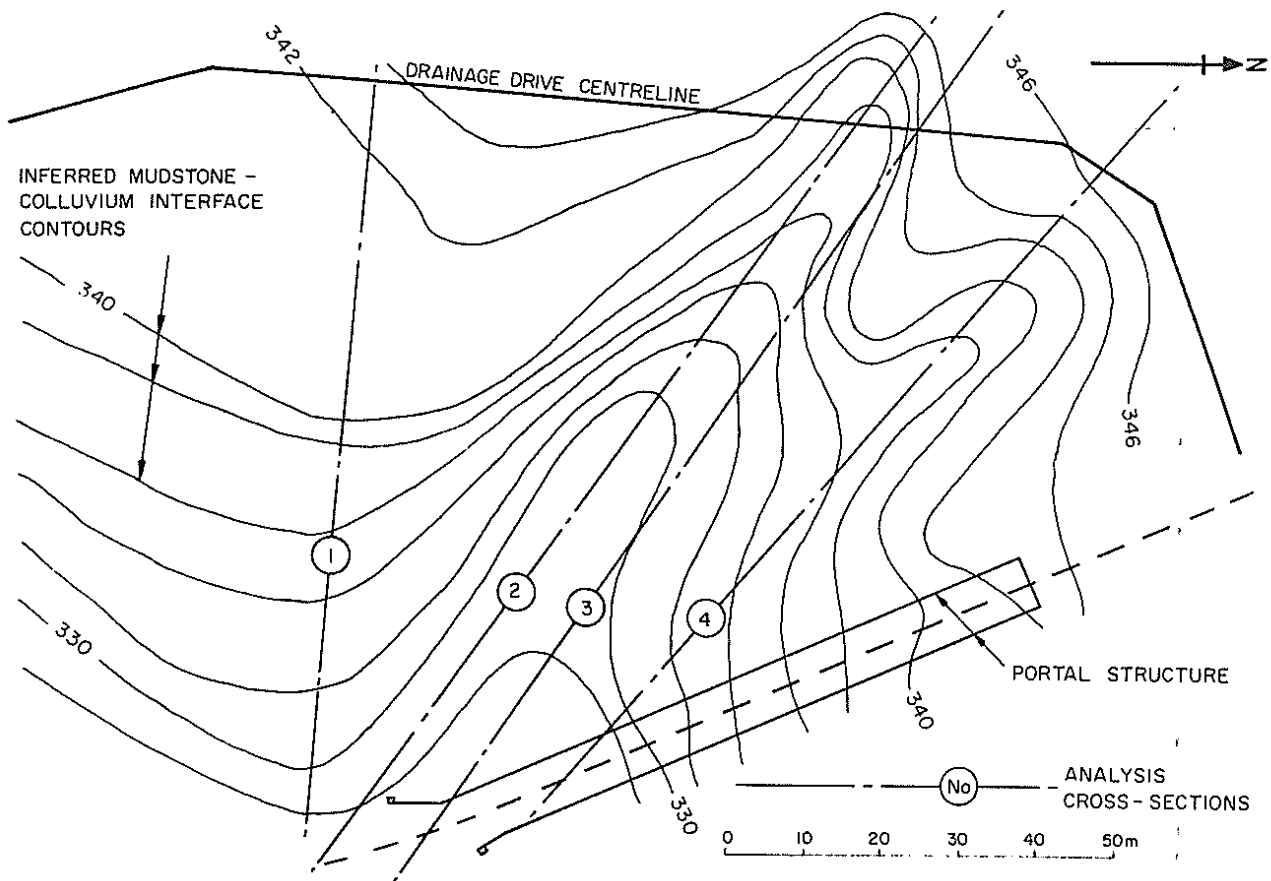
FIG. 5 CONTOURS ON MUDSTONE COLLUVIUM INTERFACE

surface exposed north of the portal structure during the first stage excavation. Figure 5 shows an inferred contour plan of the interface produced from data available at a late stage in construction. A total of 90 spot levels were available and of these 12 are not in agreement with the contours as drawn. It is possible that some of these may indicate further gullies in the interface which could only be confirmed by further extensive drilling. In other cases the discrepancies may result from difficulty in detecting the interface using disturbed NX core.

It is apparent that the interface is complex, gullied, and could not be realistically defined with reasonable pre-design investigations. In this case, the designer had 22 spot levels available of which 4 are possibly inaccurate and misleading for the reasons given above.

Further, design cross-sections derived on the assumption of a reasonably planar interface would provide an inaccurate model. The cross-sections analysed in the original design incorporated soil profiles from boreholes off set up to 30 m from the cross-sections. Some of the cross-sections did not show gullies in the interface apparent in Figure 5.

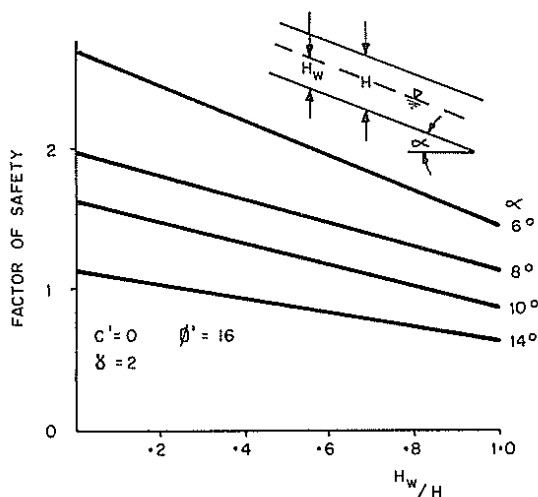
FIG.6 STABILITY OF INFINITE SLOPE

of Figure 6 suggested that if the original design slope profile was retained the stability factors of safety might be unacceptably low. Accordingly a full reanalysis was undertaken.

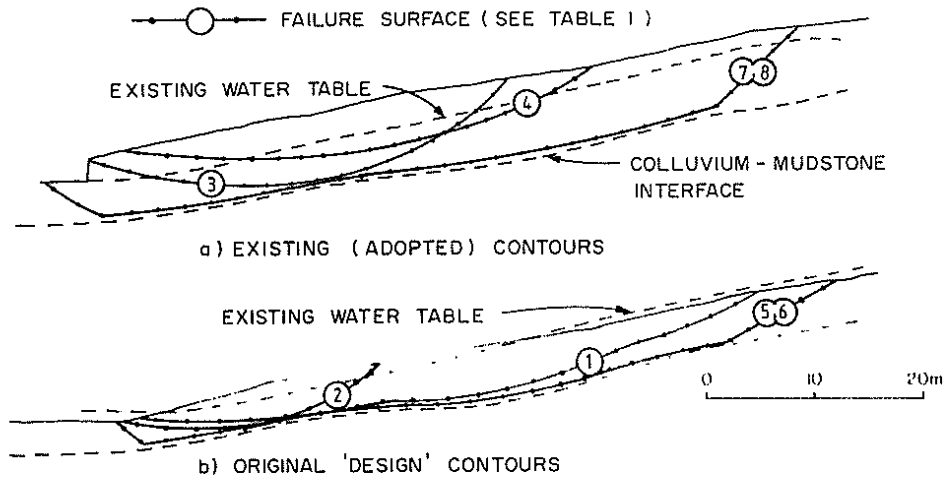
FIG. 7 CRITICAL SURFACES ON SECTION 3

Analysis showed that extending the portal structure by 15 m and thereby reducing the slope excavation above the portal structure resulted in more acceptable factors of safety. Results for analysis on cross-section 3 (shown on Figure 3) are presented in Table 1, the critical failure surfaces for the as designed and proposed modified surface contours being shown on Figure 7.

As shown in Figure 7 the critical circular failure surfaces are different for the short and long term cases.

As a result of the reanalysis the portal structure was extended by 15 metres and the extent of the second stage excavation was reduced.

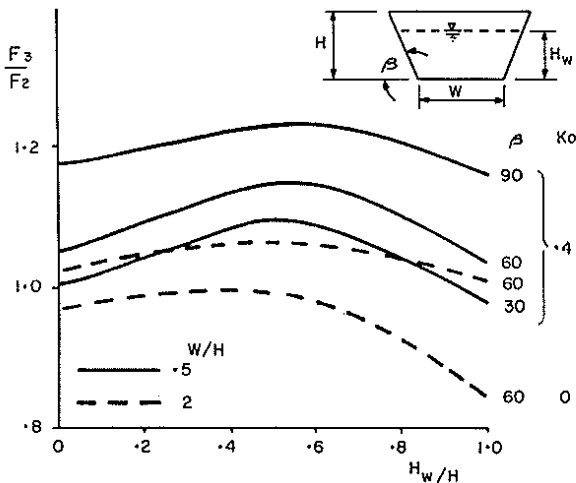
FIG. 8 RATIO OF F.S. FOR INFINITE SLOPE (F₂) AND F.S. FOR INFINITE WEDGE (F₃)

Typical results for a cohesionless material are presented in Figure 8. For the case under consideration the variation between the 2D and 3D factor of safety is not significant.
