Stress Induced Roof Collapses During Construction of the Sydney LPG Storage Cavern

Summary: This paper discusses the experience of the authors with two large failures that occurred in the roof strata of a storage facility for LPG which was being constructed deep below the ground surface in Hawkesbury Sandstone in the Sydney Basin, NSW, Australia.

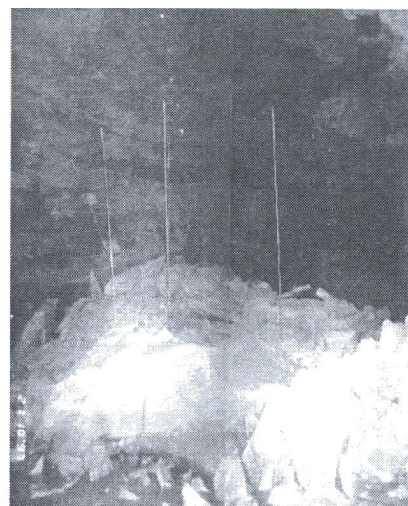
1. The roof collapse debris covered a cavern floor area measuring approximately 12m x 10m and included a number of relatively intact, large sandstone slabs up to 1.5m in thickness.

2. Some rock bolts were observed protruding upwards through the failure mass. These remained complete with bearing plates, nuts and threaded metal cones. However, on most bolts the top ends had pulled out of the shell "gripping" mechanism. Numerous other rock bolts could be seen to be bent and partly buried within the debris. Other bolts were observed protruding from the crown. These protrusions were about 1m in length and all but one was devoid of bearing plates and end fittings.

Figure 3. Roof Collapse in Gallery A showing portion of roof collapse debris and protruding rock bolts.

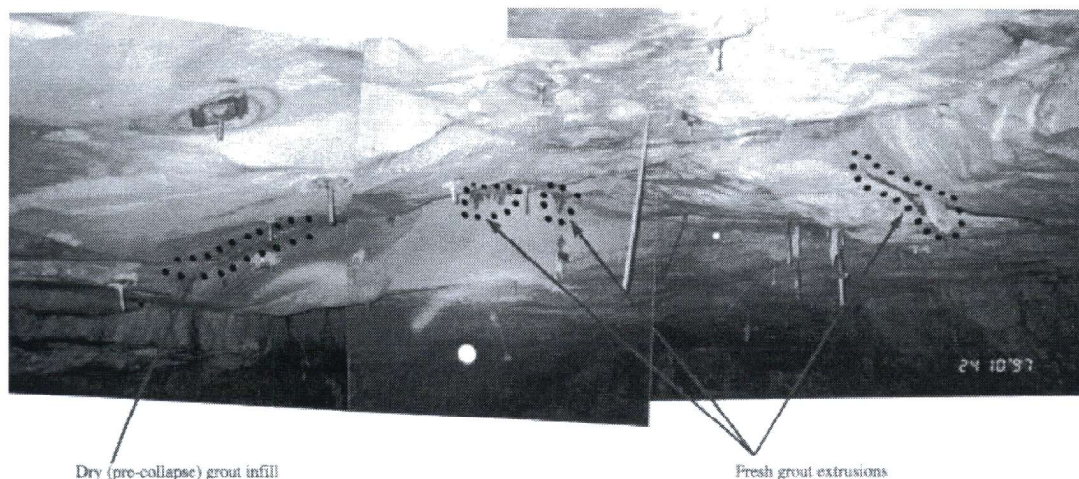
3. Visual observation in open rock bolt holes showed lateral displacements on bedding planes of up to 10mm to 15mm. The direction of movement of lower beds had been towards the centre of the opening. Detailed inspection of the roof also showed striations along the bedding planes consistent with this relative displacement across the beds.

4. Towards the centre of the failure area, zones of compression induced shear failure could be deduced from areas of freshly spalled rock in the roof. At one location in line with the west wall of the pilot heading a "dome" had been formed in the roof as a result of compression induced shear in the roof strata.

5. The surface of the failure area elsewhere comprised gently undulating bedding planes that were characterised by some localised orange-brown iron oxide staining. This surface was generally dry. The outline of the failure area was defined by individual bedding plane exposures which were cutoff by steeply dipping to subvertical, clean, curved to conchoidal fractures that had propagated between bedding planes at different elevations in the roof.
6. Numerous clean, subvertical, wavy fractures were observed to be either aligned with or emanating from drilled blast holes on the side walls of the failure site. Some of these fractures were wavy to curvilinear and parallel with the shape of the excavation between the cavern wall and the pilot heading.
7. Dry, pre-collapse grout (see later) was observed at a number of locations on bedding planes.

Figure 4. Roof Collapse in Gallery A showing failed roof area

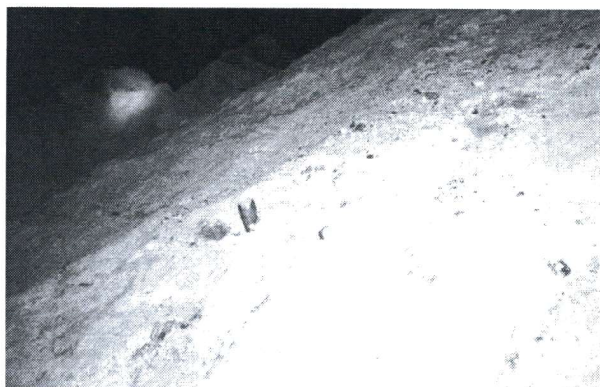
The roof of the failure area was subject to an examination with an 8mm diameter fibre optic endoscopic camera (endoscope) used either in failed and empty rock bolt holes or purpose drilled holes. The conditions observed in these endoscope holes were plotted onto surveyed cavern profiles, onto which geological observations were also mapped. The measurements taken through the centre of the failure zone at chainage 095m are presented on Figure 5.

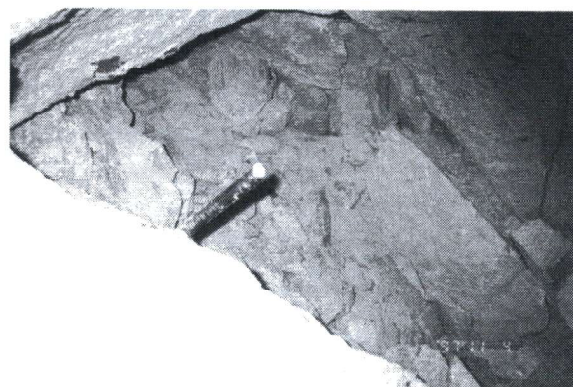
Figure 6. Roof Collapse in Gallery C showing sheared rock bolts in roof collapse debris

The bedrock which fell from the roof comprised part of a bed which had separated from the roof along a bedding plane. Inspection of the failed rock on the floor of the gallery showed that the bolts had been fractured at the location of the bedding plane involving both bending and reduction of the cross-sectional area of the bolt i.e "necking" (Refer to Figure 6). One of the bolts had been fractured across a very short gauge length at the location of the bedding plane while in several others the fracture was located a short distance above the bedding plane in what had previously been the underside of the overlying bed in the roof. The mode of failure was indicative of the bolts having been subject to both shearing and tension forces which in turn, were indicative of a relative movement of the underlying bed towards the centre of the cavern and dilation across the bedding plane as a result of this horizontal movement.

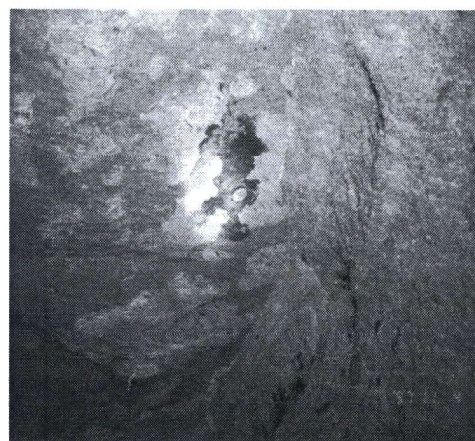
Figure 7. Roof Collapse in Gallery C showing sheared rock bolt and carbonaceous striations on bedding plane in roof.

Inspection of the remaining rock in the roof showed that the thicker remaining section of the roof beam at the side had also moved along the overlying bedding plane, as could be deduced from fresh striations in the roof (Refer to Figure 7). This movement was seen to comprise both movement along and widening of the bedding plane. A section of this remaining slab also fell from the roof a short time after the inspection.

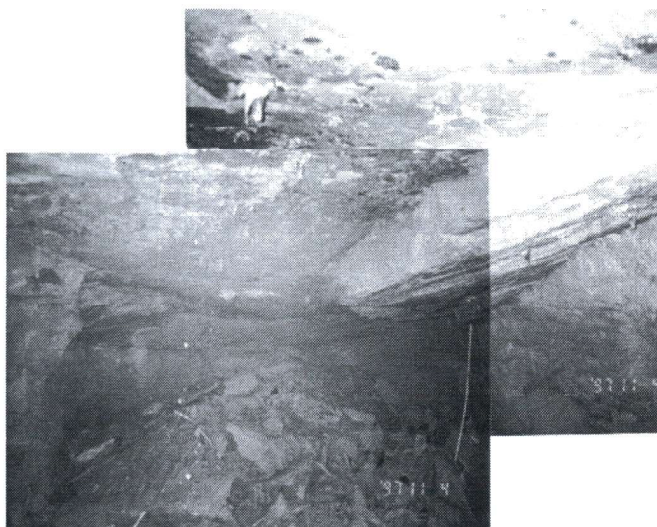
Figure 8. Roof Collapse in Gallery C showing western shoulder and localised bed thinning in central roof area.

The failed section of roof comprised a tabular mass of rock that extended from the western sidewall to approximately the cavern centreline. This consisted of two or more individual strata up to 0.5m thick with a combined maximum thickness of approximately 1.2m.
