# Investigation and Assessment of the Whakamarino Earth Dam

**Summary** The 10m high Whakamarino earth dam was completed in 1943 and forms part of Genesis Power's Waikaremoana Power Scheme on New Zealand's east coast. The dam is located on the margin of one of the world's largest intact landslide dams, the Waikaremoana Barrier. The barrier has a volume of approximately 2.2 km<sup>3</sup> and was emplaced about 2,200 years ago. Whakamarino dam has been investigated following evidence of downstream shoulder deformation. Foundation conditions were found to include a significant deposit of permeable boulder alluvium that has been derived from downcutting through the barrier debris. Indications of minor internal erosion in the homogeneous earth embankment were discovered, as was leakage past the upstream section of a culvert penetrating the dam. An assessment of the dam has resulted in preliminary recommendations for the installation of a vertical sand filter through the embankment.

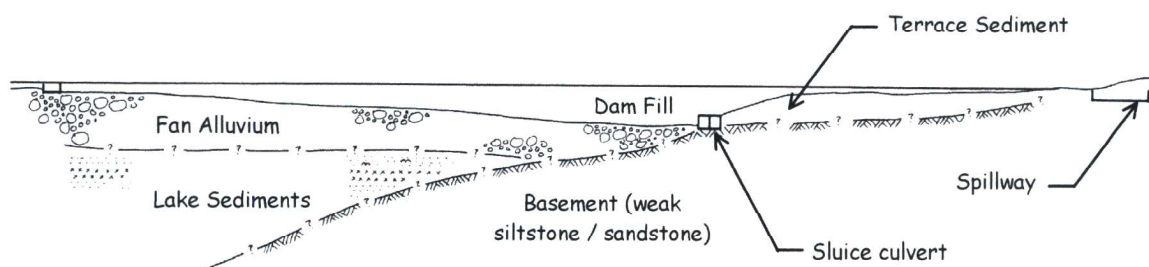
Figure 3. Geological Long Section Through the Dam Foundation (viewed from downstream)

From the left abutment, the level of the sandstone deepens westward under the dam (figure 3). The sandstone, which is weak and relatively massive, appears to be about 8m below the dam crest near the sluice and 40m near the western end. The western (right) abutment is formed by the surface of the gently sloping alluvial fan. The spillway is excavated through the left abutment sandstone spur.

It appears that the sluice structure is founded in a cutting of sandstone and / or terrace materials at the end of the left abutment spur. The level of sandstone dips steeply westward, and probably north and south, off the end of the spur. The sluice outlet apron is apparently founded on fan alluvium and fill placed as a result of scour that had occurred in this area before the structure was built.
