# Coastal Slope Instability in Auckland and Northland

**T P Adhikary**

**Abstract:** This paper considers some of the slope stability problems in coastal regions of Auckland and Northland due to continued residential development and provides a few case histories of instabilities and lessons to be learnt. The geotechnical principles to be considered in the construction of the dwellings in coastal situations have been discussed.

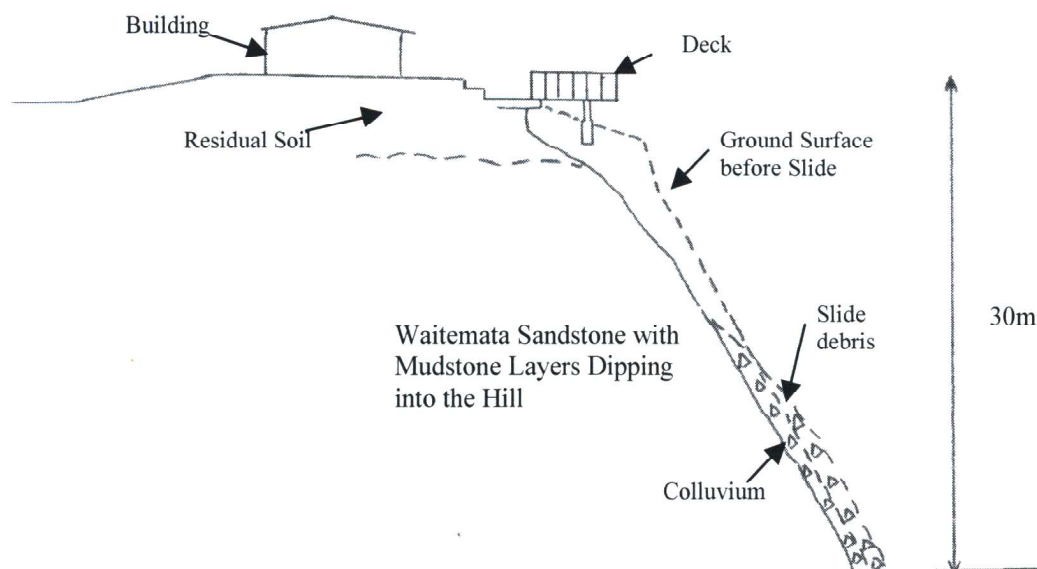
Figure 2. Schematic Cross Section: Case History 1.

The landslide site is located on the edge of a 30m high rock coastal cliff overlooking Stanmore bay in Whangaparaoa. The cliff is generally very steep (60 degrees), but sub-vertical at the upper part. Most of the ground above the cliff with residential properties is inclined away from the cliff in the opposite direction towards Vipond Road. However, there is a small strip of land that falls towards the cliff at an angle of about 15 to 20 degrees. A viewing platform exists at the backyard of the property at the edge of the cliff. The footings of the platform were founded in residual soils on pile footings (Figure 2). The platform was constructed several years ago by the previous owner without any building permit.

After a heavy rainfall, a landslide has occurred at the edge of the cliff involving the upper residual soils without affecting the underlying rock mass. The slide debris swept away the thin colluvial cover and the vegetation down the slope to the bay. The slip represents a combination of rotational and translational failures. The slip occurred as a result of high porewater pressure in the residual soil subjected to long soaking rainfalls.

The remedial options included dismantling the deck, removing the unstable material, boring into the rock and in-situ casting of timber piles into concrete sockets and re-instating the deck. Significant problems in regards to obtaining consents for the deck are obvious.

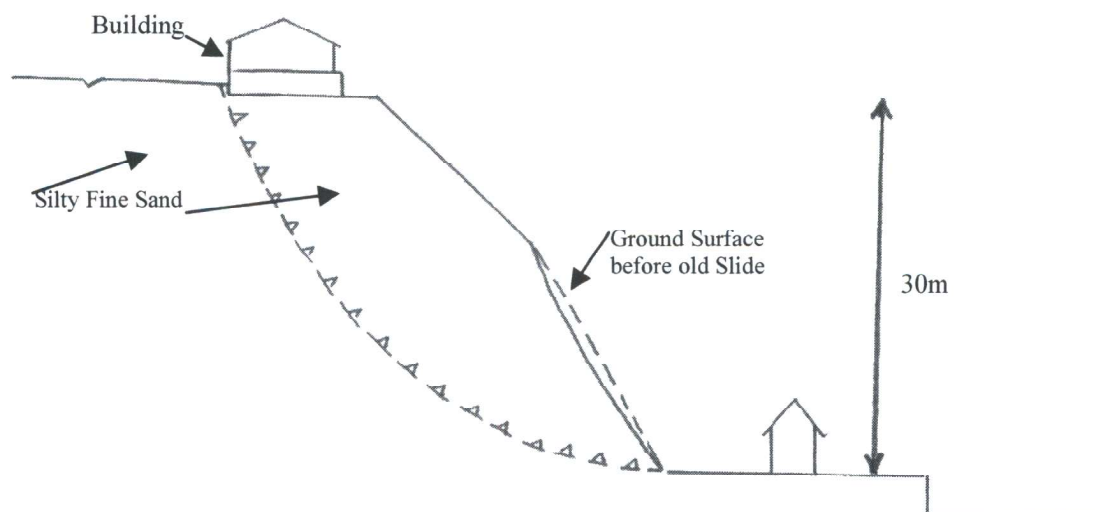
Figure 3. Schematic Cross Section: Case History No 2.

Ground movements affected two properties located above a coastal cliff in Mangawhai Heads overlooking the Mangawhai Harbour. The distress features observed were ground cracks on relatively level ground above a steep cliff approximately 35m above the Harbour. There had been a vertical drop of the ground surface and horizontal separation of several centimetres on the properties. The exposed soils on the level ground and on the steep cliff were well-drained dune sands.

The developments on site included landscaping, construction of a timber pole retaining wall and the two houses. Figure 3 shows the cross section through the northern house. The retaining wall supported the sand fill platform for the southern house. There were three downpipes on the northern property, which discharged stormwater to the failure surface.

This event caused structural damage to the first house, tilted the concrete water tank and damaged the front decking of the second house. The concrete water tank, the front decking of the second house and the retaining wall are not shown in the figure.

The tension cracks represent an outline of a rotational slide, which was probably caused by internal changes in the stability condition of the loose, cohesionless slightly silty fine sand due to intense rainfall, the steep slope gradient and high intensity rainfall. The stability conditions were exacerbated by poor drainage management on site.

Due to site constraints, the only practical means of reducing further ground movements would be to undertake measures for improvement of drainage conditions and to construct a buttress at the toe of the slope.

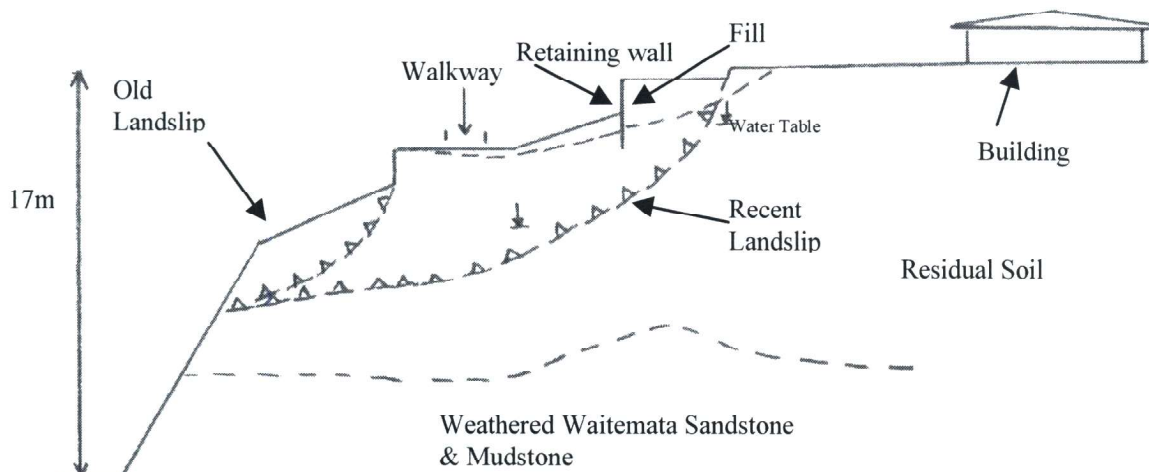
Figure 4. Schematic Cross Section: Case History No 3

In 2000, a rotational landslip occurred on the coastal cliff comprising residual soil (10m thick) and weathered Miocene Waitemata sandstones and siltstones (Figure 4). The slip affected the public reserve and the garden of a private property. Most of the property was on the coastal platform 16-17m above the sub-horizontal wave cut intertidal shore platform. The cliff face had undergone a couple of slope failures in the past as evidenced by a series of scarps. The slope movements regressed further up the cliff to the coastal platform level. The most recent scarp (0.1 to 0.4m high) ran roughly parallel to the cliff line on the front lawn. There were several other open cracks on the lawn in the vicinity of the scarp and the distress features included the rotated timber pole retaining wall. Initial movements on the slope seem to have occurred only about 10m above the shore platform.

Remedial works following previous failures included the installation of fan drains. However, the water discharged from the drains to the failed slide mass and exacerbated the potential for additional slope instability.

The loss of the support to the cliff coupled with poor drainage management as well as heavy and prolonged rainfall led to further slumping within the lawn and caused the timber pole retaining wall to lean down hill. If no remedial action taken then , additional slope movements would occur in the future.

One essential measure to remedy the situation was to divert the surface run-off and discharge from the fan drains away from the unstable ground. Most of the unstable landmass was confined to the reserve and preferred remedial measures incorporating slope retention systems such as anchored retaining walls in combination with improved drainage measures have not been erected.
