Case Study of an Investigation of a Damaged House in Brisbane, Australia

D.Lopes
Dip. Geology (R.M.I. T.)
M.Eng (S.U. T.) Aus.I.M.M.

B.Hargreaves
Dip. Geology (B.I. T.)
Affil. I.E. (Aust)

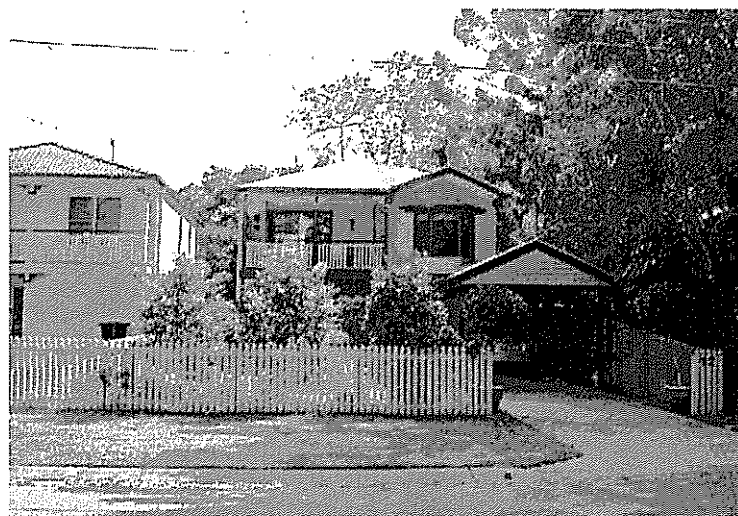
House under investigation (to the right) Remaining allotment with new house to the left

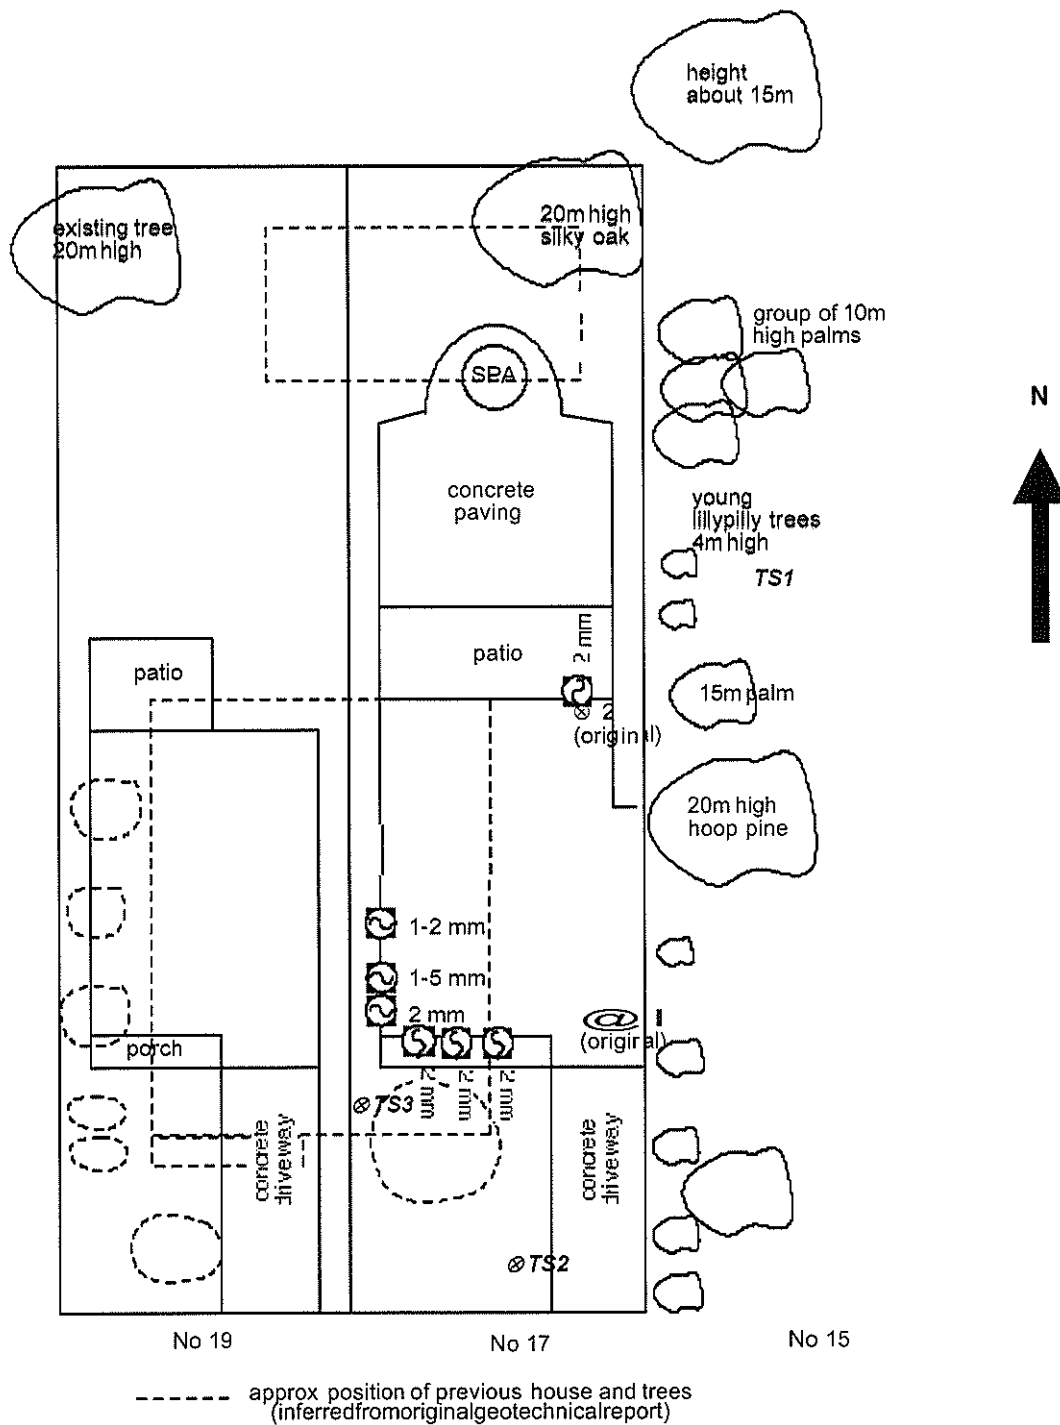
New & Old Houses

The site sketch by the original investigators shows the trees, which were removed prior to construction and the position of the old house. The second investigators plotted the remaining trees and identified most of the larger ones. (Refer Appendix 1) In particular, a 20 metre high Hoop Pine was noted near the centre of the East wall of the house; also a group of Lillypilly trees near the North East corner of the rear patio. Other large trees are still growing near the rear boundary.

There a number of cracks varying from 2 mm– 5 mm in the Western half of the front wall and Southern half of the West wall i.e. within 5 metre of the South West corner of the house. There is also a 2 mm crack near the North East corner of the house.

This degree of damage is Categorized as 2 (AS2870). The largest crack is up to 5 mm and is on the Southern side of the exterior West wall. Most of the cracks are larger in the ground floor. 2-5 mm window/wall gaps were also noted at the base of the lower windows in the front wall. (Refer Appendix 1)

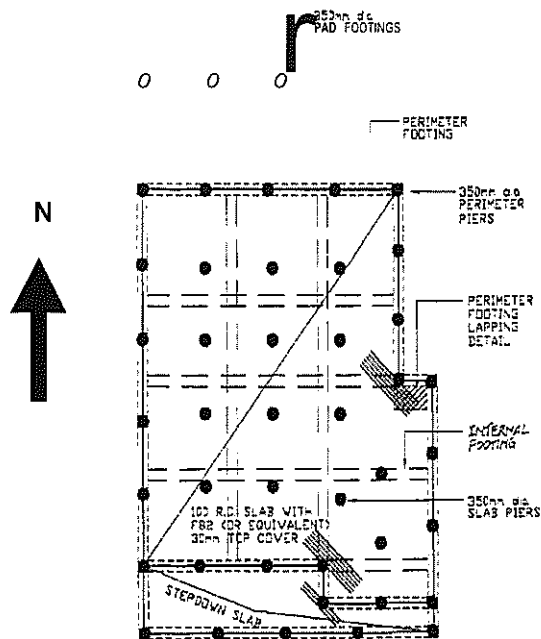
Slab and Pier Design

- ❖ The footing system is a combination of a grid of beams and a footing slab poured independently.
- ❖ The edge beam has an effective depth of 550 mm.
- ❖ The internal beams are at a maximum grid spacing of 3 metre and also with an effective depth of 550 mm.
- ❖ The slab is reinforced with F82 slab mesh (top) and the beams with a row of 3 bar F12TM in the bottom.
- ❖ The slab and footings are tied together with cranked Y12 bars at 1,000 mm spacing.
- ❖ The design allowed for a 600 mm maximum of fill under the slab to lift the floor above Flood level.
- ❖ The slab was to be supported on piers, which were founded in the natural "*firm Silty Clay*". (Appendix 2)

The slab appears to be designed as fully suspended on shallow piers, which are strangely located (Appendix 2). Apparently, the piers were to penetrate the old and new fill. In no way could these piers be expected to restrain a slab from any uplift since they are shallow and have no connection between the piers and the slab.

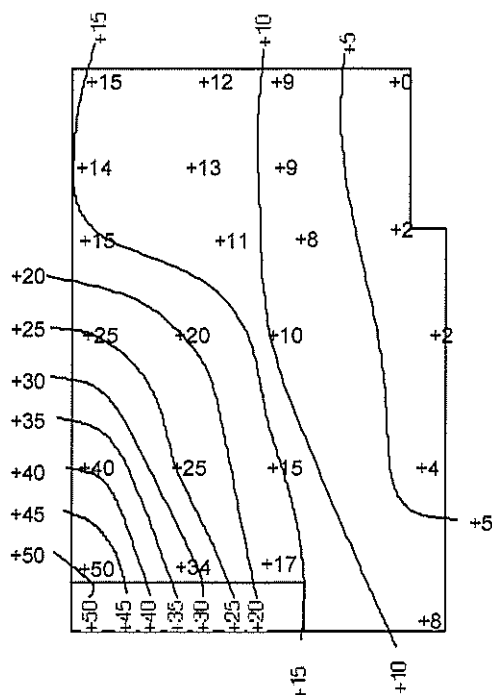
Relative Floor Levels

The floor levels show a differential of 50 mm from the North East corner to the South West corner with the sharpest change occurring closer to the South West corner. (Refer Appendix 2)

Although there is no certainty that the floor was poured level, there is a clear trend that the South West corner has heaved. (up to 50 mm?). The East wall is almost level. The back (North wall) rises 15 mm to the West. The front (South wall) is 42 mm higher at the South West corner and the West wall is 35 mm higher to the South with most of this change occurring within 5 metre of the South West corner. (Refer Appendix2).

- (1) Greatly reduce the watering in the front garden.
- (2) Wait for the soil moisture to stabilize (this may take many years).
- (3) Monitor the floor and wall levels for 2- 3 years to establish when the floor ceases to heave.
- (4) It is preferable not to fill any cracks until the monitoring period is complete however if the owner requires cracks to be filled earlier, compressible and flexible material should be used.
