# Monitoring and Remediation of a Slow Moving Landslide

**Summary:** An area in the township of Clifton Springs called The Dell is a prominent coastal amphitheatre feature of the Bellarine Peninsula in southern Victoria. The local community and visitors to the area have used The Dell as a safe access point to Corio Bay and for its recreational facilities.

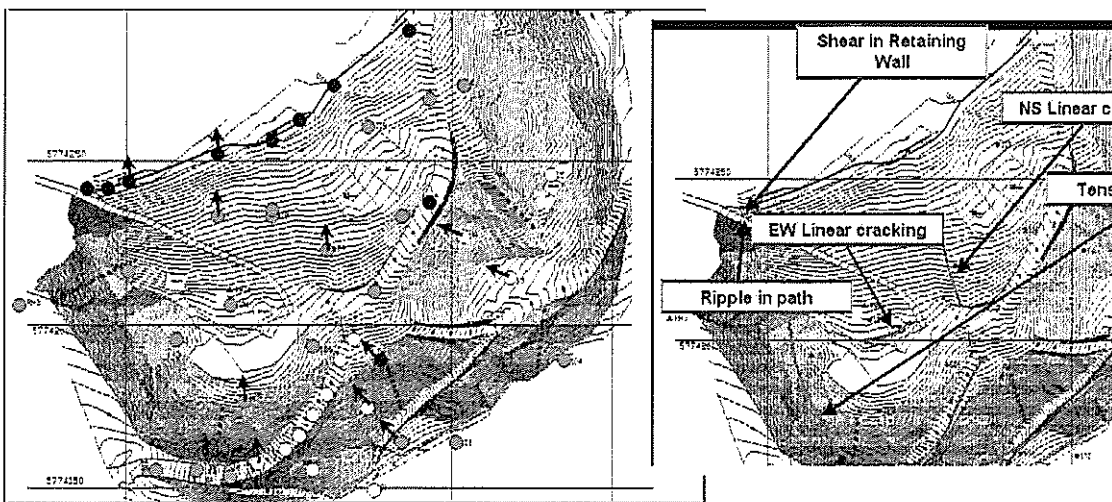
Figure 3. Monitoring and Site Observations

The survey and inclinometer results indicate that the steep area of the site to the south of the access road is moving in a NW direction. The area to the north of the access road is moving in a NNW direction. The eastern slopes appear to be moving in a WNW direction; and

Ground levels are dropping along the access road, on the southern steep slopes and on the eastern slopes. Points at the base of the steep southern slope and on the foreshore retaining wall are rising. The combination of the monitoring results and visual observations suggest that there are 3 main failure mechanisms operating at the site (Figure 4).

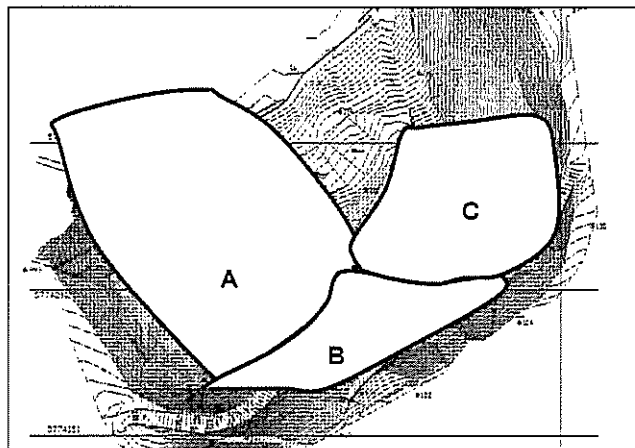
Figure 4. Postulated 3 Block Mechanism

Monitoring, visual observations and geological modelling suggest that there are 3 main failure mechanisms acting at The Dell site: A translational block extending from the access road to the foreshore, probably the reactivation of an historic landslide (Block A); A rotational block encapsulating the steep slope to the south of the site, probably a first time failure (Block B); and a rotational block in the eastern portion of the site, probably another reactivated historic landslide (Block C).

The reactivated landslides (A and C) are unlikely to fail rapidly, as the shear strengths mobilised in these slides is probably at or near a residual value; The first time slide (Block B) may fail more rapidly in a brittle manner.

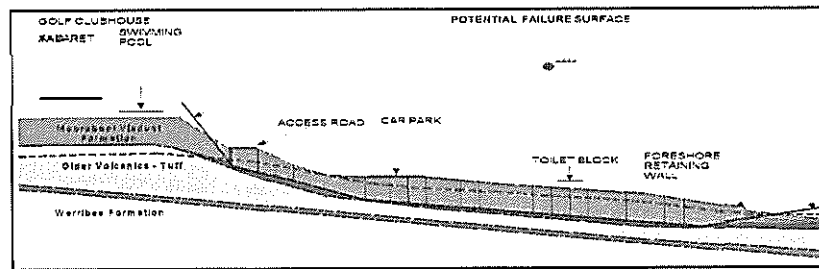
Figure 5. Cross Section

Each of the postulated landslide blocks (A to C) were analysed and the strength parameters mobilised along the failure surfaces (defined by the inclinometers) were back calculated. These strength parameters were compared to values obtained from laboratory testing results to ensure that sensible parameters were adopted. A cross section showing the inferred geology and the analysed block A is shown in Figure 5.

Block B has been interpreted as a first time slide in a natural slope which has been modified by engineering work and average shear strengths on it's failure plane were taken to be intermediate between the peak strength and residual strength.

However, for inferred reactivation slides (Blocks A and C), shear strengths mobilised during failure were considered to approach residual values. In addition, an attempt was made to assess the stability of Block C before the first-time failure in this block, by restoring the slope to its estimated original configuration. Three dimensional mapping was utilised to assist in this process. This allowed a check to be made on the intermediate strength utilised for the analysis of Block B. The back calculation process resulted in the following strengths along the failure surfaces in the 3 blocks postulated at the site.

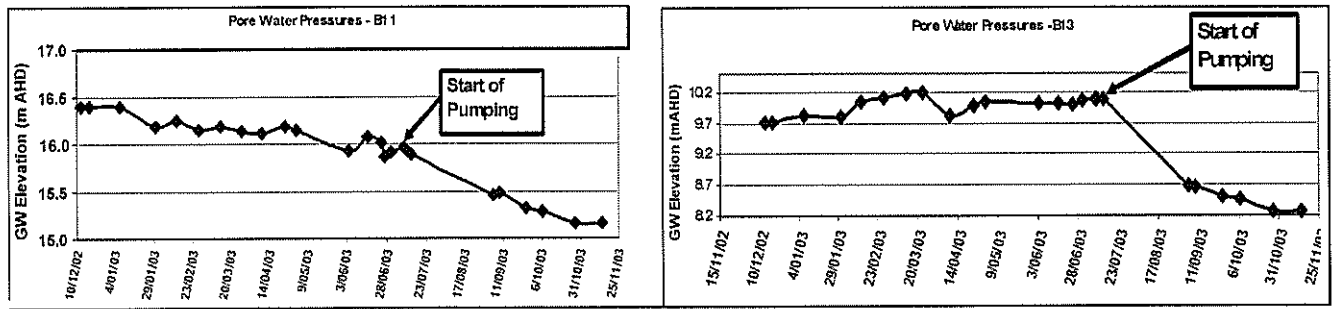
Figure 6. Typical Piezometer Results

Typical plots of piezometric level against time for the vibrating wire piezometers is presented in Figure 6, which indicates that the porewater pressures within the tuff are still reducing and that the full beneficial effect of groundwater depressurisation may still be developing. The graph on the left indicates how some of the piezometers responded to emergency remedial works before active pumping began.

Additional remedial works were proposed for the site in June 2003, involving groundwater depressurisation. These works were the first stage of site remediation, with further remedial works planned for a later date. This work included the installation of 8 active extraction wells. Two of these wells were installed at the crest of the site, adjacent to the swimming pool, within the deeper Werribee Formation sands. Four wells were installed in the central car park, within the mid-level sands. The remaining two wells were installed within existing geotechnical investigation bores, screened within the basalt. With this system in place, the 3 main aquifers identified at the site were targeted for de-watering.

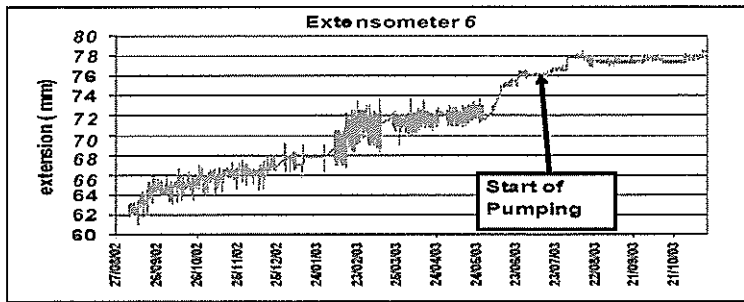
Figure 7. Extensometer Results

Before groundwater depressurisation, extensometer No 6, which is located in one of the more active parts of the site, indicated a general increasing trend of movement. However, during groundwater depressurisation the extensometer has stabilised and has shown relatively steady readings. This is highlighted by the extension versus time plot for this extensometer, presented in Figure 7.

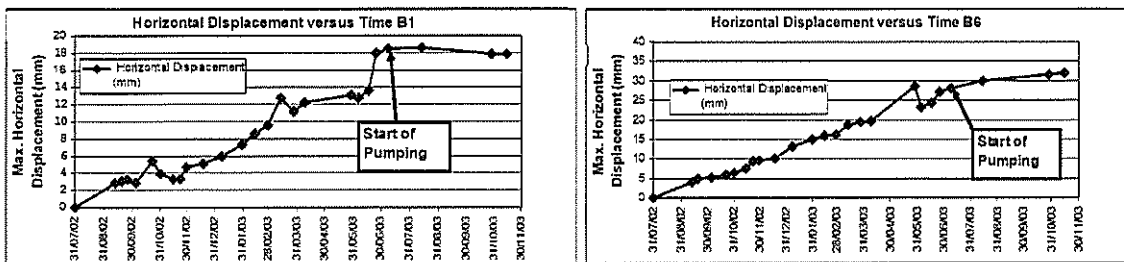
Figure 8: Inclinometer rates of Movement

Inclinometer results suggest that there has been some reduction in the rate of slope movement in some of the inclinometers at the site since the commencement of groundwater depressurisation. This is highlighted on the plots of rates of movement presented in Figure 8. Inclinometer results from other bores are inconclusive at this time and additional monitoring data is required to assess trends. However, it should be noted that even though there has been significant rainfall over winter 2003 (96mm in July), there has been no increase in rates of movement in sections of the site which had been accelerating coincident with high rainfall.
