Large Debris Flows in the Townsville Urban Area and Associated Remedial Works.

Summary: Landslides and Debris Flows have occurred in Townsville, Queensland, during intense tropical rainfall events. This paper describes two recent debris flow events, their effects on infrastructure and the remedial works undertaken.

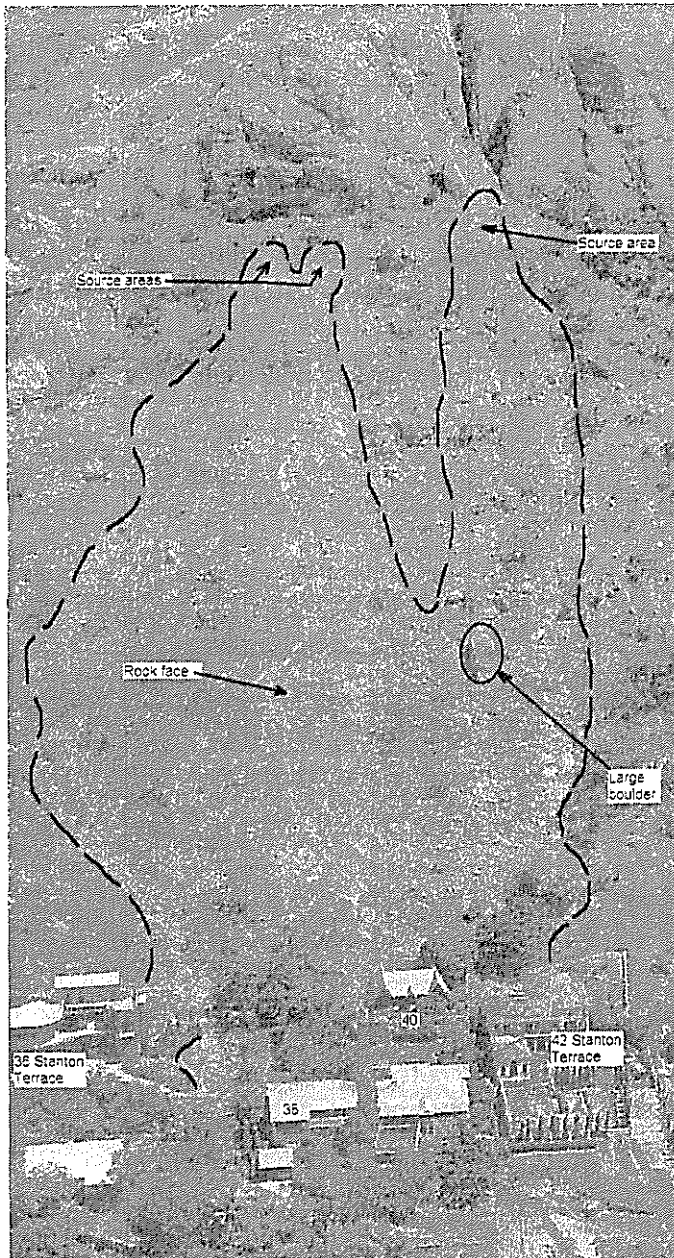
Figure 2, Stanton Terrace Debris Flow

The Stanton Terrace debris flow initiated from three source areas close to the base of the rock cliffs on the northern face of Castle Hill. From newspaper reports and an eyewitness account, it is understood that movement of soil commenced high up above the gully between 36 and 38 Stanton Terrace (two overlapping source areas), immediately followed by rapid movement of debris down the hillside. Movement was accompanied by sound like that of "a 747 taking off". Boulders moved with the other debris, and did not bounce and roll ahead of the remainder of the flow. Within 20 seconds, similar movement and debris flow occurred in the area uphill from 42 Stanton Terrace (the third source area). The eyewitness's impression was that the entire duration of movement for the flows in this area was approximately 45 seconds, with speed of the flow approximately 60 km/h.

Debris travelled some 200 to 250 metres reaching occupied houses at Stanton Terrace. The debris flowed around and into the house at 42 Stanton Terrace, filling the courtyard with debris up to 2 metres deep (Figure 5). Debris flowed underneath the "A-frame" house at 40 Stanton Terrace, filled the backyard swimming pool at 38 Stanton Terrace, flowed down the driveway at 36 Stanton Terrace (Figure 6), and blocked the drainage pipes beneath 34 Stanton Terrace and down the side of 42 Stanton Terrace. The house numbers are shown on Figure 2. No one was injured in the event.

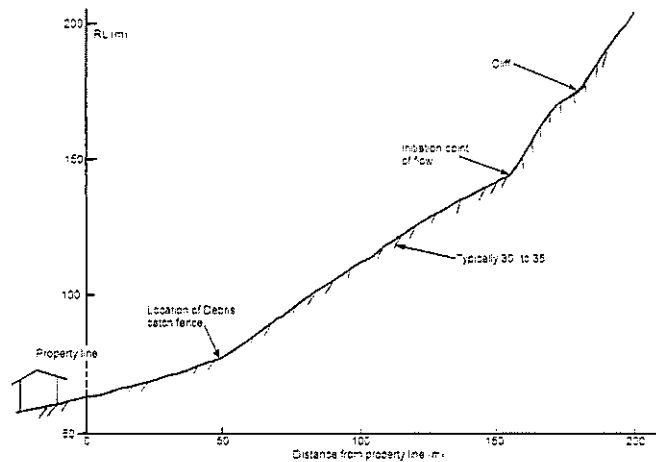
Figure 4, Typical Slope Section through Stanton Terrace Debris Flow

Prior to the debris flows the slopes were lightly vegetated with some trees. Vegetation had been severely damaged by bushfires during the 1999 dry season. A generalised hillside cross-sections through the Stanton Terrace debris flow is presented in Figure 4. The overall slope of the hillside from approximately 50 metres behind the residential properties to the base of the cliffs is 30° to 35°. Isolated small to large boulders were located both within the established gullies and on the open slopes. Similar slopes occur in the headwaters of the Stanley Street debris flow.

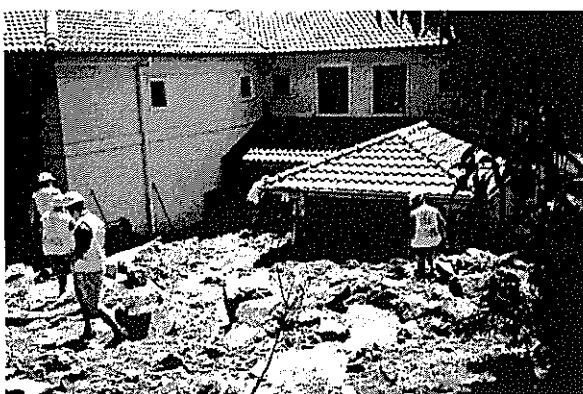
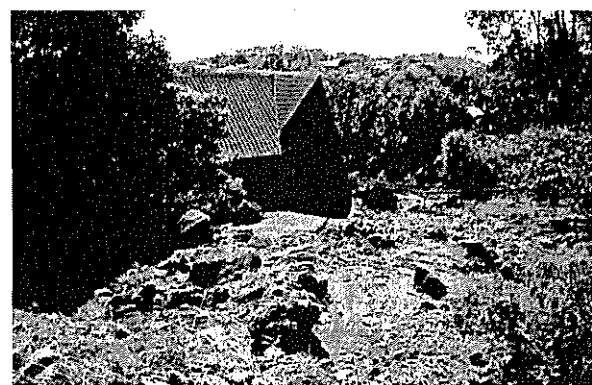
Figures 5 & 6, Typical debris to rear of Stanton Terrace houses.

The debris varied from mud (silt-clay-sand mixtures) to silty gravelly sand, with frequent cobbles and boulders. Much of the material was saturated, with the consistency of liquid mud in places. Boulders with dimensions up to 4 metres had been transported down the slope and deposited in the area behind the houses and in the pool at 38 Stanton

The "A-frame" house was ultimately demolished and replaced. The other houses were found to be substantially undamaged when the debris was removed.

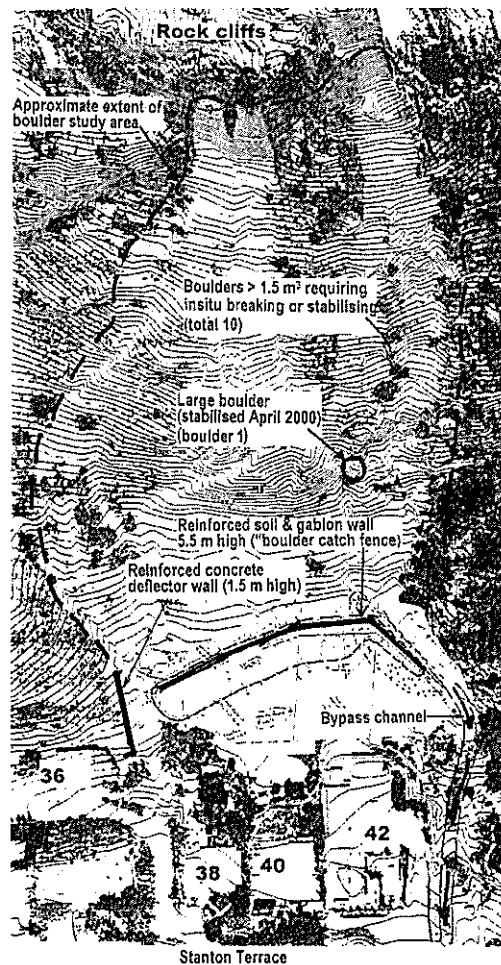
Figure 7, Remedial Works at Stanton Terrace

Following the failures a large number of boulders remained on the slope, some of which have been moved and/or subjected to scour, locally steeper slopes existed around the perimeters of the source areas, and loosened debris remaining on the steeper part of the slopes could not be removed. Major stabilisation and/or clean up of these areas were not considered feasible in view of the scale of work required and severe access difficulties. The adopted remediation strategy included localised stabilisation of some larger boulders insitu on the slope, and the construction of rock bunds and boulder catch fences on the lower slopes to reduce the exposure of residents and structures downhill to risk from further debris and/or boulder movements. Insitu stabilisation measures included the provision of concrete buttresses, erosion protection and cable staying. Rock filled gabions were constructed below some boulders to provide additional support. A number of boulders were broken up insitu once the boulder catch fence was installed. In some cases, in order to reduce the risk of boulders rolling, cargo nets were placed over the boulders to be broken and tied back to the slope with grouted rock bolts.

A plan showing location of several of these features is presented in Figure 7. A similar approach was adopted for the 1998 Magnetic Island debris flow, and the debris flow at Stuart Street. In each case stabilisation of the source area and scoured debris flow path was considered impractical due to severe access difficulties, and remedial works were individually designed to suit local conditions and make use of local materials.
