Landslides and Rehabilitation of the Highlands Highway, Papua New Guinea

Summary: A study was recently completed for a multi-disciplinary assessment of 600 km of the Highlands Highway that extends from the port city of Lae, through the Highlands to Mendi in Papua New Guinea. The purpose of the study was to investigate and design for the rehabilitation and reconstruction of the Highlands Highway to bring it to a standard where it provides an acceptable level of service.

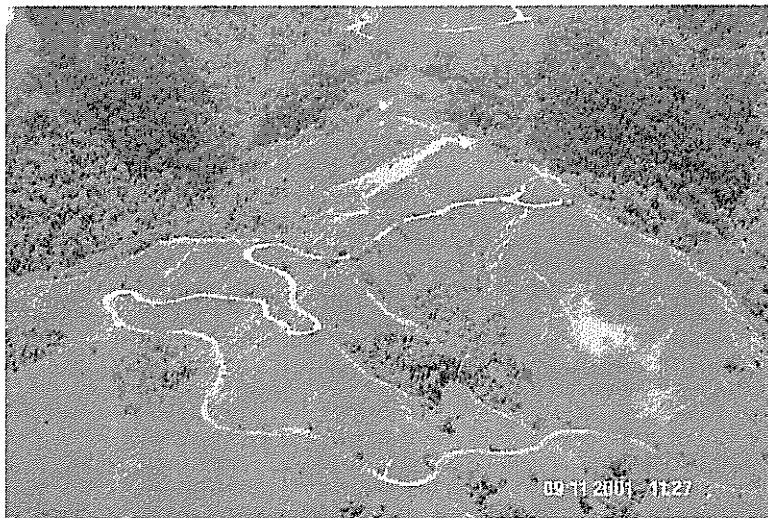
Figure 2. Kassam Pass section of the Highway that climbs through interbedded sedimentary rocks.

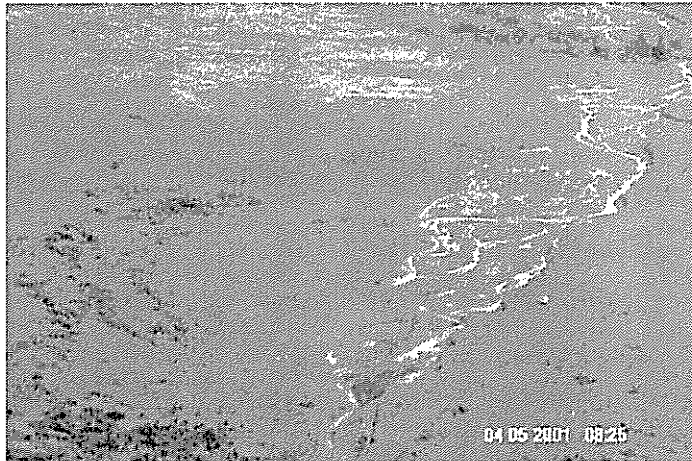
earthquakes in the area in 1993 also contributed to massive landsliding in the catchment areas that added to the stream sediment load (Tutton & Kuna, 1995). One result has been an increased flow into Garia Creek, a distributary from the Maniang River. The lower reaches of the Garia Creek aggraded by 2001 to the extent whereby the flow has been blocked and the creek then broke out of its channel and cut back to the western side of the Highway where it now follows it for about 1.2km. The creek banks have locally scoured out 50% of the carriageway (Figure 4). Recent rock fill placement has temporarily protected this section of the road.

Figure 4. Garia Creek cutting the western edge of the Highway in the Markham Valley.

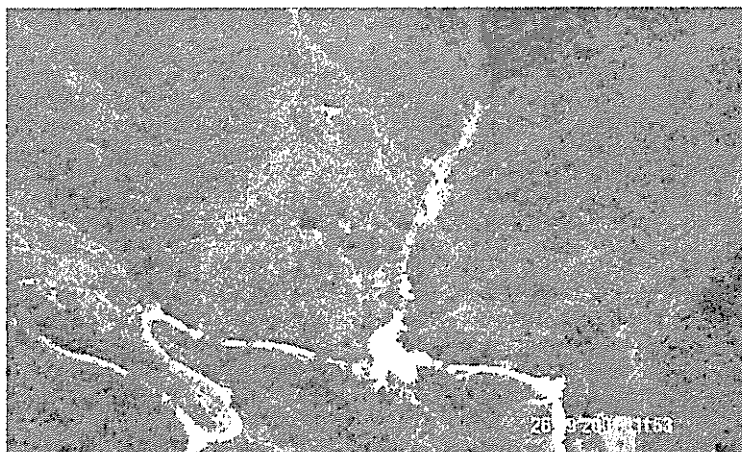
In late 2000 the Highway at Nambawaniku Creek (Figure 5) was cut for several days following a debris torrent 700m in length and involving 80,000m³ of saturated weathered volcanic rocks and soil. This event demonstrated that geological studies along the Highway need to include all the catchment areas and not just an assessment of the immediate road corridor area. Clean up of the debris proved to be difficult due to the steep gradients downstream and the need to avoid damage to dwellings and cultivation on the lower slopes. Rehabilitation involves better drainage control and a multi-plate culvert with a facility to remove debris as it accumulates.

Figure 5. Major debris torrent that blocked the Highway at the Daulo Pass in 2000.

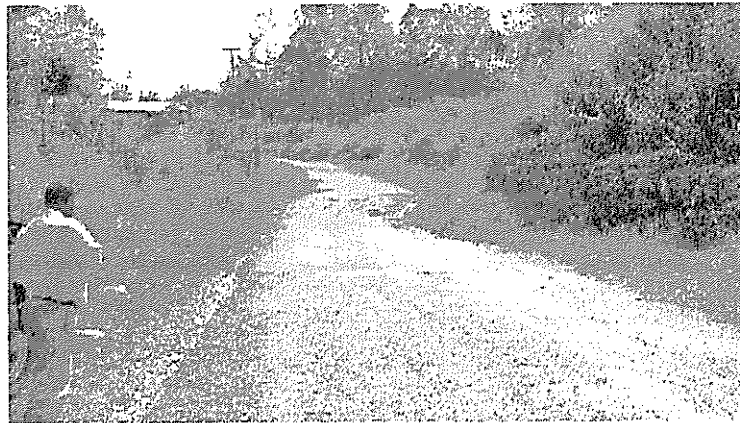
Many sections of the Highway are affected by displacement downslope, disruption of drainage and overriding from debris coming from the upper valley slopes (see Figure 6). Evidence of such landslides is sharp lateral shears and steps in the road profile up to 1m in size. Surging movements have been known to displace the road by 20-30m in one year. The engineering approach to rehabilitation is restricted by budget and thus it has been necessary to accept the process and effectively manage it by drainage improvements, pavement edge reinforcement to delay the inevitable deformation and minor diversions. The earthflows are well defined and are mostly separated by stable ridges, thus if funds are available in the future more sophisticated stabilisation techniques may be employed such as tie-back walls, debris bridges and larger road diversions.

Figure 6. Overriding earthflow partly blocks the highway in eastern Simbu Province. Note also the lateral shear that displaces the road pavement.
