Adding new levels to old buildings: A case study in foundation assessment

S. Colls

Golder Associates Pty Ltd, Melbourne

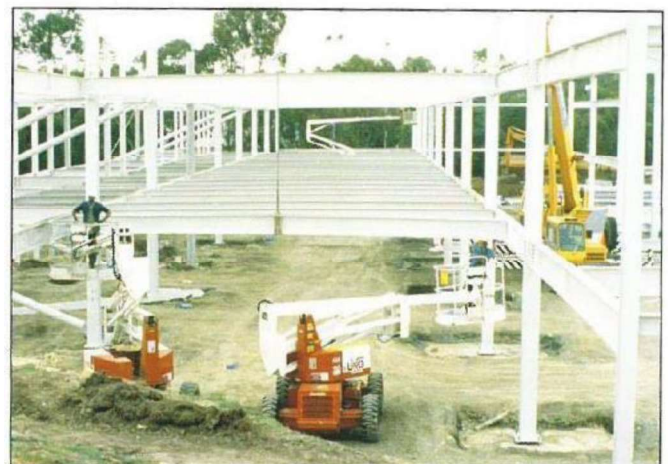
Other notable information obtained during the review of construction records related to documentary evidence of construction of CP6 East in Bennetts et al (1999). Figure 1 shows a photograph from this publication which appears to confirm that the columns are supported on pad footings.

Figure 1. CP6 East during construction (Bennetts et al, 1999).

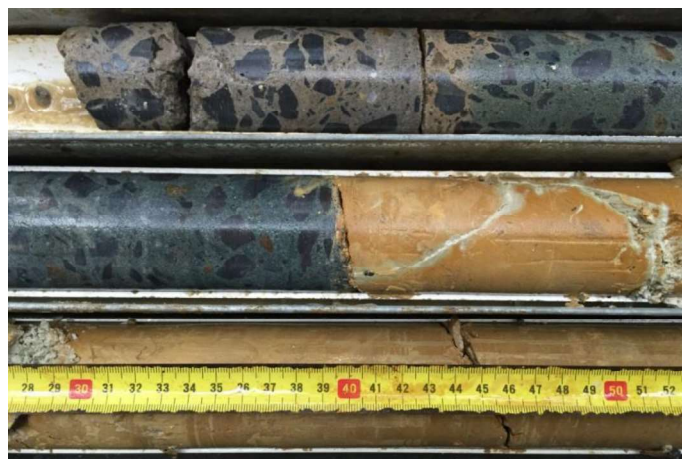
Figure 2. Core photograph showing the contact between the concrete footing and underlying weathered siltstone.

- CP6 East (pads): At the two investigation locations, the pad footings were founded on extremely or highly weathered siltstone. There was no evidence of loose debris between the base of the footing and the founding materials at the two locations investigated.
- CP6 West (piles): The fill thickness ranged from about 3.0 m to 7.5 m. Waste materials including plastic, cardboard, metal and glass fragments were encountered within the fill indicating it to be uncontrolled. Highly to moderately or less weathered siltstone was encountered in both boreholes below about 7.4 m to 8.0 m depth.

The results of the intrusive investigation provided further evidence of redundant capacity of the CP6 East pad footings, given that the design maximum allowable bearing pressure of 300 kPa was below what is typically adopted for founding materials that comprise extremely or highly weathered siltstone. The investigation results also helped to provide confidence that the original construction methodology included cleaning of the base of the footing excavations prior to footing construction.

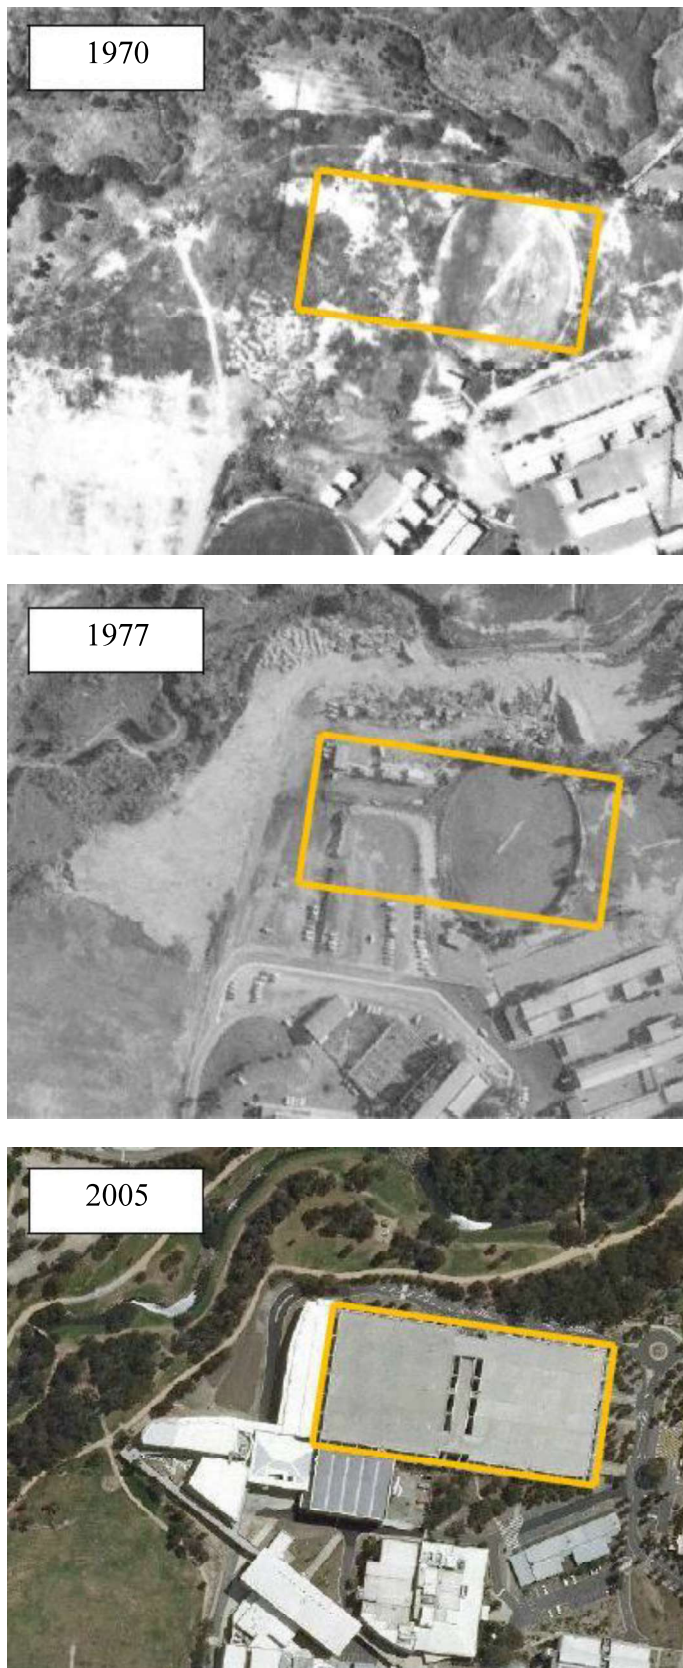
Within CP6 West, the significant depth of the fill and presence of waste materials had not been expected prior to drilling the boreholes. Subsequent review of historical aerial photographs provided confirmation that significant filling works had taken place (probably associated with backfilling and levelling of the Gardiners Creek floodplain, including re-routing of the creek) between the 1960s and 1980s (Figure 3). The elevation below which weathered rock was encountered also agreed well with the 'minimum pile level' contours on the original construction drawings. This provided confidence that the contours had been generated based on a geotechnical investigation of the depth to rock and that piles had likely socketed into the rock. Once the original geotechnical report had been obtained it was apparent that seven boreholes were drilled to depths

Figure 3. Aerial photographs dated 1970, 1977 and 2005 (Victorian State Government), with the approximate footprint of the CP6 building highlighted.

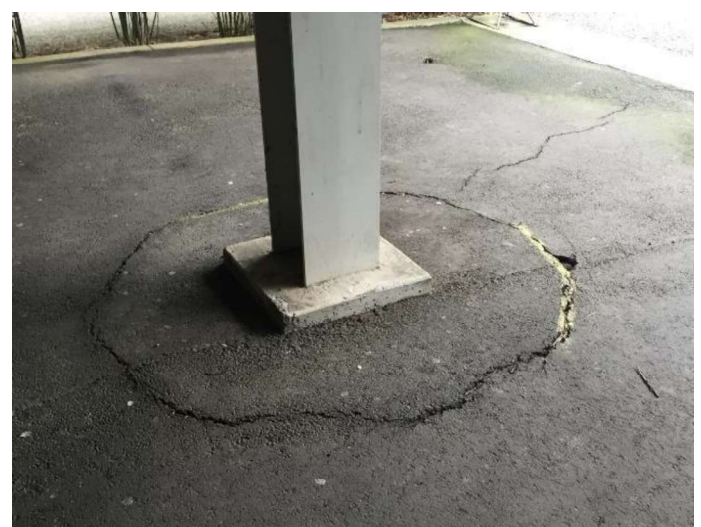
- Weathered siltstone materials were exposed in cut batter slopes to the east and south of CP6 East.
- Evidence of differential settlement was observed between the asphalt pavement surface and piles within CP6 West (Figure 4).

The observation of differential settlement within CP6 West provided further evidence of the nature of the uncontrolled fill materials and the potential for downdrag loads to develop. For the column shown in Figure 4, the difference in surface level across the cracks was about 20 mm to 40 mm, which was inferred to have developed in less than 17 years. The shape of the crack pattern (the circular shape was about 1.6 m to 1.7 m in diameter and centred on the column) also provided confirmatory evidence that the pile diameter was consistent with the construction documents.

Figure 4. Differential settlement between piled footings (CP6 West) and the surrounding asphalt pavement.
