# Shallow Mine Subsidence – A Case Study

J. Johnston

S. Fityus

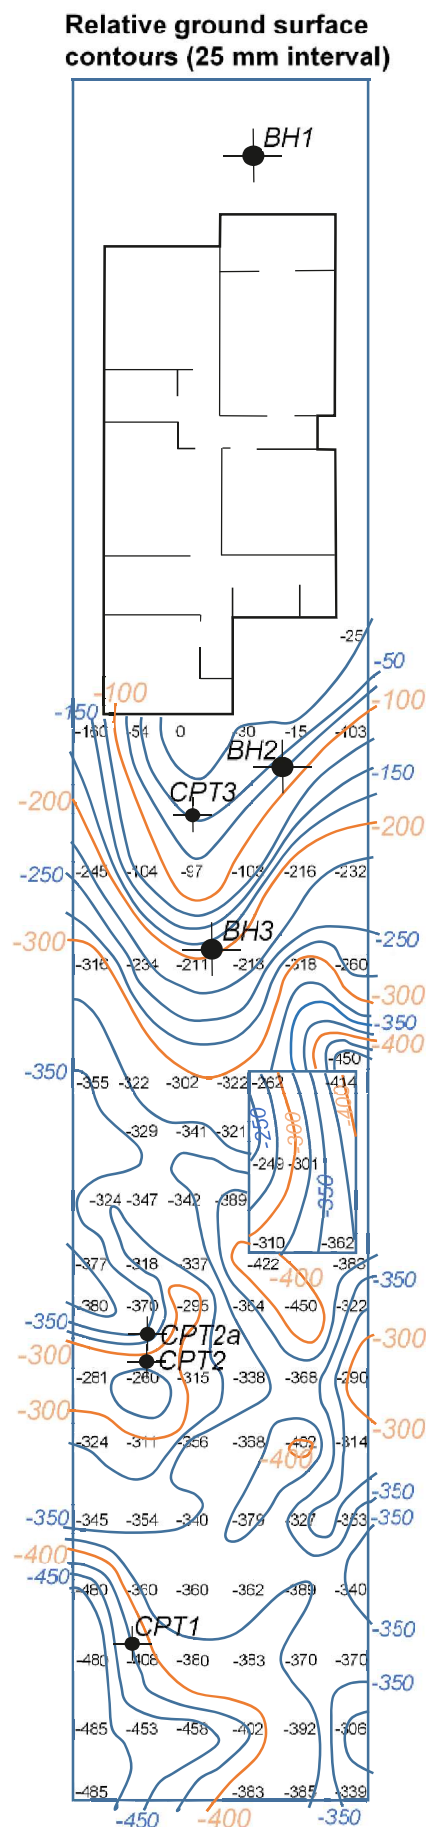
Figure 2 shows the studied site, indicating the position of the residence, and relative ground surface contours of the back yard at the time of purchase. Notwithstanding a general fall from front to back (top to bottom of figure), the yard surface displays pronounced hummocks and swales in what is otherwise an empty yard comprising only mown lawn. The structural conditions are detailed below.

Figure 2. Ground surface contours in the yard. The numbers in black are ground surface spot levels. Locations of sub-surface investigation are also shown.

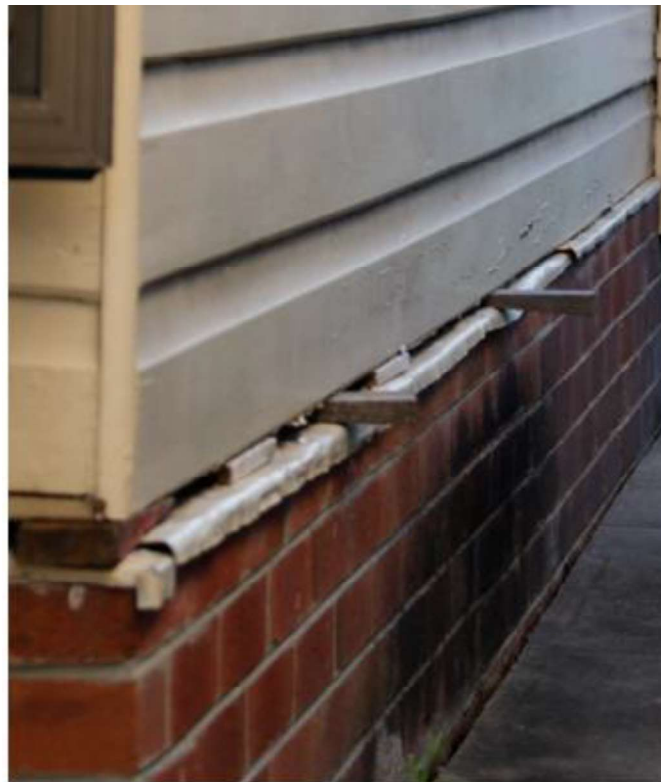
Figure 3 shows examples of some of the severe structure-foundation separations that have occurred. It is important to note that the piers and footing walls in these photographs are clearly younger than the house itself, and it is believed that all of the footings have at some stage been replaced (presumably with the house being re-levelled) which means that the presently observed settlements are only a portion of those that have occurred on the site since the house was constructed.

a) packing of gaps between house and support walls

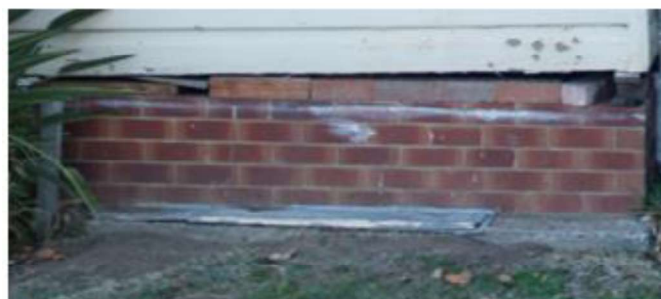
b) severe settlement of support walls

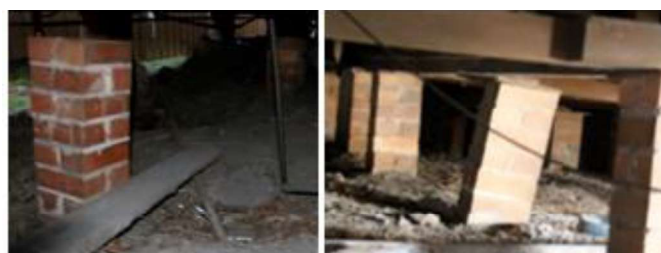
c) drop and/or rotation of piers

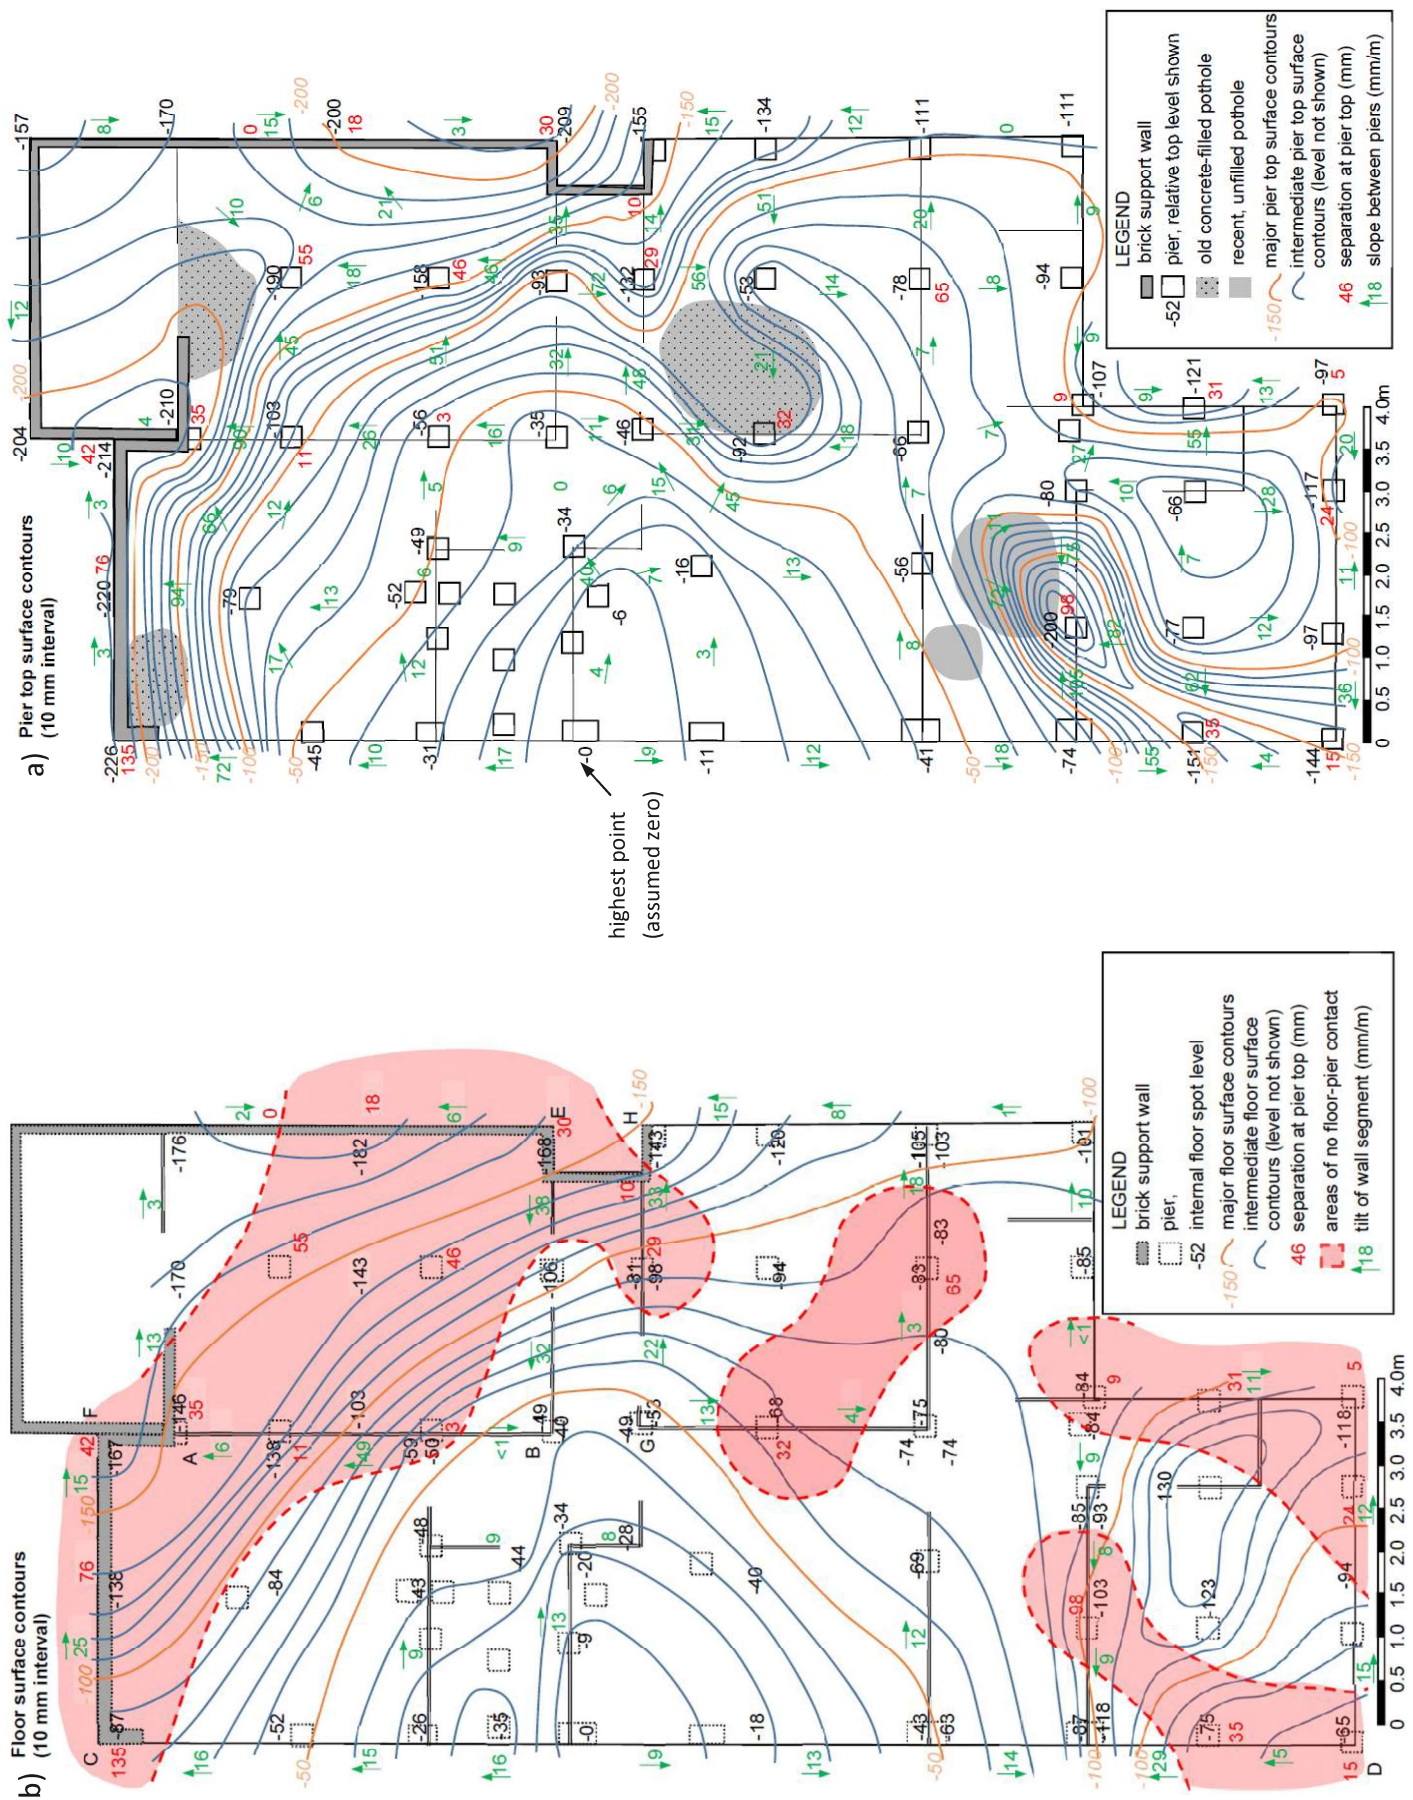
Figure 4. Contoured surface of the relative pier top levels (a) and internal floor surface contours (b) showing areas of no pier-floor contact. Note that the pier top levels contain only information from the pier tops and do not reflect the ground levels between piers.

Figure 4a shows the levels of the pier tops beneath the house, (figures in black) relative to a value of zero assigned to the highest pier, as indicated. The maximum differential movement between piers is 226mm. The pier-top levels have been contoured at a 10mm interval to represent the surface upon which the overlying structure is supported (and not the surface shape of the subsided ground). Also shown in Figure 4a (shaded in grey) are regions where potholes have formed, with some having been filled with concrete, and some not.

An inevitable consequence of the severe foundation settlements is the separation of the house structure from the piers in many locations, resulting in 14 piers and approximately half of the front and side support walls no longer being in contact with the bearers or floor plates. The values in red in Figure 4 represent the magnitude of the gaps (in mm) between subsided piers and the floor bearers.

Figure 4b shows relative levels of the internal floors (values in black) of the house. Also shown (again) on this figure are the pier-bearer separation values (values in red), with the areas of the structure that have lifted off the piers shaded in red. The highest point on the floor coincides with the highest pier top, and the floor levels fall away from this point in all

The green values in Figure 4 represent slopes and tilts for different segments of the structure. Figure 4a shows slopes between pairs of adjacent piers in mm/m, which are as great as 105mm/m, with about 20% of all adjacent piers having a slope greater than 50mm/m. Figure 4b shows tilts along wall segments throughout the house. Localized tilts at floor level along walls of up to 50mm/m were recorded, with around 15% of wall segments tilted by more than 20mm/m.

Perhaps most significant are the curvatures that result from changes in tilt along particular wall segments. The segments denoted C-F and G-H in Figure 4b) each experience a change in slope of around 10mm/m along their length. Even more severe are the tilt reversals in the wall from C-D, and the double tilt change in segment A-B, which is greater than 40mm/m in each case. Despite this, the most severe damage in wall A-B is that shown in Figure 6.

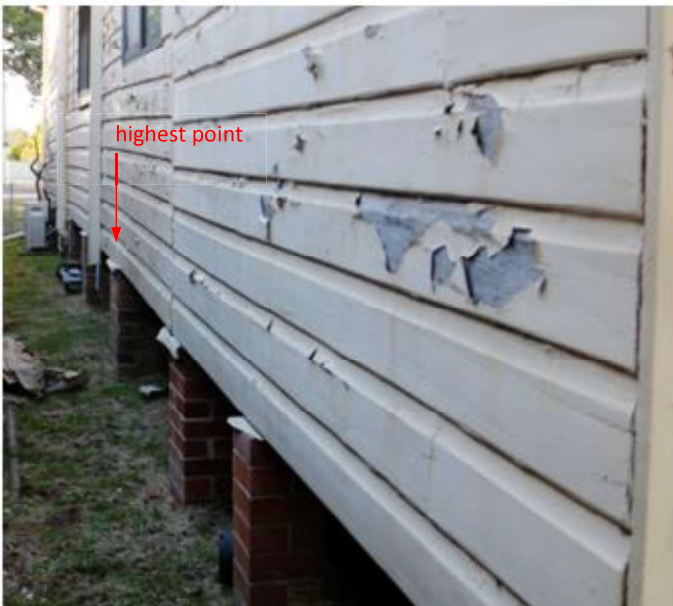
Figure 5a is a profile along the side of the house which includes the highest pier, about half way along. The reversal of tilt either side of the highest point is readily apparent, however no appreciable splits or separations of the weatherboards was noted.

a) curvature of weatherboards along the side of the house. (wall C-D in Figure 4b)

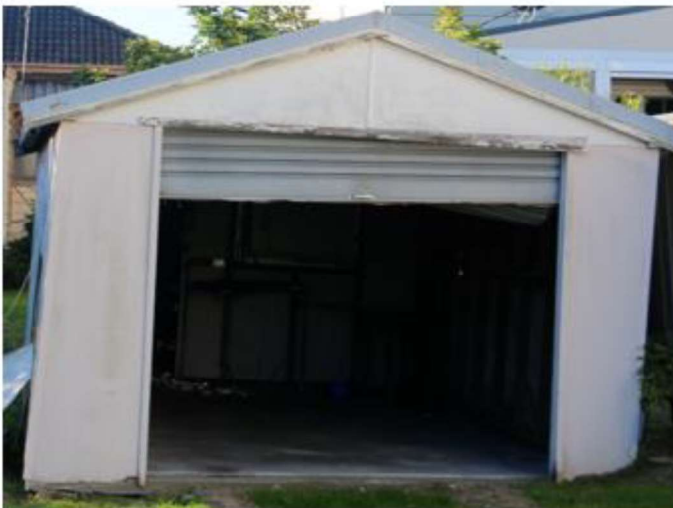
Figure 5b shows the severe deformations in the garage in the yard. Contours of deformation in the garage slab are shown in Figure 2, indicating that the slab deformation is consistent with that of the house.

b) tilts in the garage (see slab contours in Figure 2).

Deformations in the garage structure were sufficiently great to cause rigid sheet cladding to detach and the roller door to jam.

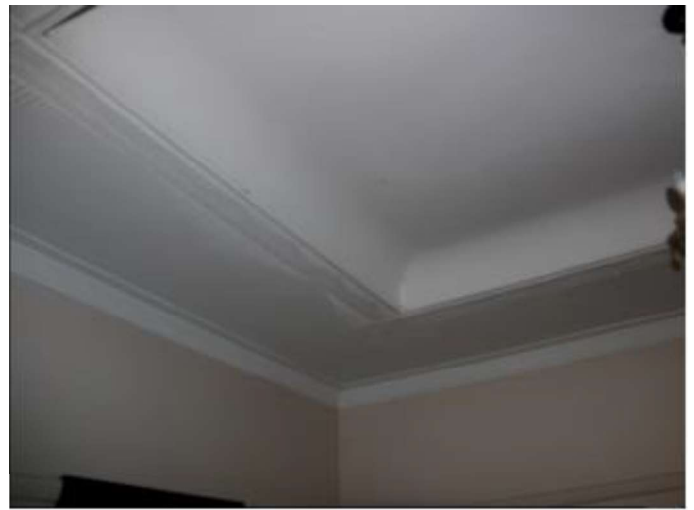
In contrast to the severe deformations evident in the exterior and floors of the structure, internal distress predominantly consisted of minor cracking of plaster-work ceilings, minor cracking and separation of cornices and some straining of horse-hair plaster sheet linings, where joins are concealed beneath moldings and battens. Despite being finished with a decorative plaster ceiling and cornice, damage to the living room was moderate, with the most severe damage shown in Figure 6.

a) relatively minor damage to decorative plaster ceiling

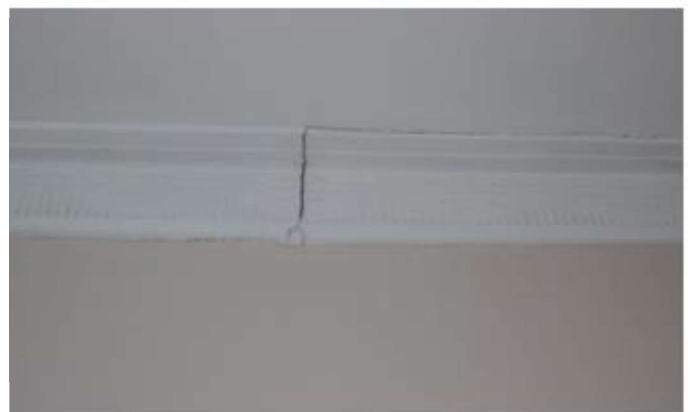
b) most severe damage observed in internal linings.

Overall, the internal damage was classified as Damage Category 1 – 2 in accordance with AS2870 - 2011, with minor areas of Damage Category 3 – 4 limited to that shown in Figure 6. However, the significant differential movement in the floor of the residence is well above any suggested limit values derived from AS 2870-2011 or those summarized in Appleyard (2011). It was concluded that despite the mild damage to internal and external walls, the house was rendered unserviceable by the significant differential settlements of the floor plate.
