Collapse of the Old Pacific Highway, Piles Creek, Somersby

S.J. Clarke, G. Mostyn & B. Shen
Pells Sullivan Meynink

ABSTRACT: On 8 June 2007 a section of the embankment collapsed along the Old Pacific Highway at Somersby, New South Wales (NSW), Australia. The collapse occurred during a heavy rain storm, at a location where three corrugated steel pipes conveyed Piles Creek through the base of the road embankment. Not long after the collapse, a car drove into the resulting void and all the occupants drowned in the flooded creek.

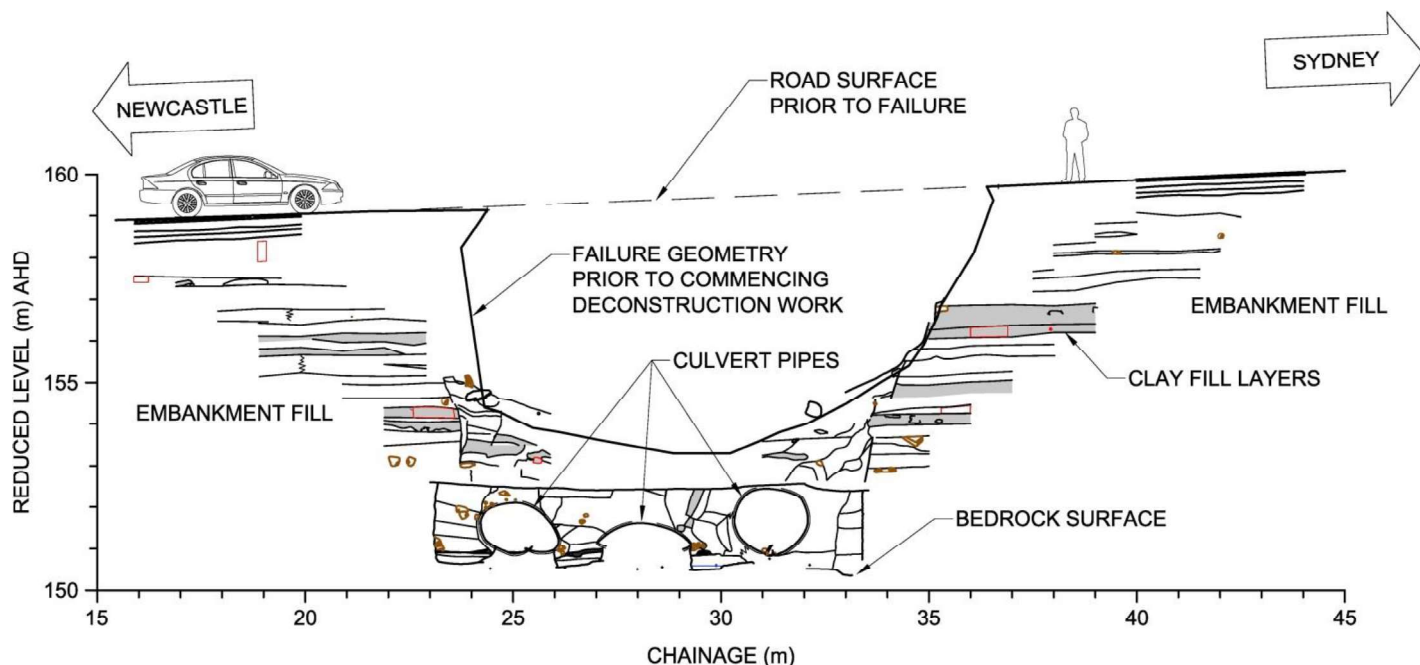
The causes of the failure were the loss of the pipe inverts, and subsequent ground loss into the pipes leading to increased erodibility of the loosened and voided fill, with the failure triggered by the flood event.

Once the flood waters had receded, a gap in the road of 11.5 m length was left, with a void up to 7 m depth below the adjacent intact road surface. The top of the pipes were visible in the base of the void.

Figure 1. Section along the Old Pacific Highway showing the failure geometry and damaged culvert at Piles Creek.

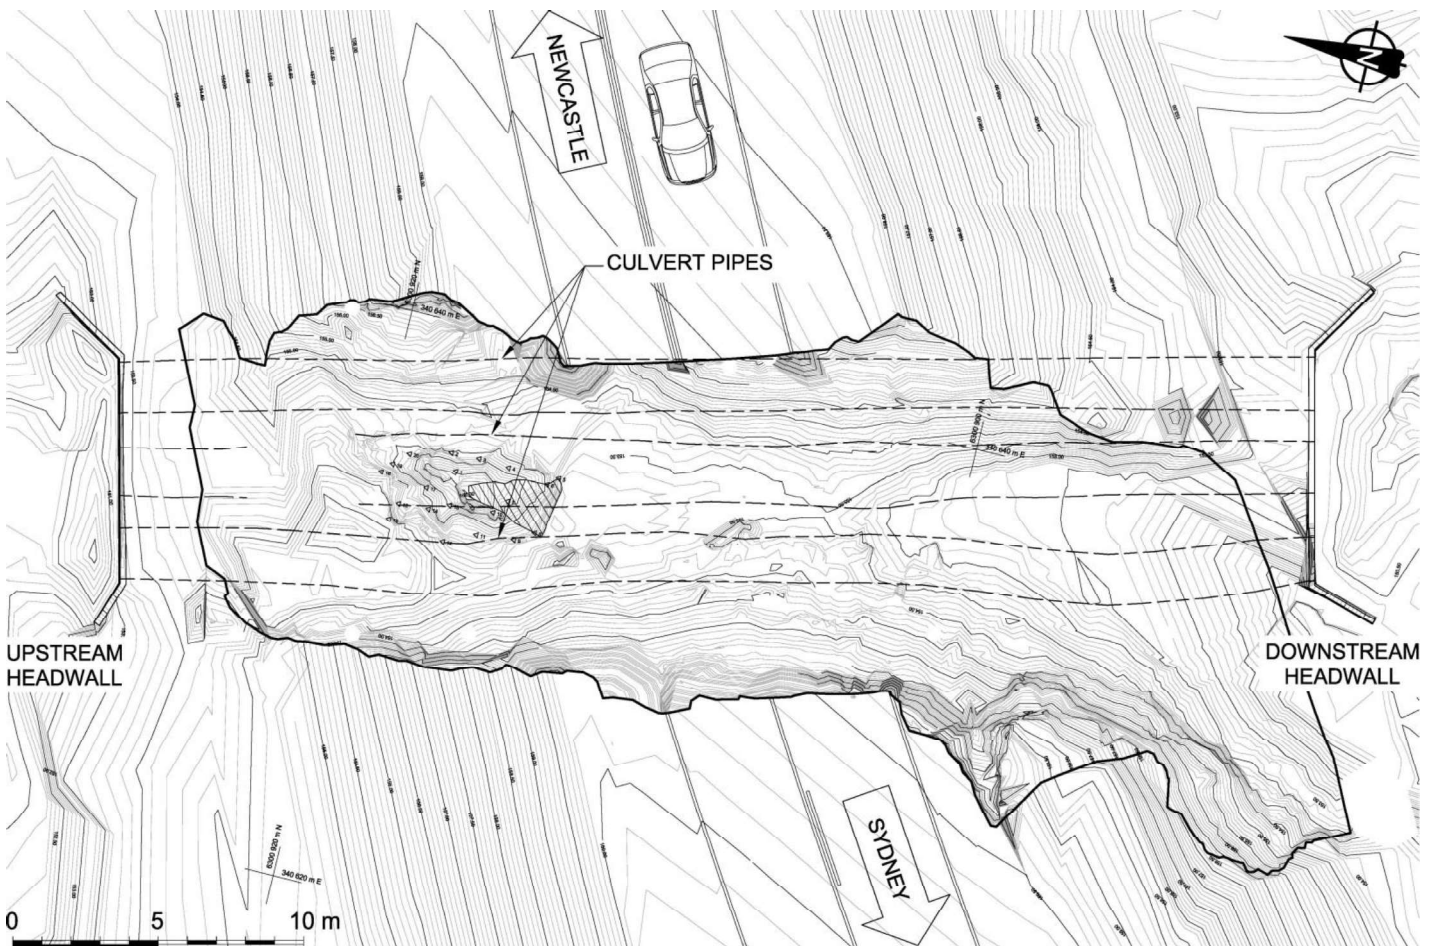
Figure 2. Plan view of the remaining road embankment and failure geometry at Piles Creek.

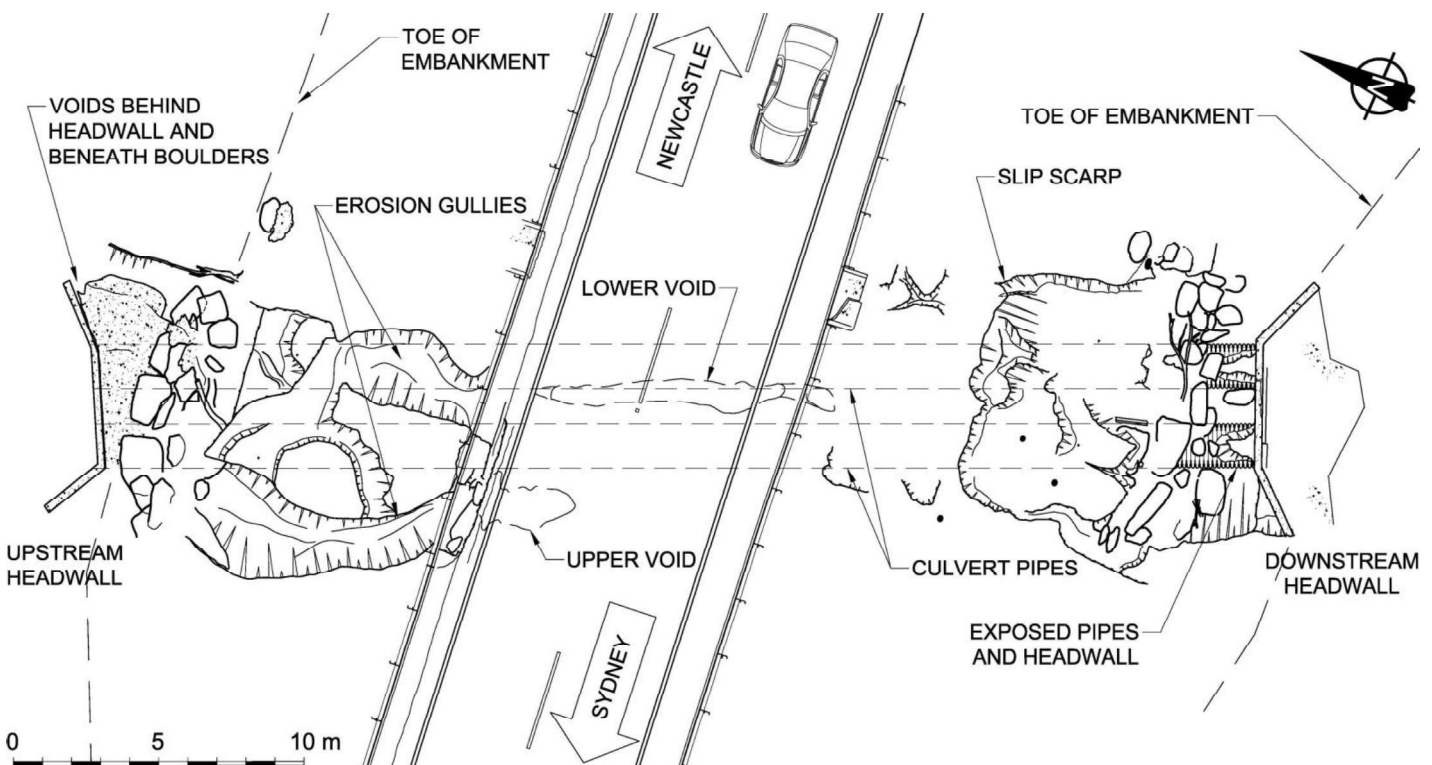
Figure 3. Plan of Leask Creek culvert, showing main distress features found during the investigation.

Voids behind the headwalls and beneath the boulders on the upstream face were apparent prior to the deconstruction works, as described above. Two additional voids were found during deconstruction of the embankment (Fig. 3 and Fig. 4).

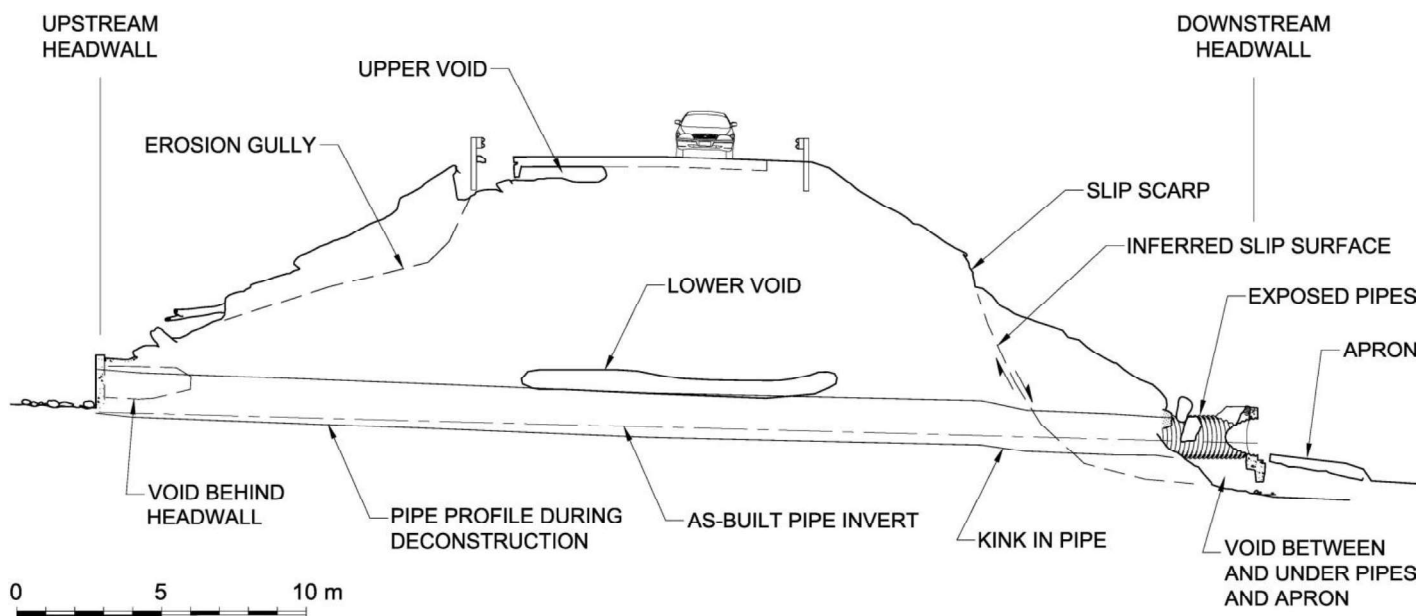
Figure 4. Long section through Leask Creek culvert, showing features found during the investigation.

The pipe survey also indicated the presence of a change in level of about 0.2 m over a length of 1.5 m about 9 m from the downstream headwall. Based on this kink, DCP test results, survey monitoring, and the scarp observed on the surface, the location of a slip surface was inferred (Fig. 4).

Stability analysis of the slope indicated that failure would not occur for the original embankment slopes, strength parameters corresponding to compacted fill, and low groundwater levels. Further analysis indicated unstable slope conditions associated with over-steepening from loss of material around the headwall, reduced strength of the disturbed fill, and higher groundwater conditions, consistent with the observed slip surface.

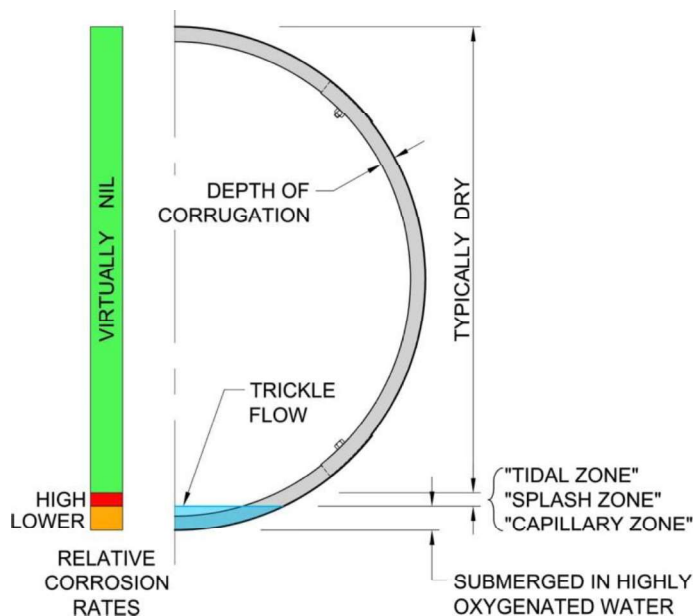
Figure 5. Relative corrosion rates in corrugated steel pipes.

Three zones of corrosion are shown in Figure 5:

1. The upper portion is normally dry and exposed only to atmospheric corrosion. The corrosion rate is virtually nil. The bituminous coating was still present over most of this area at both Piles Creek and Leask Creek.

2. The lowest portion is permanently submerged by trickle flows. It is exposed to highly oxygenated water and thus presents a moderately corrosive environment. It is subject to periodic erosion by hydraulically transported sand, which is sufficient to remove the products of corrosion (e.g. rust), particularly on the upstream sides of the corrugations.

3. A small zone is located above the trickle flow level and subject to continual wetting and drying. Various terms are used to describe the zone just above the water level, e.g. tidal zone, splash zone, and capillary zone. It experiences high corrosion rates as well as periodic erosion, particularly on the upstream sides of the corrugations.

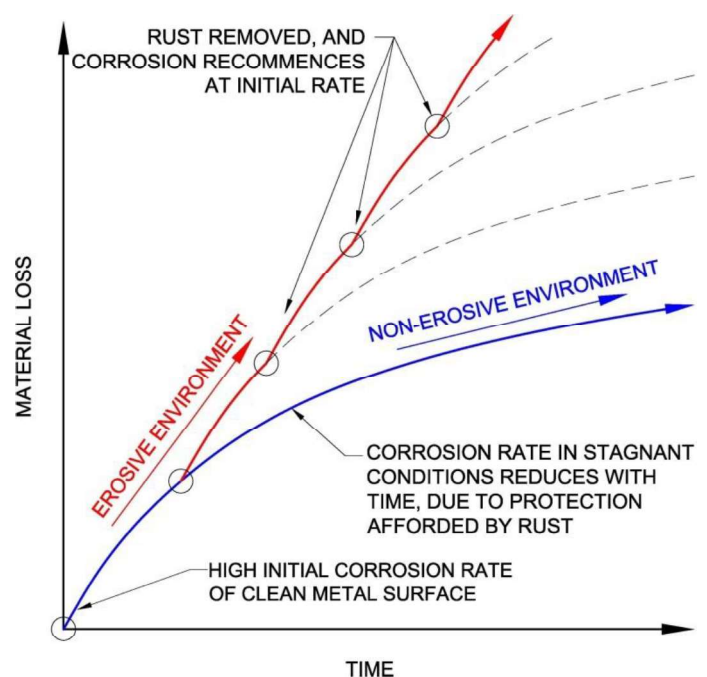
Figure 6 compares the rate of metal loss for an erosive environment against non-erosive conditions (e.g. stagnant). In stagnant conditions the rust layer inhibits diffusion of oxygen to the metal, such that the rate of material loss reduces with time. For an erosive environment the corrosion products are periodically removed, such that the process

recommences at the initial higher rate of corrosion. This erosion mechanism is associated with removal of the weaker products of corrosion rather than of the base metal itself. It follows that an erosive environment results in an increased rate of material loss compared to a non-erosive environment.

Figure 6. Rates of material loss from corrosion in erosive and non-erosive environments.

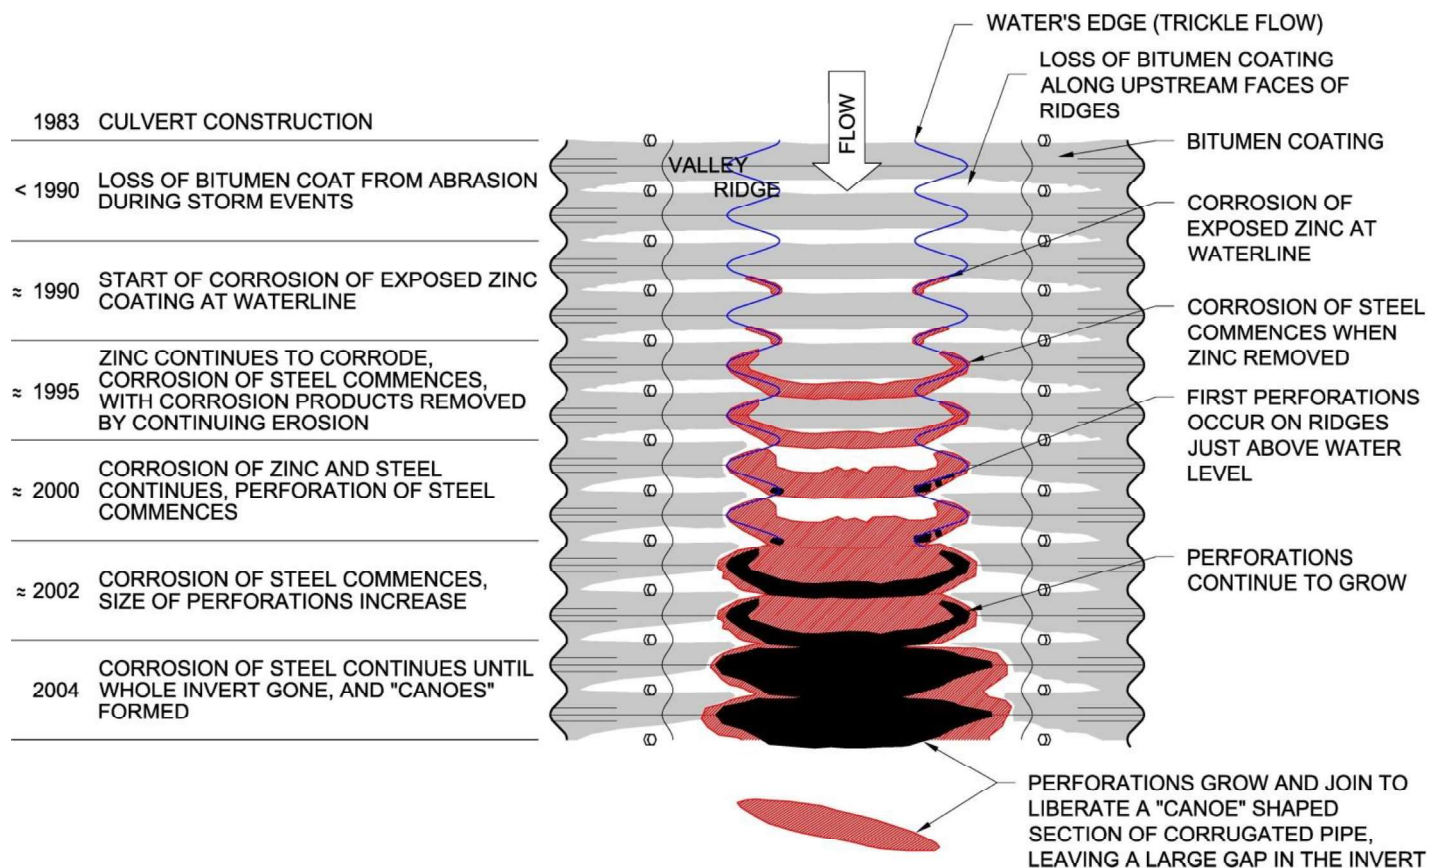
Corrosion of the zinc starts along the waterline, followed by corrosion of the underlying steel. The extent of the corrosion increases and follows the upstream side of the corrugations in the invert. The first perforations occur on the ridges along the waterline, and then coalesce to form a broad “U” shape, before finally joining to liberate a “canoe” shaped section of corrugated steel. Thus the progression from initial perforation to complete loss of the invert is quite rapid.

The mechanism illustrated in Figure 7 was supported by observations of the recovered Piles Creek and Leask Creek pipe culverts, as well as several other corrugated steel culverts inspected in nearby districts which were at varying stages of this process. The liberation of the canoe-shaped section occurs over a short period of time, such that the chance of observing this stage is low, but “canoes” were recovered during the investigation. Gadsby (1974) describes corrosion mechanisms observed in culverts in Victoria that are consistent with that shown in Figure 7.

Figure 7. Plan of pipe invert showing progressive stages of corrosion. These stages are shown on one section of pipe for the purposes of brevity only – in reality only one stage occurs at a time.

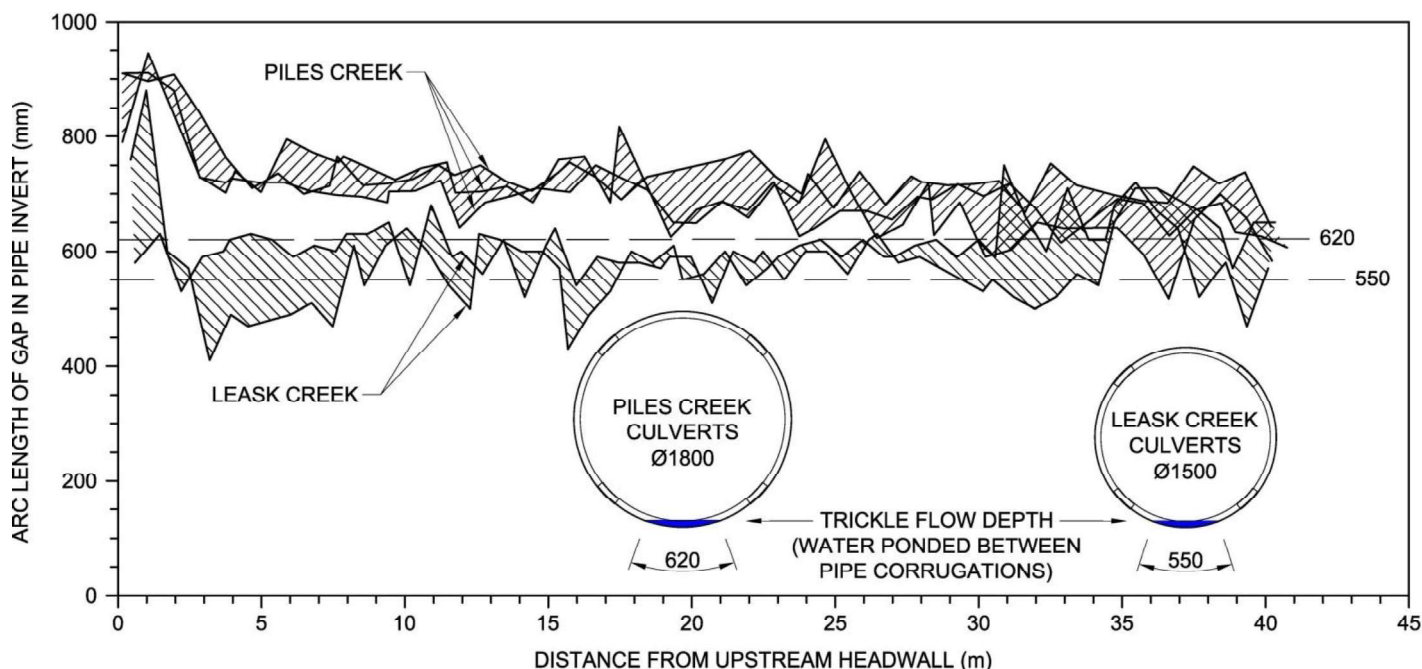
Figure 8 shows a graph of the measured circumferential gap in the invert of the Piles Creek and Leask Creek pipe culverts, together with the arc length of the intact pipes submerged by trickle flows. It can be seen that the extent of metal loss coincides with the width just above the trickle flow level.

Figure 8. Comparison of gap length in Piles Creek and Leask Creek pipes with length of pipe invert inundated by trickle flows.

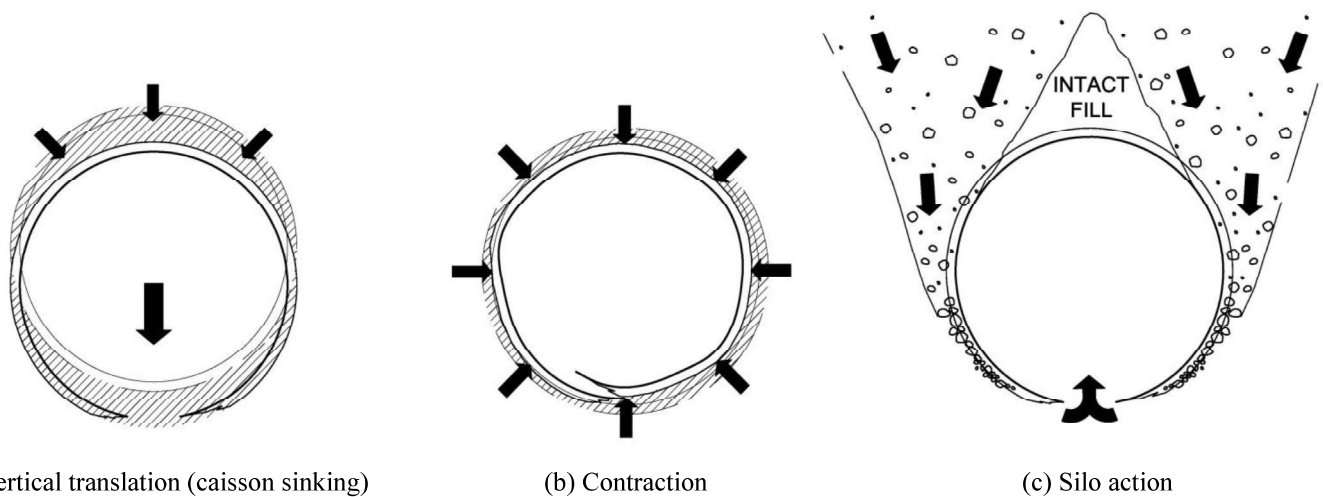
flushing action tends to remove the finer sized fill particles, leaving coarse grains around the pipe, as was observed during construction (Fig. 9c). The rate at which the silo action occurs is dependent on the rate of water level changes, and on the frequency and magnitude of such events. Based on the comparison of hydrology presented in Table 2, Leask Creek would be much more benign in these respects than Piles Creek.

Fill becomes disturbed when it undergoes transportation or reworking and loses its original structure, with associated reductions in stiffness, strength, and density (i.e. loosening). It may also experience segregation in which some of the particle sizes are separated from the remaining fill (Fig. 9c).

The ground loss mechanisms shown in Figure 9 result in disturbance to the fill where it fails and displaces towards the “lost” material, or formation of voids where the fill has sufficient strength.

Figure 9. Ground loss mechanisms associated with loss of pipe invert.
