# Rock Structures and Associated Rock Alteration, Danjera Creek Dam, N.S.W.

A. D. M. BELL, M.Sc., M.Aus.I.M.M.

**SUMMARY.** - Danjera Creek damsite is an interesting case history of the association of rock structure and rock alteration. The most critical conditions are where fracture zones form permeability paths for hypogene and supergene circulations. Petrographic studies combined with structural analysis indicated sub-surface rock defects. At this damsite bedrock is comprised of steeply dipping intercalations of low-grade meta-sediments and basalt. Rock defects are caused by a combination of fracture and alteration associated with possible thrust faults. The "axial plane" of an anticline is parallel to the valley and dips  $70^{\circ}$  W. The resultant discontinuity pattern is asymmetric to the valley profile and rock cuts in the right abutment are less stable than those in the left abutment. Later deformation produced two fault/fracture sets at  $50^{\circ}$  and  $90^{\circ}$  to the valley axis. Secondary fracture porosity is greatest at the intersection of faults and is associated with alteration within basalt. Decomposition of basalt was initiated by hypogene circulation

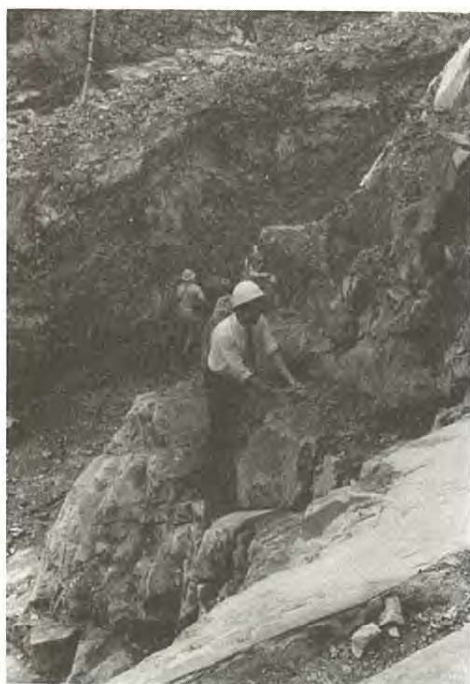
Fig. 2 - Slip surface on low-angle cleavage in meta-sediments.

- i) Instability in the right abutment where three discontinuities trending parallel to the slope form potential slip planes viz. bedding planes with dip  $60^{\circ}W$ ; "axial plane" faults and cleavage with dip  $70^{\circ}W$ ; cleavage with dip  $35^{\circ}/40^{\circ}W$ .
- ii) The presence of zones of alteration in fault zones within the valley floor basalt - see Fig. 3.
- iii) The irregular depth to sound bedrock due to

- a) Lowering the buttress foundation level in the abutments to alleviate slip on the low angle ( $35^{\circ}$ ) cleavage planes.
- b) Excavation of highly fractured fault zones then backfilling with mass-concrete to a height which would effectively buttress less stable slopes - see Fig. 5.

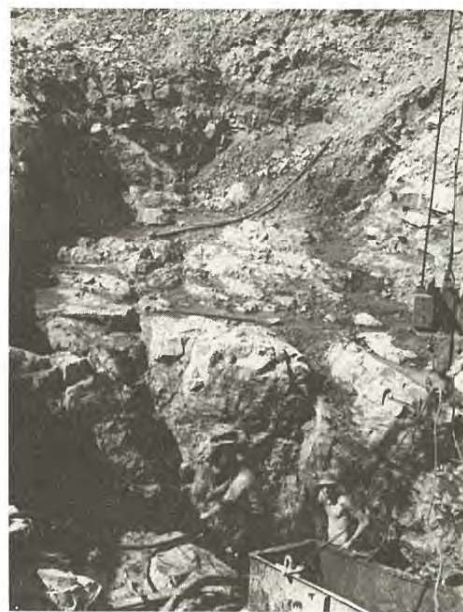
Sulphide mineralization is prominent in faulted basalt with a quartz, calcite, pyrite, galena assemblage. Wallrock alteration occurs in mineralized zones with the rock substance grading from plastic clay to clay-basalt of moderate strength. The zone of alteration is a few feet wide along fault lines increasing in thickness within highly fractured basalt at fault intersections. The strength of fractured decomposed basalt increases with depth as the effect of supergene groundwater percolation decreases. The most critical zone of alteration was found in the eastern part of the valley floor where three fault sets intersected. A mass of clay, clay-basalt and fractured basalt extending over an area of 30' x 60' was excavated to 30' depth.

Fig. 3 - Clay seams and altered fractured basalt in fault trench.

- e) Examination of the basalt was initiated, weak rock excavated and backfilled with mass concrete. Longitudinal faults (i.e. normal to the dam wall) were trenched and sealed with concrete to increase the permeability path of water circulation below the structure and prevent scouring.

- f) Cross-faults in the valley floor basalt were excavated and the excavations utilized to pour concrete ribs between buttress footings. This method of strutting between buttresses will resist any earth pressures which might develop tending to rotate the buttresses in the valley floor.

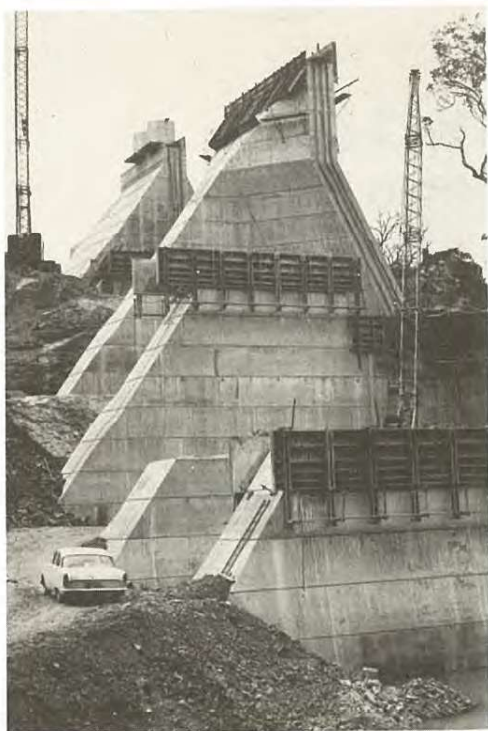
The dam is an articulated diamond head buttress design approximately 120 feet in height (see Fig.4) which has relatively low foundation loading, but needs uniform foundation conditions and stable abutment slopes. At the initial excavation stage (1969) it became apparent that the bedrock was highly fractured in fault zones and that rock alteration associated with mineralization would occur within the basalt. Three problems were to be expected:-

Fig. 4 - Right abutment.

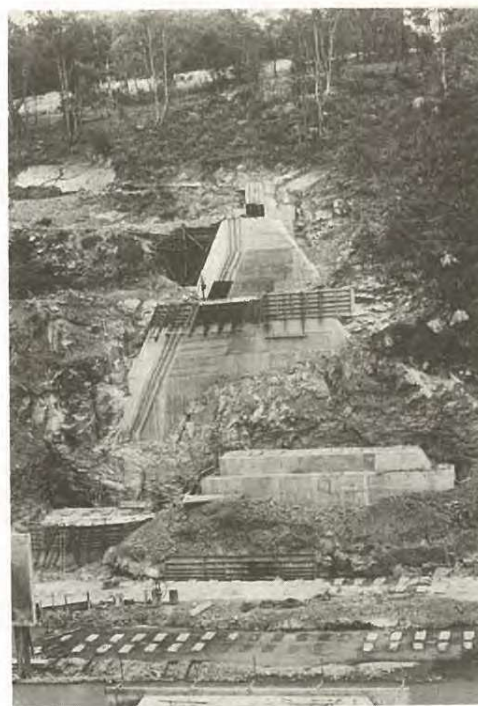
Fig. 5 - Left abutment - note buttress foundation supporting base of cut.
