Stabilizing a Landslide Above Fisher Penstock, Tasmania

SUMMARY. A landslide occurred in talus above the penstock during commissioning trials for the Fisher Hydro-Electric Scheme. Investigations showed the slide to be initiated by pore pressures generated by a substantial rise in the water table resulting from leakage of tunnel pressure water. Control was effected by drainage by means of an adit system in the underlying bedrock and by establishing a curtain of drainage holes drilled through the talus from the surface and into the adit.

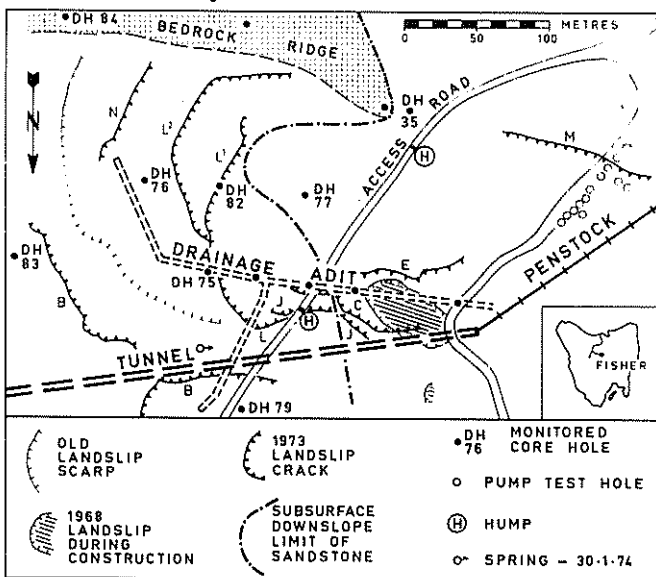
Fig. 1 Locality plan

Commissioning trials for the Fisher Hydro-Electric Scheme (Ref. 1 & 2) began in December, 1972, and a landslide in talus was observed in progress above the tunnel outlet portal on 4th April, 1973. The slide (Fig. 1) affected an area mostly south of the tunnel 150 to 210 m wide and extending up slope for 360 m. The upper penstock and tunnel were immediately drained, but gradual minor movement continued for about two months. Movement did not seriously affect the penstock though it is sited on talus for a distance of 180 m near the outlet portal.

When inspected on 5th April the main cracks (Fig. 1) were B, N, L, L₂, C and D. The humps in the road were present and an echelon cracks were visible between B and L and between N and the lower hump on the road. A mudflow had formed where crack D crossed the construction slip area and water flowed freely from it. This area was oversaturated and completely cracked. Another spring flowed from a crack south of the lower hump on the road and smaller seeps were present especially along the Permian outcrops. The whole area was interlaced with surface cracks from a few metres to 30 m apart, with crack widths up to 200 mm and vertical movement of up to 1 m. The general heading of the slip was towards the penstock. Further movement extending crack J and causing a drop of 600 mm along crack L occurred on 10th

Because there was little velocity contrast between the water saturated talus and the Permian bedrock, the seismic survey was unsuccessful in delineating the bedrock profile and data was obtained by drilling. Beneath the penstock the bedrock surface has a 1° slope developed on mudstone and siltstone, but a steep change in slope occurs along the line of the subsurface downslope limit of the main sandstone bed (Fig. 1), and above the change the surface has a 10° slope developed on sandstone.

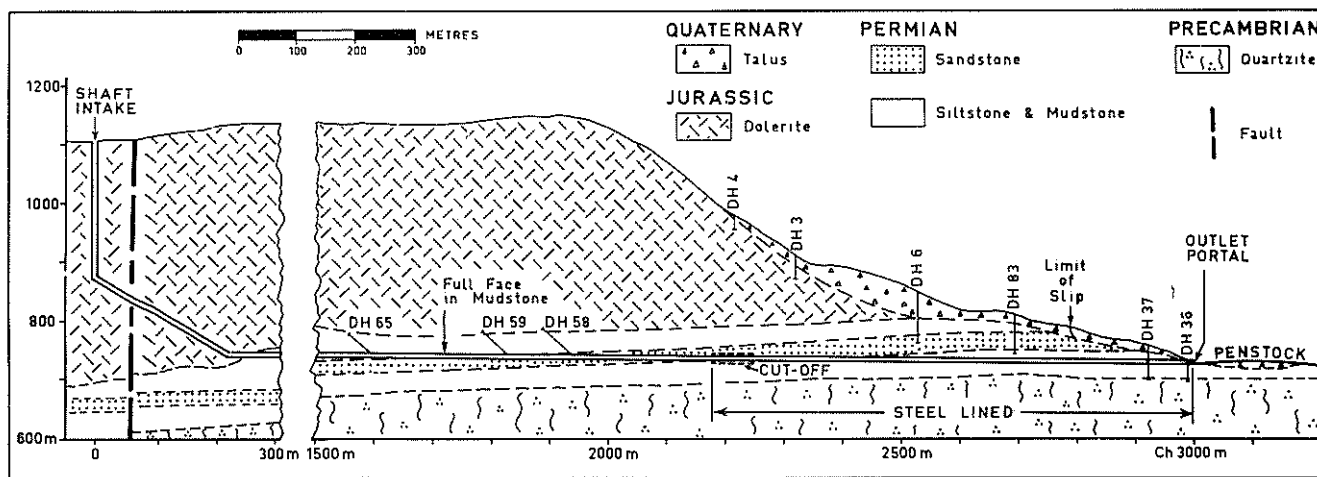
Fig. 2 Geological section of Fisher Tunnel

The 'Mole' bored section of the tunnel (Chainage 254 to 3 000 m, Fig. 2) was generally lined with unreinforced concrete of 230 mm nominal for structural reasons. A major fault at ch. 709 m received a steel liner and the thickness of the adjacent concrete lining was increased to 550 mm. An open jointed and seamed area at ch. 1 905 to 1 926 m also received the thicker lining. A steel liner was installed for a distance of 820 m from the outlet portal, and at the upstream end of the steel liner the first 73 m was grouted to form a 'cut-off'. The rock-concrete interface of the cut-off was grouted through holes drilled 1.5 m into rock at up to 2 800 kPa, and a curtain was established at each end of the grouted section by grouting at 700 kPa via holes drilled 6 m into rock. About 17 t of cement was used.

Tunnel water can reach the slip area via the interlocking joint and fault systems. The path in the dolerite is long permitting dissipation over a wide area, thus the most probable path is via joints and faults in the sandstone beds situated from ch. 2 174 to 1 714 m. The tunnel grout cut-off was established in the main sandstone bed and grouting had been carried out for a distance of 247 m upstream. This left some 212 m of tunnel within the sandstone bed with free connection with joints and seams by means of the pressure relief holes. The major fault at ch. 709

to 715 m probably also provides a leakage path from the tunnel to the joint systems in the main sandstone bed, which at this location is below the tunnel. The upper limit of the slip was located within the contact zone of the major sandstone bed with the base of the talus, and springs occurred above the contact of the lower boundary of the bed with the base of the talus.

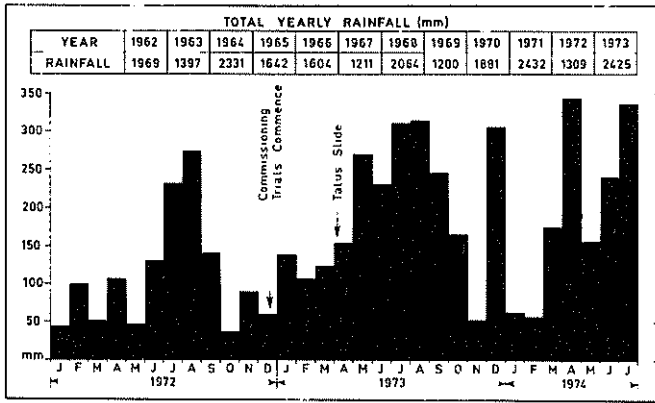
Fig. 3 Cumulative rainfall at Lake Mackenzie

The rainfall pattern for the area is shown on Fig. 3. The commissioning period from December, 1972 to April, 1973 was wet, but the following months were wetter and this produced no significant change in groundwater activity or ground movement. Clearly the landslide was not the result of exceptional rainfall.

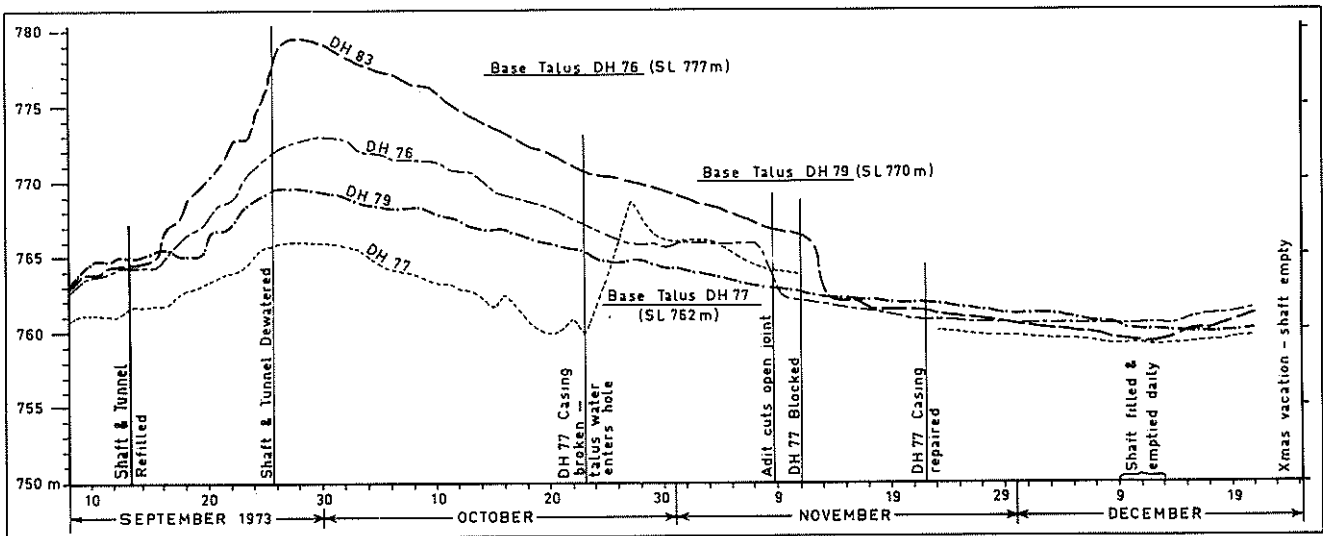
Fig. 5 System test filling - plot of water levels in some of the drill holes recording water movement in the Permian bedrock

The system was refilled on 13th September, 1973 and dewatered on 25th September when it was clear that the water level could rise to the base of the talus over a considerable area. A plot of water levels in some of the holes recording levels in the bedrock is shown on Fig. 5. It shows the marked and rapid rise following filling and the slow fall subsequent to dewatering.

The mechanism causing the landslide was then clear. Continued leakage from the tunnel raised the water table in the bedrock joint systems such that near artesian conditions were created owing to the presence of an overlying blanket of talus of low permeability. The pore pressures generated were sufficient to initiate basal shearing, presumably along the talus bedrock interface.

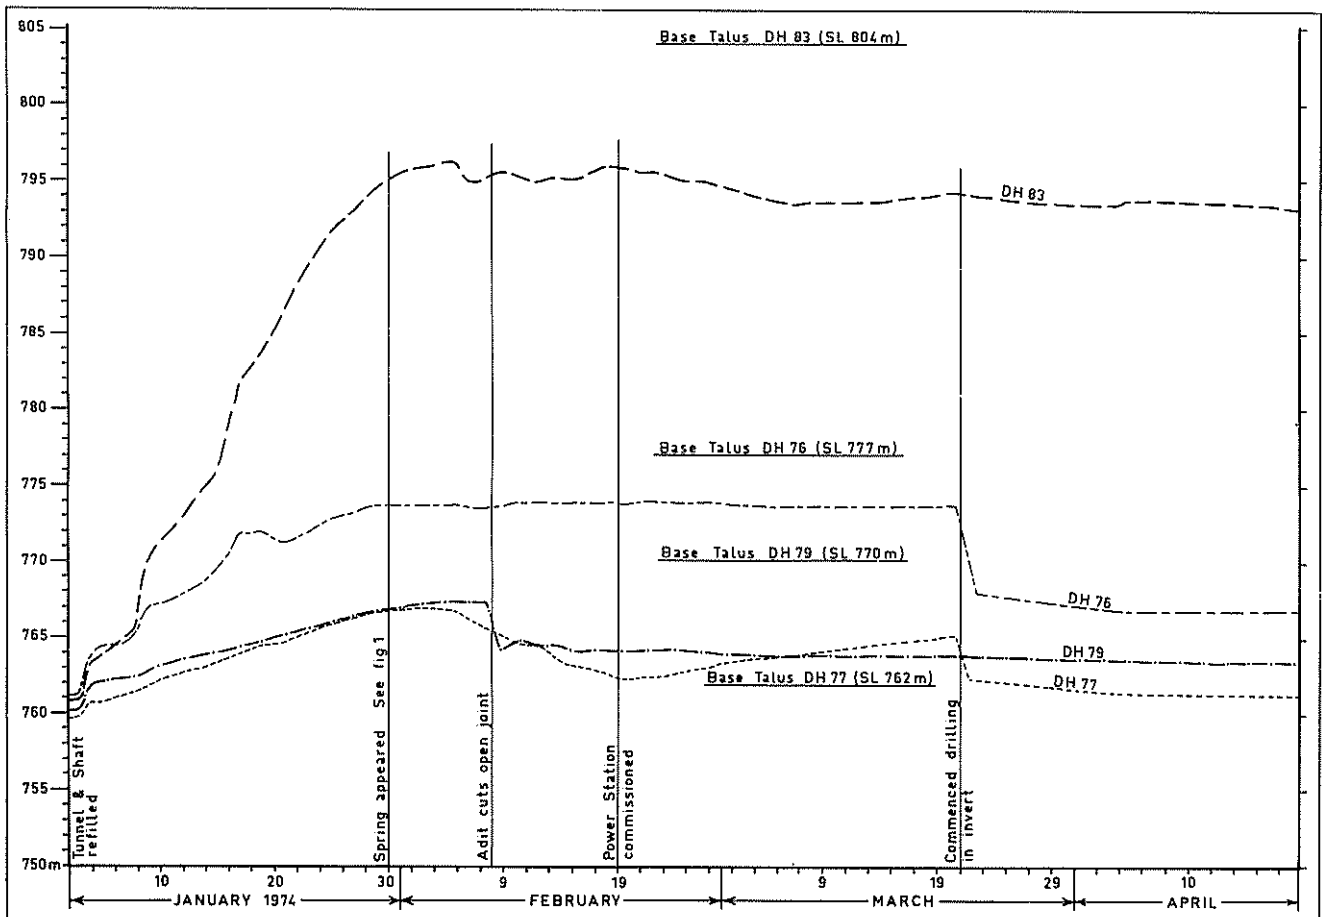
Fig. 6 System re-commissioning - plot of water levels in some of drill holes recording water movement in the Permian bedrock

As shown on Fig. 6 the level in each recording hole reached a maximum, then remained relatively steady with a flow of about 270 l/min into the adit. A spring (Fig. 1) appeared upslope from the position of the north branch of the adit on 30th January, just before the maximum level was reached, and this has built up and maintains a flow of 70 l/min.

Aditing ceased on 18th February and activity was then concentrated on improving the flow into the adit by drilling holes from the adit to intersect open joints. A series of 6 m long blast holes were drilled from the spring line to intersect any perched water. Some produced good flows but most were only damp. Diamond drill holes up to 30 m long were drilled upwards and downwards. These produced good flows and raised the flow into the adit to 410 l/min. It is interesting to note that it was the last series of holes, those drilled downwards into a minor sandstone bed, that produced the most dramatic fall in level in the recorder holes and lowered the level in holes downslope from the adit branches to below the base of the talus.
