# Special Instability Problems in the Illawarra and Warringah Shire Areas of New South Wales

R. H. AMARAL, B.A., B.A.Sc., M.A.Sc., M.I.E.Aust.  
Director, Golder Associates Pty. Ltd.

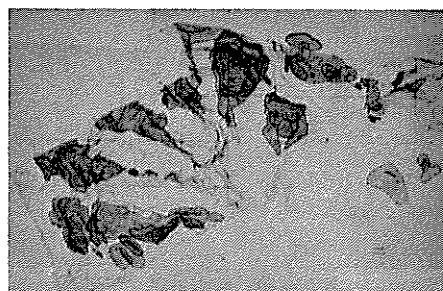
Fig. 3 Unstable areas within 45 hectare site, Figtree (Illawarra)

Area of Slide (hectares)	Depth of Soil in Slide Area (metres)	Average Slope Angle	Comment
FIGTREE SITE - Percentage of unstable area = 35% (15 hectares out of 43.5 hectares)

4.1	0 - 3	15°	. within old slide area - springs evident
1.8	1½ - 4½	12°	. within old slide area - springs evident
1.3	0 - 3	14°	. within old slide area
3.7	1½ - 3	16°	. within old slide area - springs evident

1.5	1½ - 6	15°	. within old slide area
1.5	3 - 6	15°	. within old slide area
0.4	1½ - 4½	11°	
0.1		16°	
0.7		12°	. within old slide area
UNANDERRA SITE - Percentage of unstable area = 9.2% (14.7 hectares out of 160 hectares)

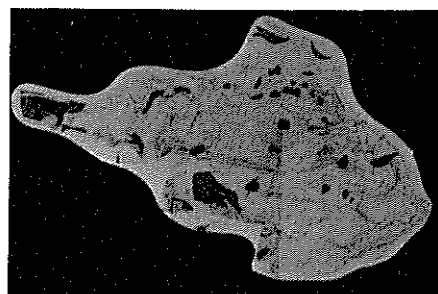
Fig. 4 Unstable areas within 160 hectare site, Unanderra (Illawarra)

3.78	0 - 3	20°	. within old slide area - springs evident
0.36	1½ - 3	22°	. within old slide area - springs evident
0.06	0 - 3	18°	
0.09	0 - 3	18°	
0.40	0 - 3	20°

0.11	0 - 3	21°	. springs evident
0.11	0 - 3	22°	. springs evident
0.28	0 - 3	22°	
0.16	0 - 3	19°	
0.15	0 - 3	22°	
0.17	0 - 3	16°	
0.24	1½ - 3	15°	. within old slide area - seepage evident

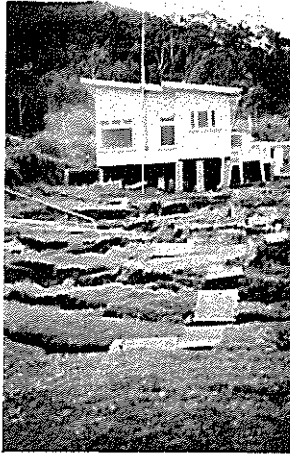
As with most of the earth slides in the Illawarra the area of these movements is large in comparison with their depth. As may be seen from Table III the depth of these slides is generally less than 5 metres and often less than 3 metres. It is considered that the major portion of these movements fall into the category of "sheet slides" or "earthworks" (Zaruba, 1969). Two typical and related features of these movements are the apparent extensive internal movements within the moving earth mass (as evidenced by closely spaced tension cracks, see Fig. 5) and the obvious "flow" pattern resulting from the slide (see Fig. 6).

Fig. 5 Coledale Heights, Illawarra - Note closely spaced tension cracks within failed area

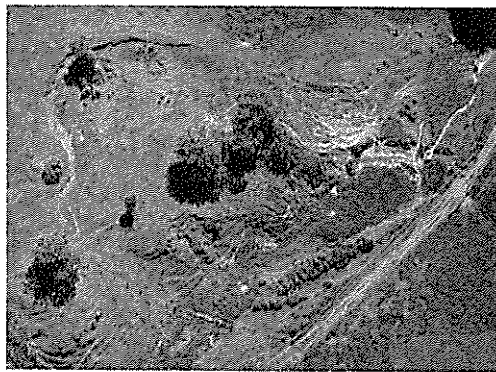
Fig. 6 Gerringong area, Illawarra - Note "flow" pattern of "sheet" type slide

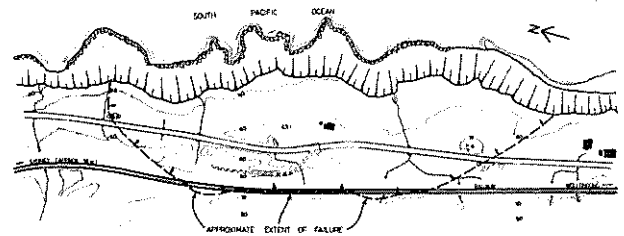
An earth slide to the immediate north of Coalcliff Railway Station (Fig. 7 below) on the South Coast (Mile 36) exhibits several features typical of the slides described above. A mass of soil having a plan area of approximately 9 hectares an average depth of approximately 7 metres (determined from borings and a seismic survey) and a ground surface slope of about 7° (1 vertical to 8 horizontal) has moved progressively to the east on a sloping rock surface of approximately the same angle of inclination. Groundwater level fluctuations of up to 4 metres have been recorded in borings within the slide area by the Rail Division of the Public Transport Commission of N.S.W. (unpublished report). Continuous pumping from a single row of well points discharging an average of about 7 gpm over a four month period was successful in lowering the groundwater level some 1 to 1½ metres. During this period a total of approximately 4,800 points of rain fell at the nearby Stanwell Park monitoring station. In addition to the single line of well points extending into the underlying rock a series of horizontal drains have been installed through the fill and talus overburden and into the shale/sandstone bedrock. The most successful of these drains yielded an average of some 4 gpm during the very wet period from October, 1973 to July, 1974. In general the total yield from the rock formation and overburden soils was not large but this approach does show promise in lowering the groundwater level in this area and in helping to control the land slip.

Fig. 7 Slide area of 9 hectares involving railway line and main road, Coalcliff (Illawarra)

It has been noted by Public Transport Commission Engineers investigating this slide that movements often occur two to four days after heavy rain even though the intensity of storm runoff in this area is very high and the duration correspondingly short. The rise in the groundwater level (and possibly excessive hydrostatic pressures) appears to be related to subsurface seepage through the rock and/or along the soil rock interface from a source remote from the slide area.

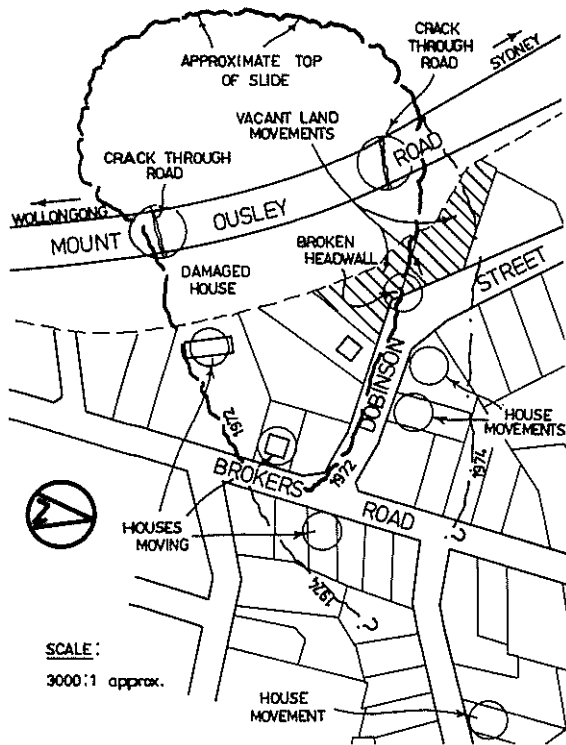
An old failure in the Mount Ousley area (Fig. 8) has become active again during the period from March, 1972 to at least August, 1974 after heavy rains. The area of this obviously unstable area was about 3 hectares in 1972 but is now about 4 hectares. The depth of the unstable area appears to be about 4 to 6 metres and the average slope of

the talus soil cover is less than 10 degrees.

Fig. 8 Large slide in built-up area of Mt. Ousley, Wollongong (Illawarra) involving several properties.

A combination of low soil strength with perhaps a "residual" angle of internal friction of between 8 to 12 degrees and an artesian groundwater condition are considered to be responsible for the continued movement of this earth slide. The use of "residual" strength parameters in this case are justified by the fact that this is an old slide with records of previous movements dating back to at least 1951. The existence of an artesian condition was demonstrated during drilling operations on a nearby property when water was encountered at a depth of 5½ metres in an underlying coal seam, rose up the open hole and flowed out at ground surface.

It is also believed that the source of this seepage water is remote from the slide area itself since major movements of the soil mass (as determined by survey measurements on a house within the slide area) tend to occur three to four days after heavy rain. It is hypothesised that water enters the rock formation at locations above the slide area, seeps through the rock mass towards the east and becomes trapped beneath the relatively impervious blanket of clayey talus. It is further hypothesised that the hydrostatic pressure beneath and within the talus increases to a maximum some days after the rainfall (and peak surface water runoff) thus causing the delay in movement.

In view of the very large capital investment that has already been made in this slip area (a major state highway, two Council Streets, at least 11 private properties and ancillary water supply and electricity installations) it is obviously important to arrest this movement. Although technically feasible, very little effort has been made to prevent further movements. It is believed that the basic reason for this inactivity is the complex legal situation whereby State, Local Government and private individuals are all caught

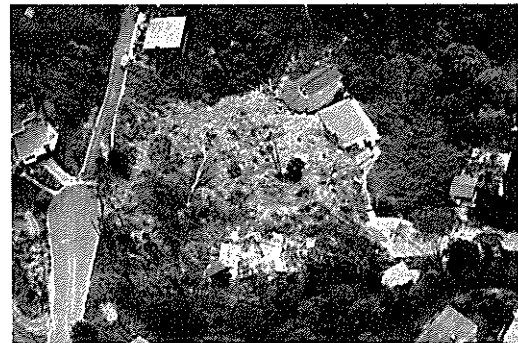
One of the more tragic earth slides to take place in talus material in either the Illawarra or Warringah Shire areas in recent years is that which occurred during the early months of 1972 in Newport (Fig. 9).

Fig. 9 Aerial View, Belinda Place Slide, Newport (Warringah Shire)

The area of the slide is approximately 0.37 hectares and has effected some seven private properties, two Council Streets and a Council footpath. Two new homes have been completely lost to date and another home is on the verge of being lost. The average depth of the sliding earth mass before failure was estimated to be 4 to 5 metres and the average slope angle 21 degrees. The depth of the soil cover was determined by means of borings and seismic traverses.

As with the vast majority of slides investigated in the Illawarra this failure occurred along the interface between the underlying sloping rock surface and the talus overburden following heavy rain. This slide is also similar to many others investigated in the Wollongong area in that the underlying rock is near horizontally bedded and there is an elevated plateau uphill of the site which acts as a catchment for water percolating into the rock mass. The free drainage of this percolating water from the bedrock is hampered and restricted by the clayey talus material.

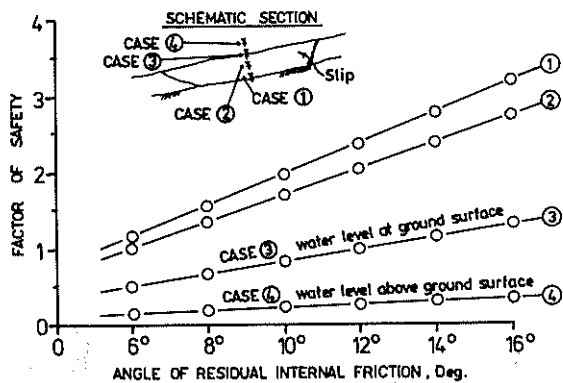
During the heavy rains of early 1974 an earth slide occurred on an 8 degree slope towards the base of Mount Brown in Dapto. The area of the slide was about 0.6 to 1 hectare and the average depth of the sliding earth mass was about 4 metres.

The soil cover in this case is colluvium consisting essentially of silty clay (CH) and the underlying rock is siltstone. An examination of the site immediately after failure revealed several local "springs" where water was bubbling out of the ground, evidently under a slight excess hydrostatic "head" relative to ground surface.

The results of a sensitivity analysis carried out on this failure are given in Fig. 10 where it may be seen that failure would occur when the groundwater level reached ground surface for a  $\phi_r$  value equal to about 12 degrees. For a  $\phi_r$  value in excess of 16 or more degrees, failure would still occur if a hydrostatic head equivalent to a water level above ground surface developed along the failure plane.

Fig. 10 Sensitivity analysis of slide area, Dapto (Illawarra) involving several building blocks
