Controls on slope failure and erosion in weak rock to strong soil in the coastal escarpment west of Matata, New Zealand

James M. Arthurs, Warwick M. Prebble, Colin J.N. Wilson

Institute of Earth Science and Engineering, and Geology Programme, SGGES, University of Auckland

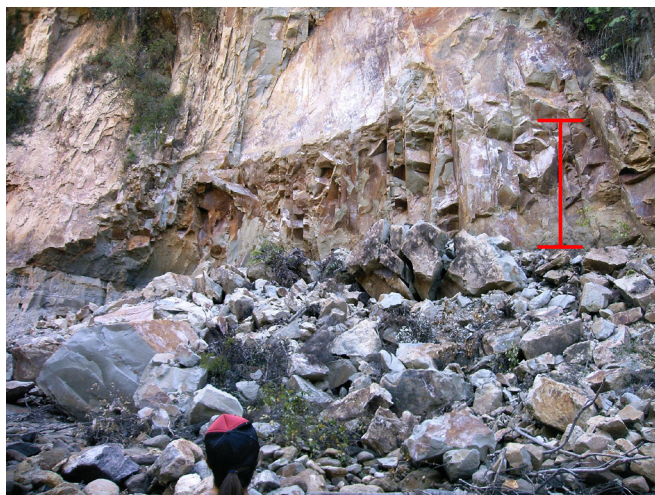
Figure 2-Rock Fall in Awatarariki Stream. Scale bar is approximately 3 m.

As noted in Section 2, the clayey silt below Tephra A is underlain by the easily erodible lower sand. When the contact between the sand and silt deposits is exposed near a stream or road level, slope failures become ubiquitous. As stream water or rainfall drainage flows along the face of the exposure, it removes the sand, undercutting the clayey silt or “mudstone”. Soon after undercutting, a slab of this material will drop or slide off of the cliff face, usually along fractures. In some cases, smaller blocks will regularly fall from the face, rather than a single catastrophic failure (Fig. 2). According to the classification of Cruden and Varnes (1996), these landslides classify as active, retrogressive, complex, rapid to very rapid, moist to wet, rock slide-falls.

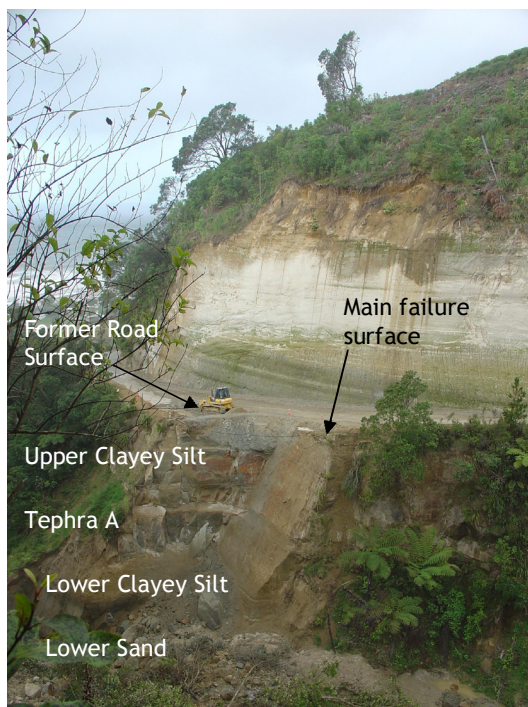
Figure 3- Landslide from 2005 floods below Herepuru Road. Ohinekaia Stream bed and the sand layer are visible in the bottom of the picture. Tephra A is ~ 1 m thick.

This style of erosion poses the greatest hazard to Herepuru Road, located 3 km west of Matata (Fig. 1). At this site, erosion of the sand layer mentioned above by the Ohinekaia Stream, which runs generally parallel to the road, has caused rock falls that undermined or removed the road platform in 2005 (Fig. 3). Further east, surface drainage at the side of the road is sufficient to cause erosion of the same sand unit and to trigger rock falls onto the road surface (Fig. 4). Maintenance costs of this road are extraordinarily high (circa \$2M: data from Whakatane District Council) relative to the number of people the road serves (six families).

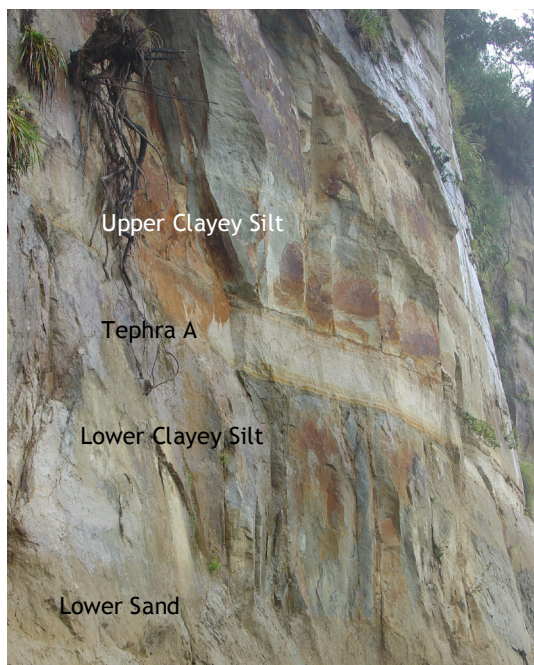
Figure 4- Failed surface along Herepuru Road from moderate storm in 2006. Fracturing and oxidation of clayey silt is evident. Lower sand is exposed at the base of the photo. Tephra A is ~ 1 m.

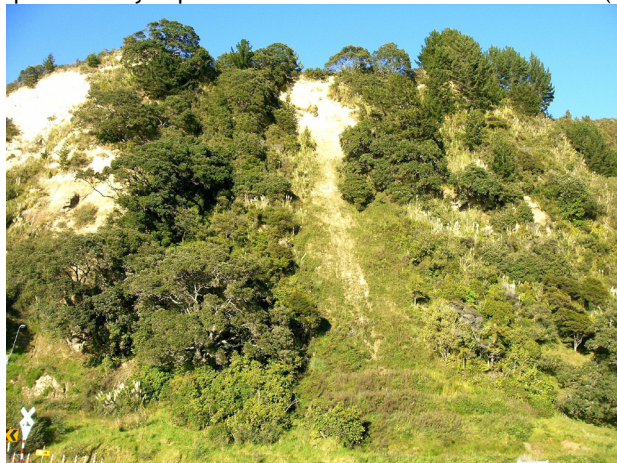
In the coastal area, debris avalanches generally occur from pumice gravels near the top of the cliffs. When dry or damp, these units exist in a metastable state. High pore water pressures due to heavy and prolonged precipitation or seismic accelerations have overcome the cohesion of the deposits and sent them avalanching downslope. These debris avalanches are moderately erosive, and tend to incorporate organic material, residual soil, and some weaker *in situ* material as they move. These landslides generally classify as active, complex, rapid to very rapid, moist to very wet, debris flow-debris falls (Cruden and Varnes, 1996). The term “debris avalanche” is used to

indicate that these landslides are not confined to channels, but instead flow rapidly in a nearly straight line down slope until they deposit their loads at the base of the cliffs (Fig. 5).

Figure 5 - Typical debris avalanche originating in pyroclastic deposits near the top of the cliffs. Flow path and deposits are also shown. Railroad crossing sign is approximately 2.5 m high. Location noted on Fig. 1.

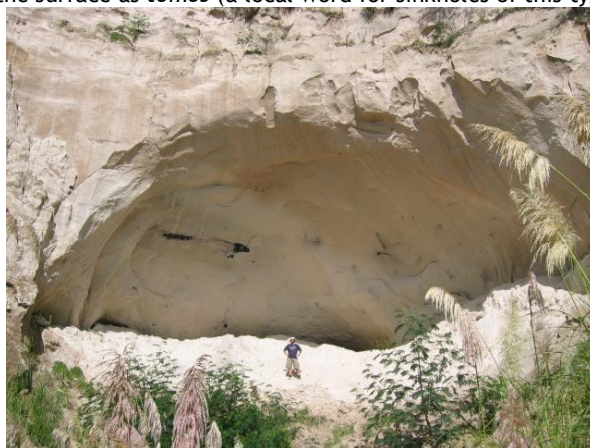
The two major ignimbrite units in this area were erupted over a pre-existing incised topography. In the case of the Rotoiti, it was deposited on top of a moderately developed paleosol or impermeable sediments. These sediments or the paleosols act as aquitards, preventing water from percolating further downwards and forcing groundwater to flow along the contact between the overlying pyroclastic material and the paleosol. During periods of intense and prolonged rainfall, pore water pressures can build near the cliff face until a catastrophic piping failure occurs (Fig. 6). This process can propagate through the materials, leaving large voids underground. In some cases, they will propagate up to the surface as *tomos* (a local word for sinkholes of this type).

Figure 6 - Large piping failure in Rotoiti ignimbrite. This pipe formed as a catastrophic failure during the May 2005 storm that also caused debris flows in Matata. See person for scale.
